# **Burundi – Management and Protection of Groundwater Resources**

Lineament mapping for the localisation of high groundwater  
potential  
using remote sensing

Dr. Kai Hahne

Hannover, December 2014

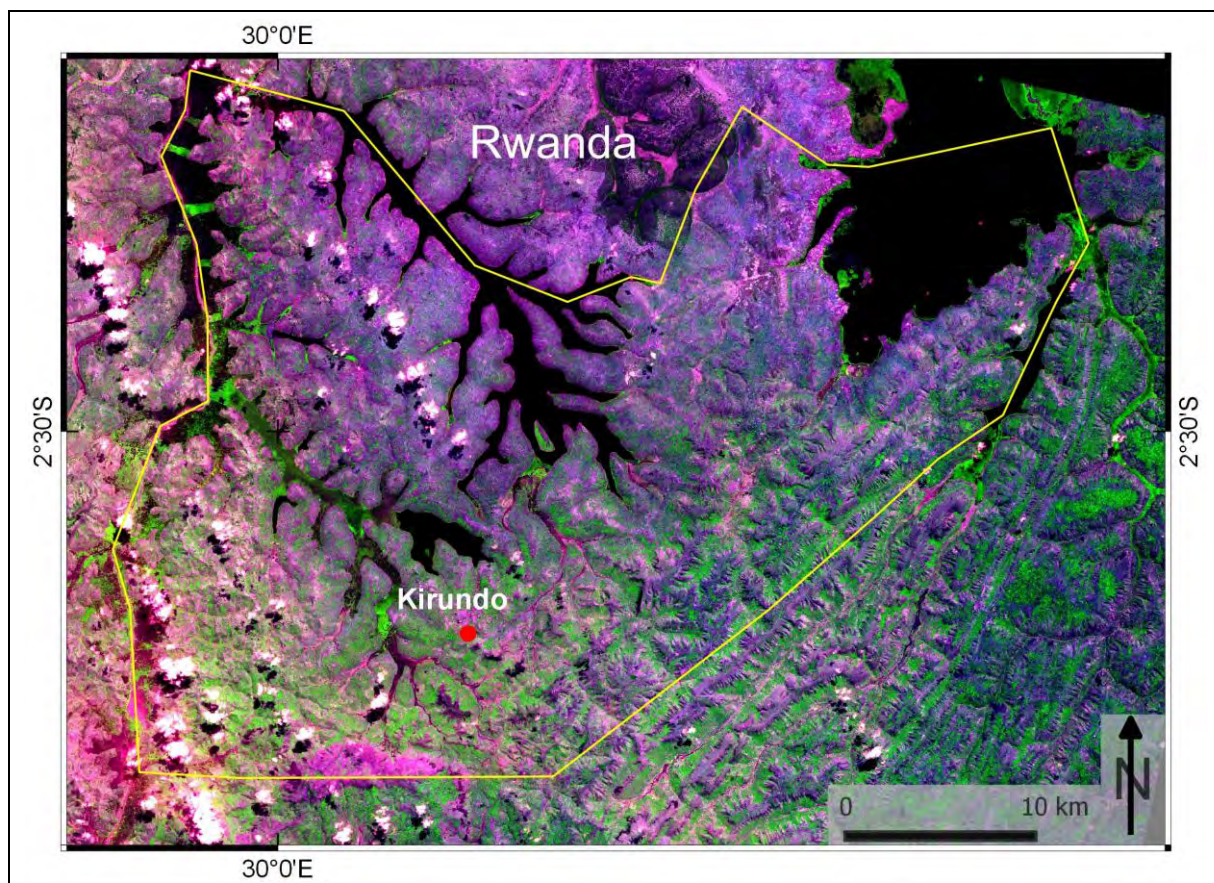
Figure 2.2: Working area 1 in Kirundo province. Projected onto SPOT bands 2,3,1 (RGB).

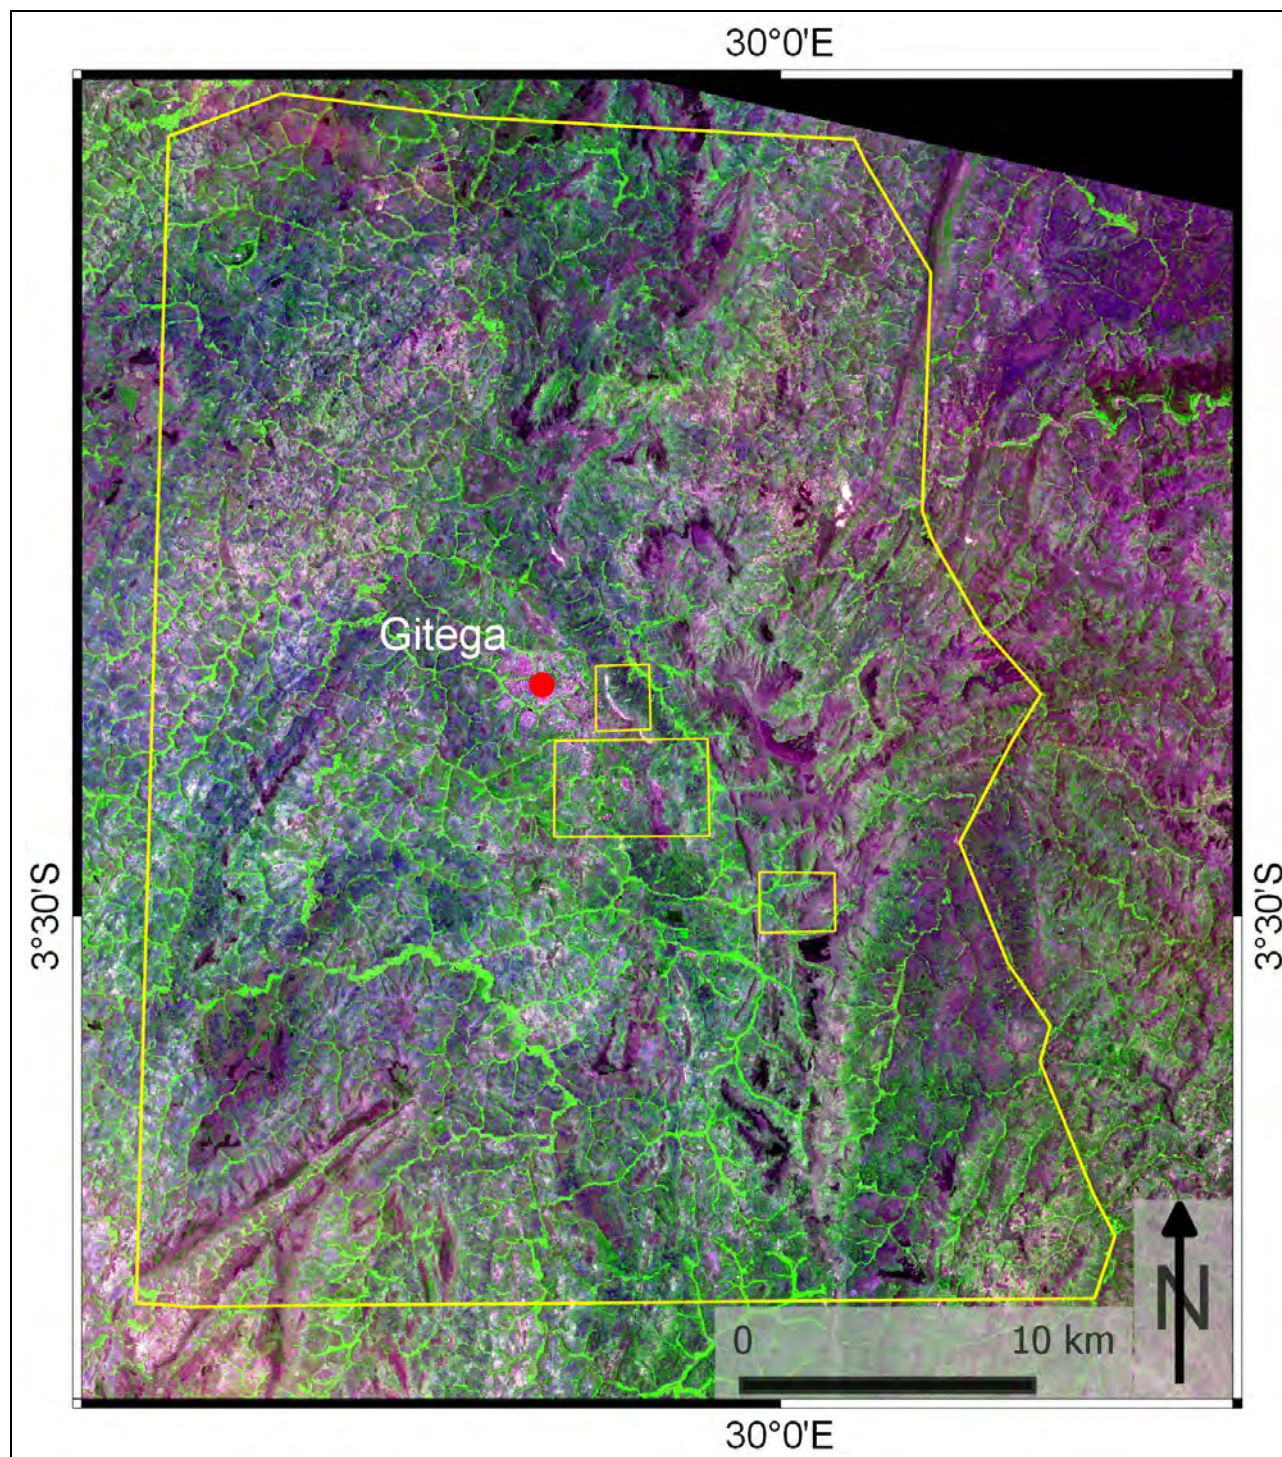
Figure 2.3: Working area 2 in Gitega province. Yellow rectangles mark areas of special interest. Projected onto SPOT bands 2,3,1 (RGB).

In the area of Gitega (Fig. 2.3) the main structural trend is NW-SE. Lineaments are striking parallel to this trend (SE, app. 130°-170°) as well as in diagonal directions (NE 050°-060° and SE 110°-120°. Fig. 5.7).

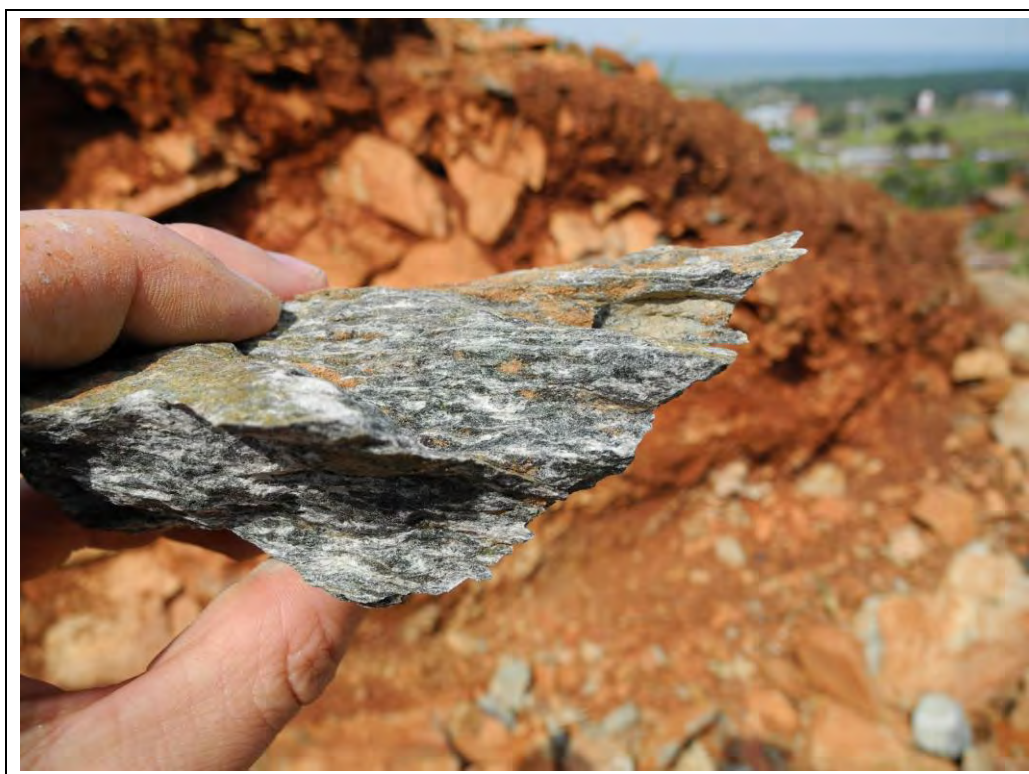
Figure 4.1: Amphibolitic gneiss in a building pit north of Rumonge (WP 83).

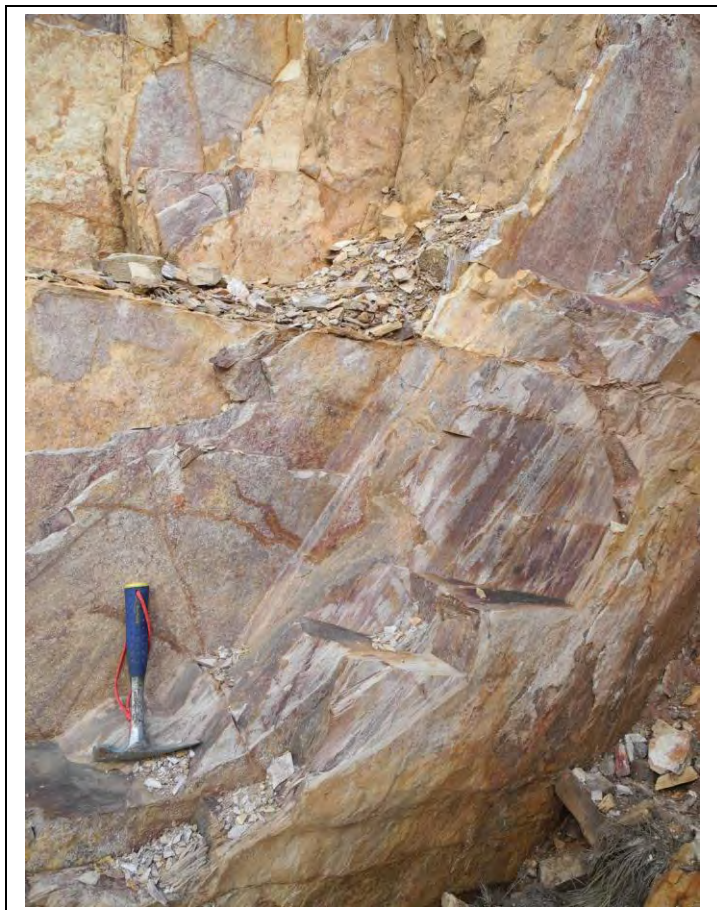
Figure 4.2: Fine pinkish Quartzite east of Gitega (WP 53).

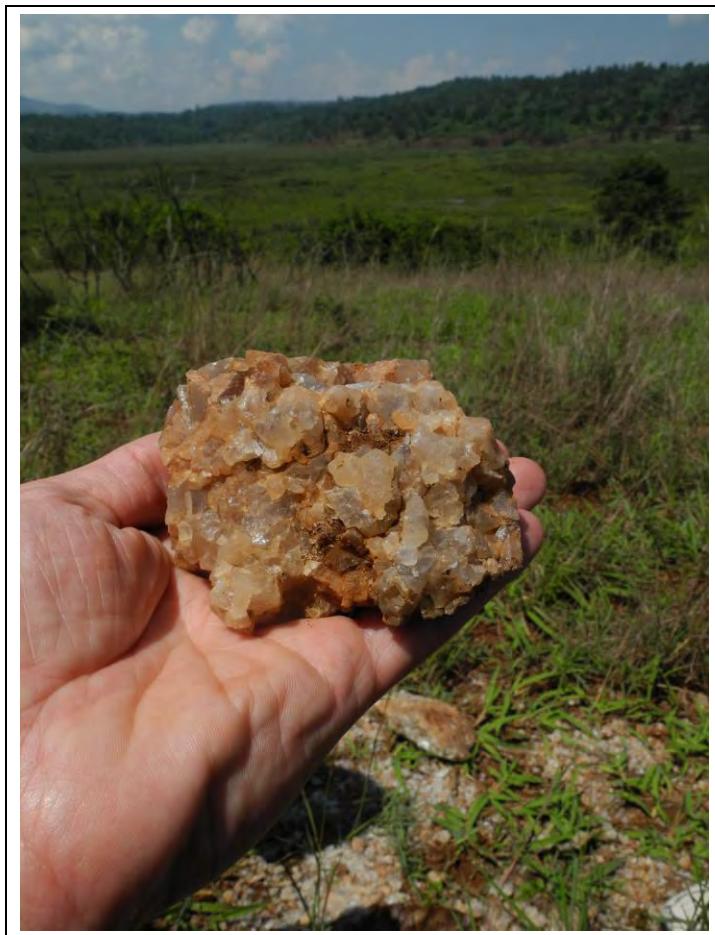
Figure 4.3: Coarse undeformed Quartzite north of Kirundo (WP 01).

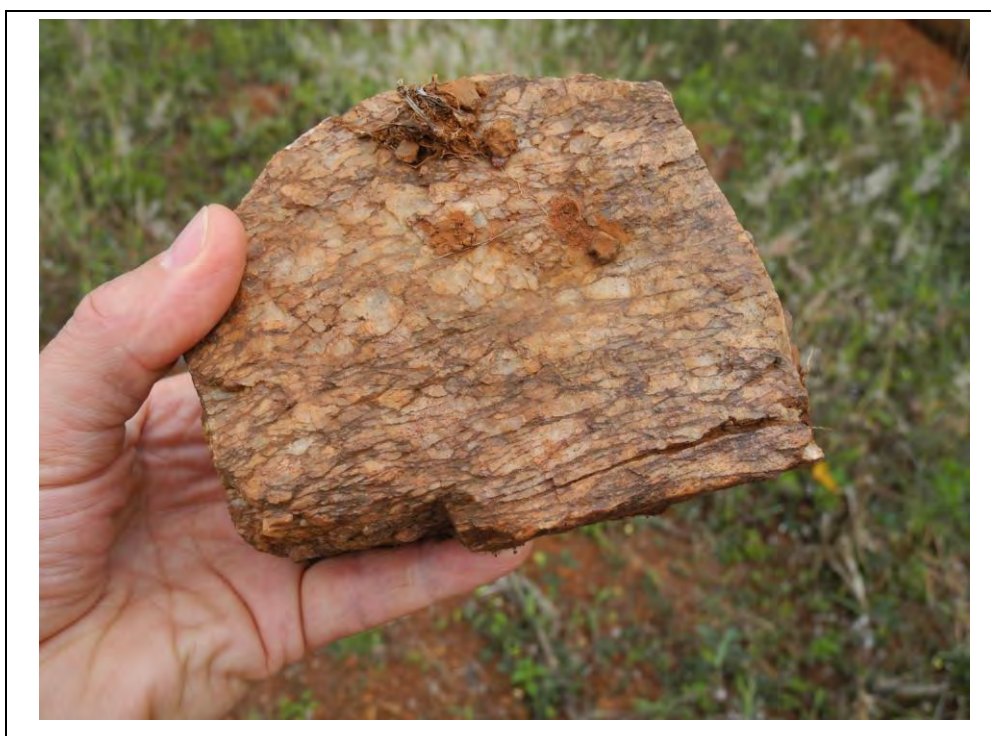
Figure 4.4: Quartzite with cataclastic texture north of Kirundo close to Rwandan border (WP 52).

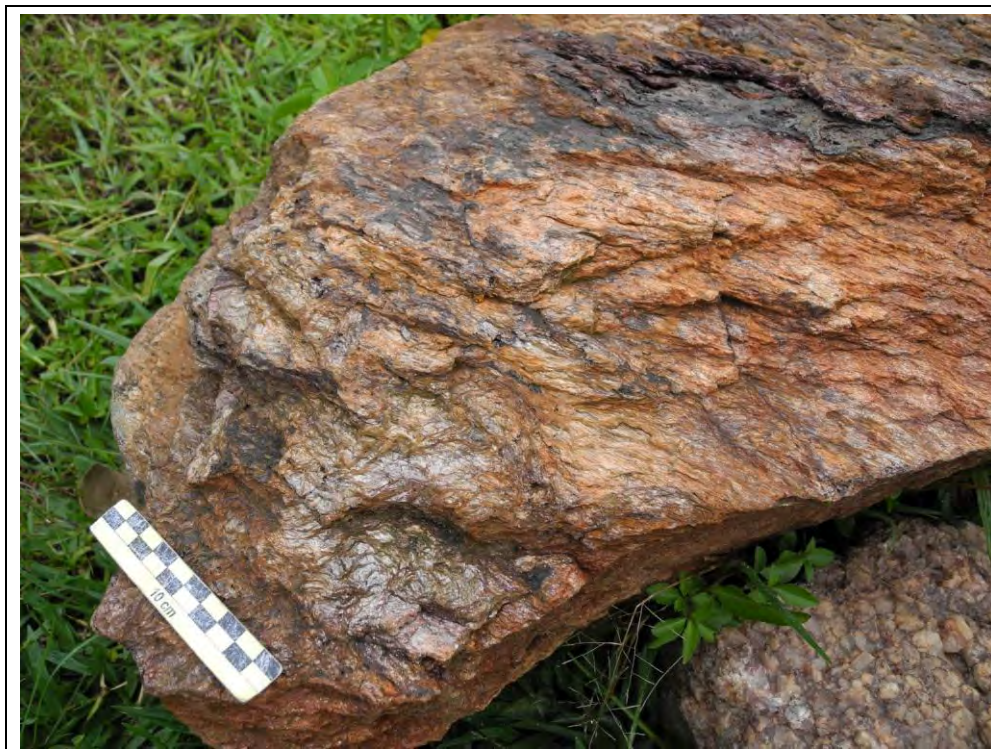
Figure 4.5: Mica schist with graphite. Location north of Kirundo (WP 21).

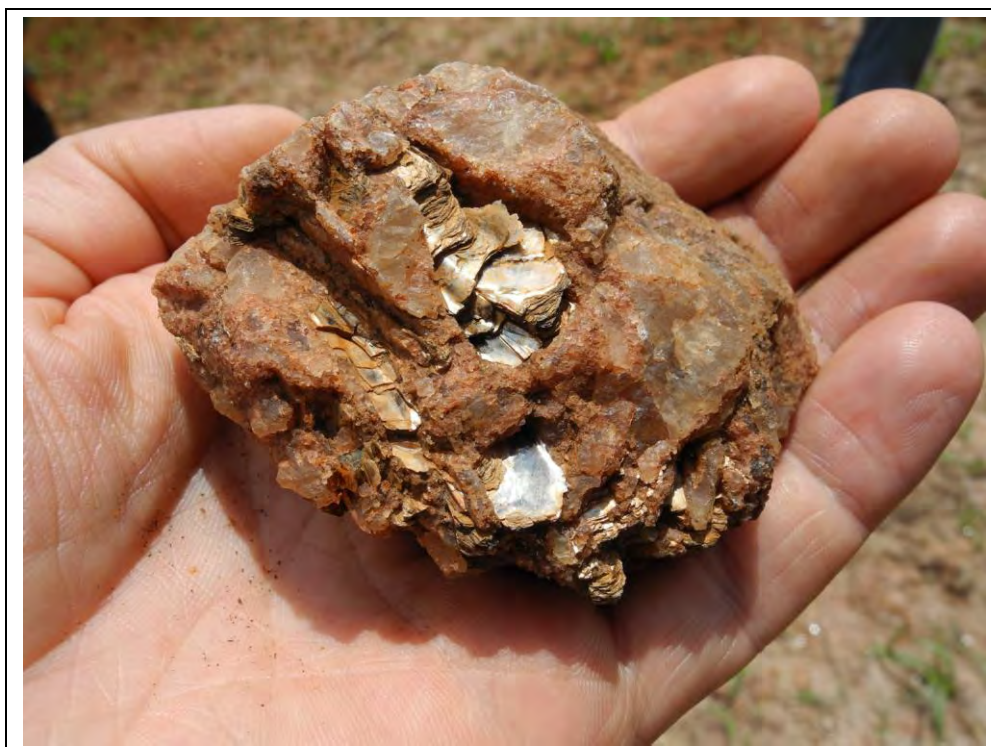
Figure 4.6: Tall Mica and Quartz crystals of a pegmatitic vein. Location north of Kirundo (WP 29).

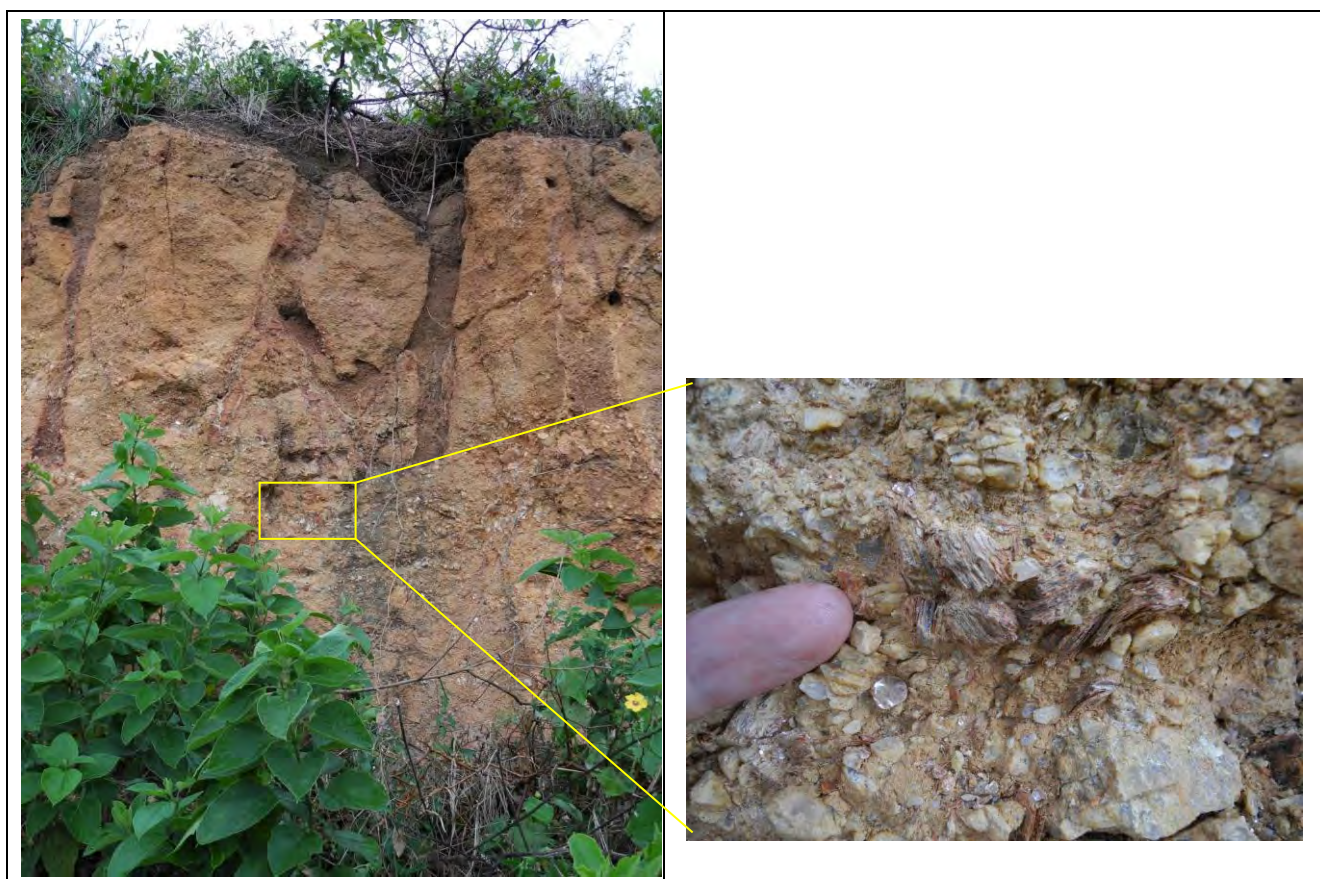
Figure 4.7: Left: Soil development (with holes from roots) on pegmatitic substrate. Right: altered pegmatite. Locations north of Kirundo (WP 40).

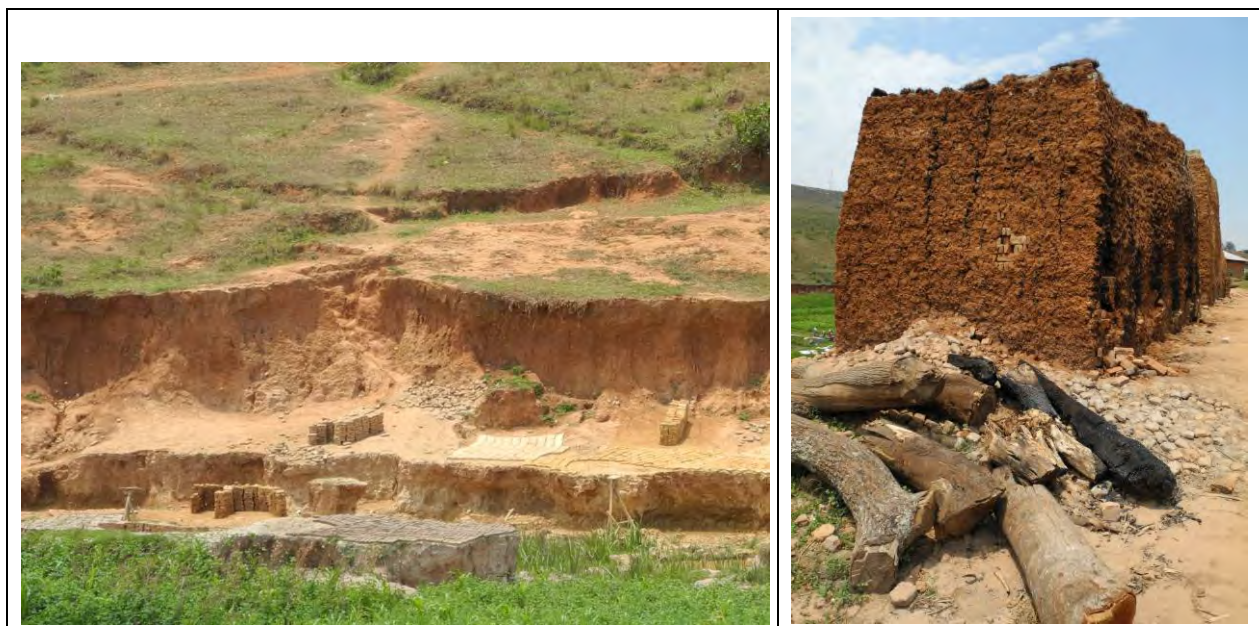
Figure 4.8: Left: thick soils in valley bottoms are used for the production of bricks. Right: Simple oven for the brick production. Both locations situated east of Gitega.

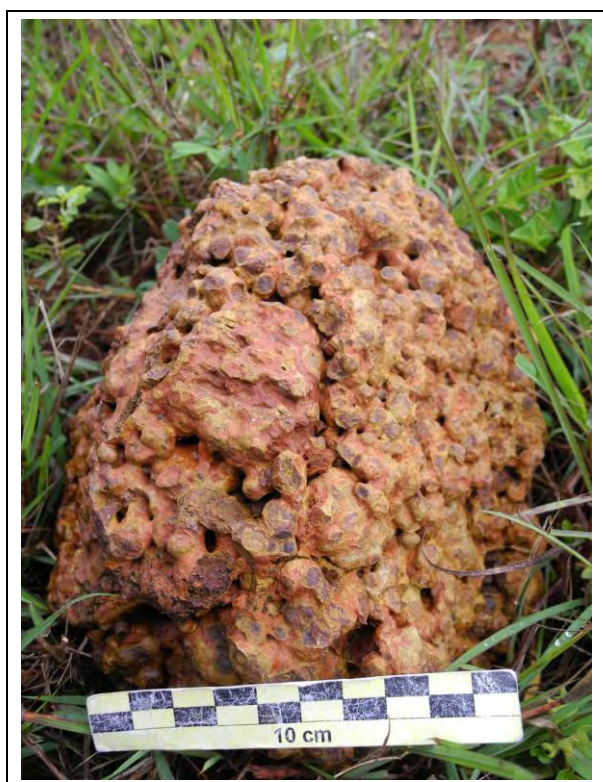
Figure 4.9: Pisolithic laterite crust. Location north of Kirundo (WP 15).

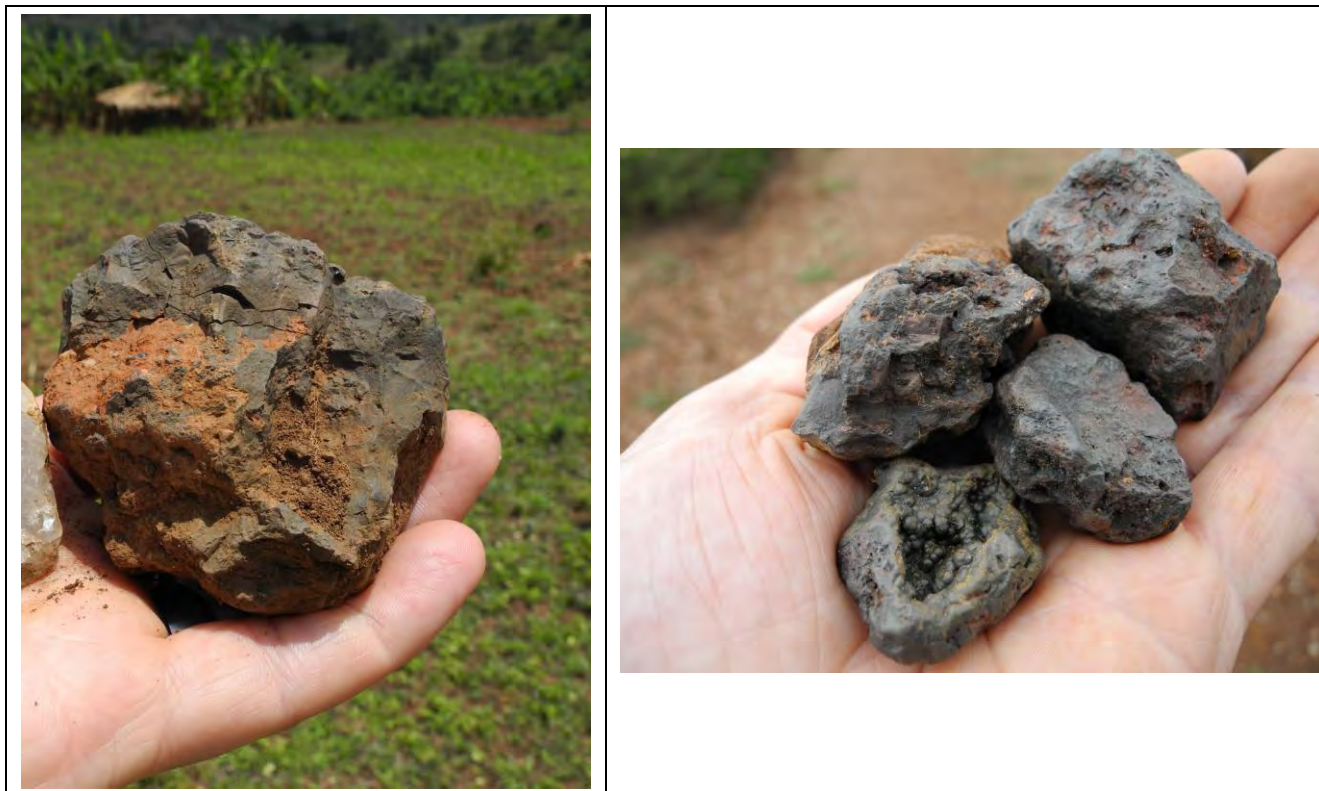
Figure 4.10: Left: thick iron oxide crust (WP 29). Right: Iron concretions (WP 21) genesis by intensive tropical alteration. Both locations are situated north of Kirundo.

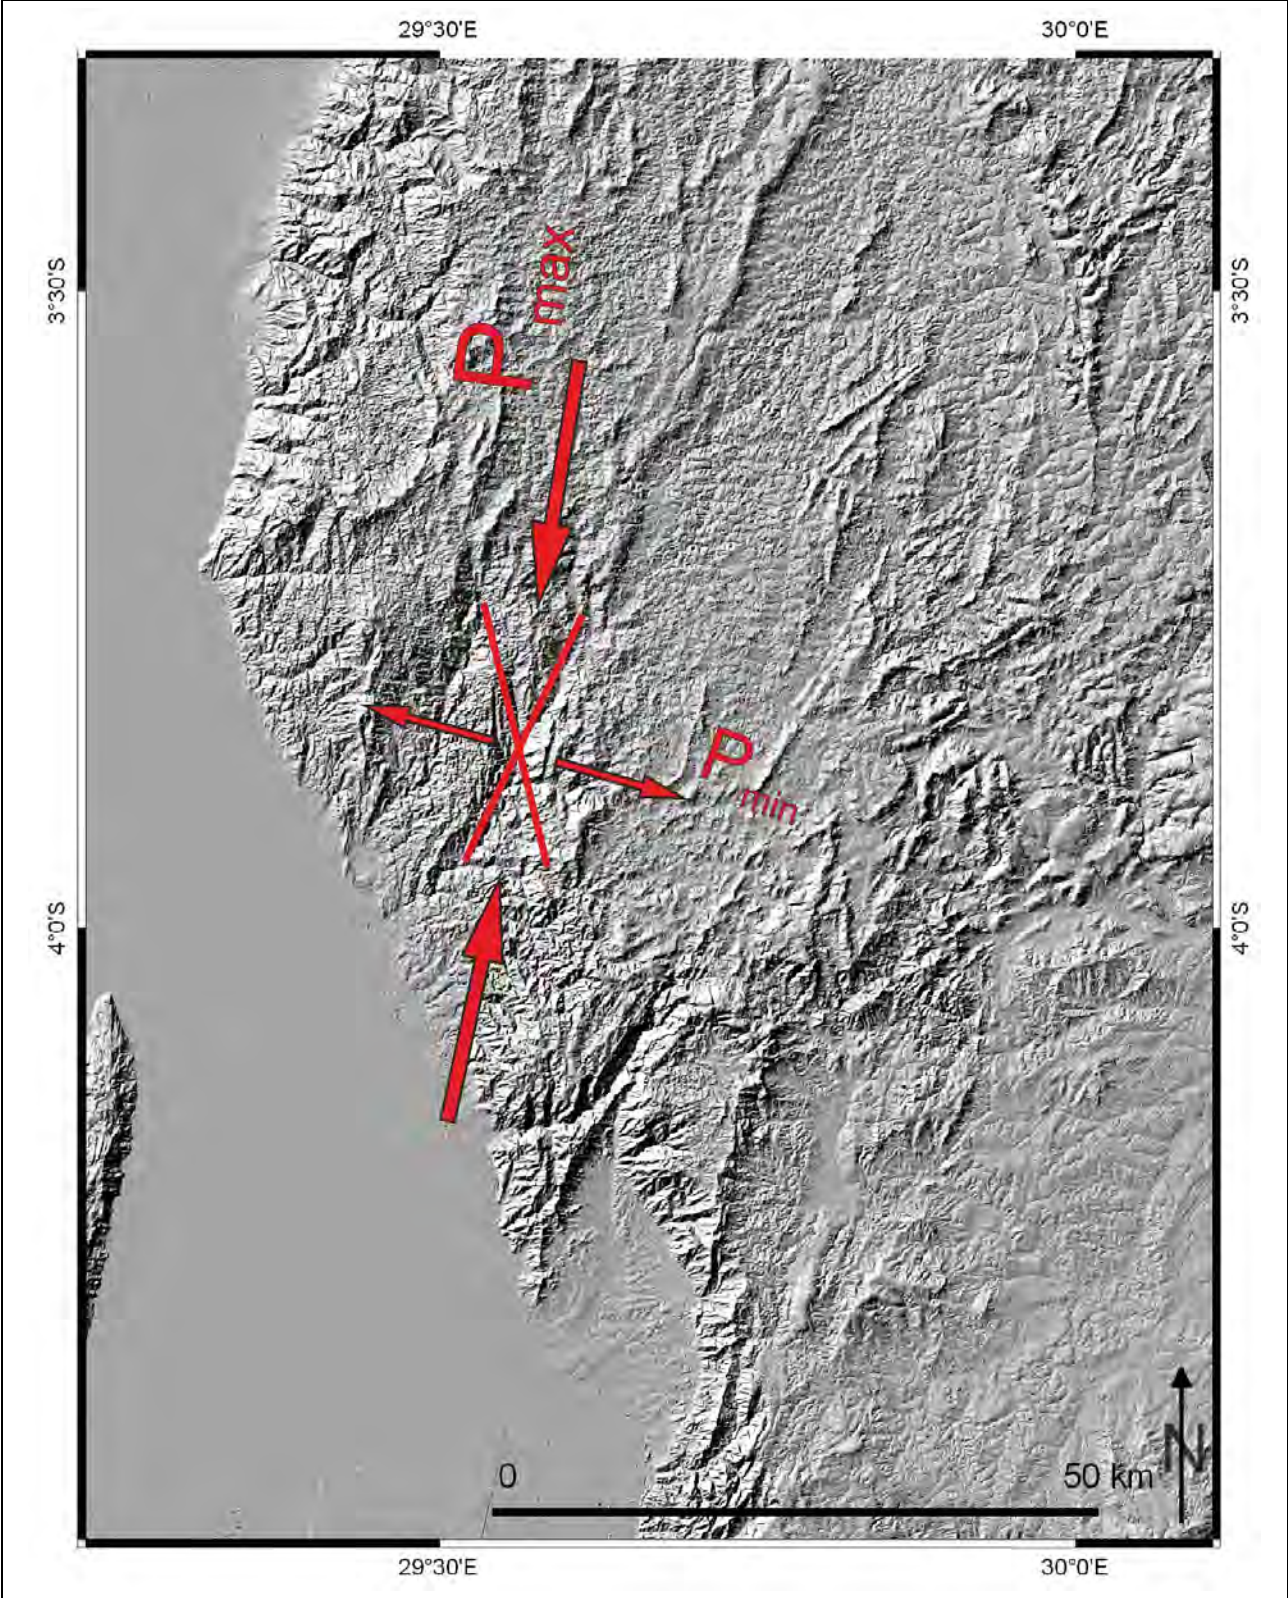
Figure 5.2: Close up of the area defined by the rectangle in fig. 5.1. The directions of maximum principal stress can be derived from satellite imagery, regarding the X-shaped stress indicators (red lines). The acute angle between conjugate faults (red lines, one example of plenty existing) is bisected by the maximum principal stress direction (Pmax). The direction of effective Pmin corresponds to the direction of the opening rift.

Around the area of Rumonge the rift direction of Lake Tanganyika becomes clear on satellite images by the expression of x-shaped stress indicators which are formed by conjugate fault systems (Fig. 5.2).

The acute angle between conjugate faults is bisected by the maximum principal stress direction ( $P_{max}$ ). The direction of the effective minimum principal stress ( $P_{min}$ , perpendicular to  $P_{max}$ ) corresponds to the opening direction of the rift (Fig. 5.2).

Coast parallel lineaments belong to a system of conjugate faults (Fig. 5.2) striking NE ( $040^{\circ}$ - $060^{\circ}$ , subordinate  $010^{\circ}$ - $025^{\circ}$ ) and SE ( $135^{\circ}$ - $170^{\circ}$ ). They express a relatively young tectonic movement, which is strongly connected to rifting. The young age of the movement becomes obvious, as Cenozoic and Quaternary sediments are affected as well as the basement rocks (Fig. 5.4).

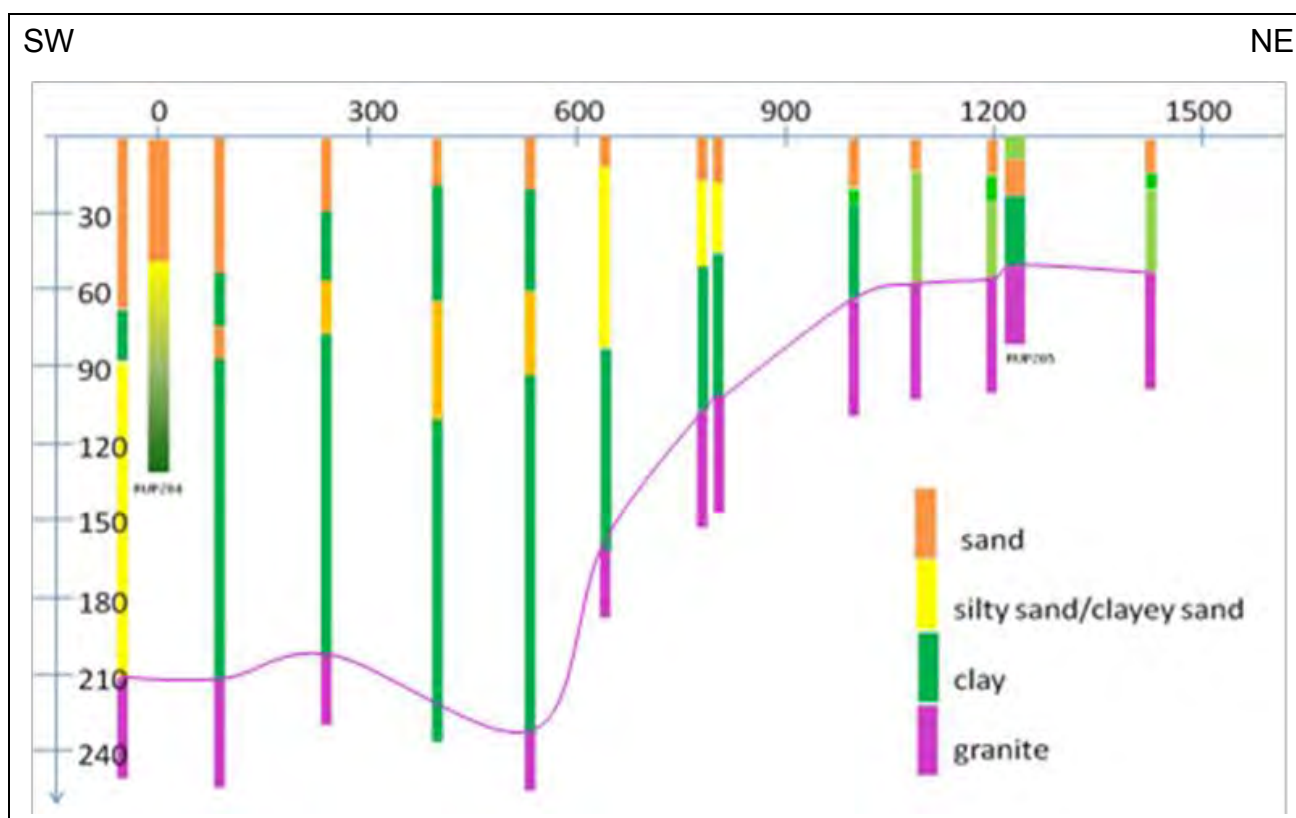
Figure 5.3: Interpretation of a TEM profile in Rumonge perpendicular to the shoreline of Lake Tanganyika. The diagram (modified after NOELL, U. 2014) reveals strong evidence for the developing rift structure. Vertical offset of the basement (granite) coincide with lineaments visible on satellite imagery (Fig. 5.4).

Where young sediments are present closer to the shore, they overlay the basement rocks (metamorphites and granites). The increasing thickness of the sedimentary layers towards Lake Tanganyika is shown very clear in a recent TEM measurement profile. It reveals strong evidence for the developing rift structure (Fig. 5.3, NOELL, U. (2014).

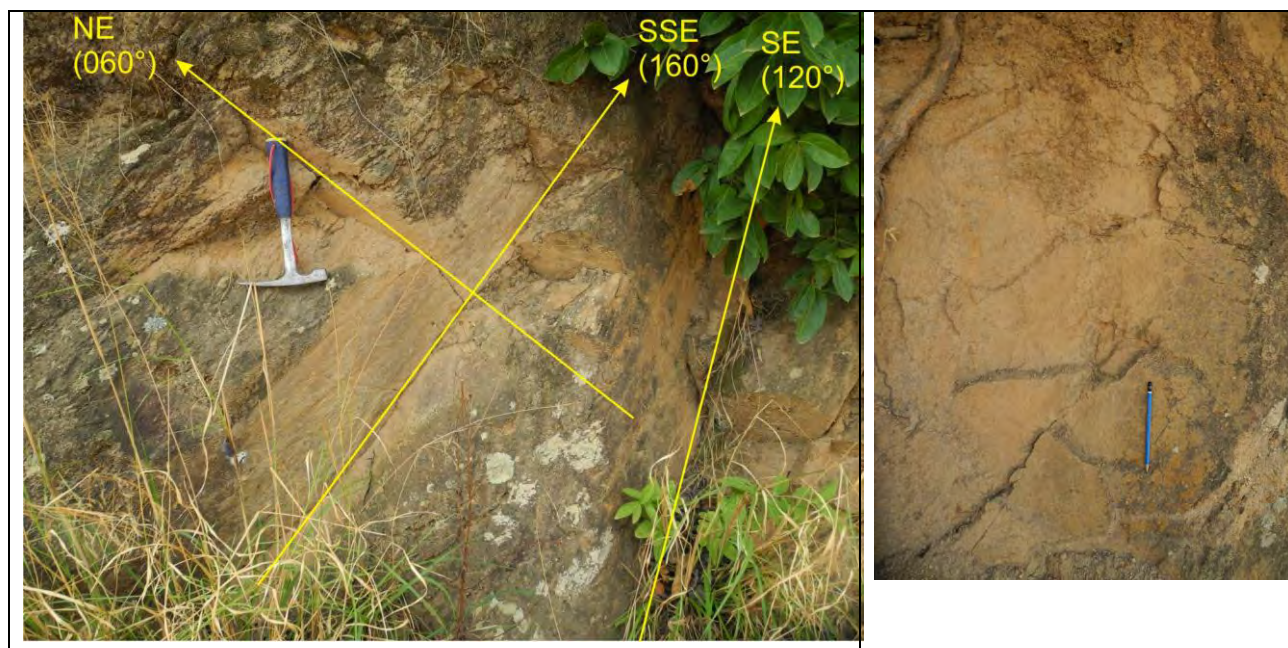
Figure 5.5: Left: (WP 85) Outcrop showing different joint planes with corresponding lineament directions at a small scale. Right: (WP 84) Tear-off edges show an upward-directed relative-movement of a former hanging wall.

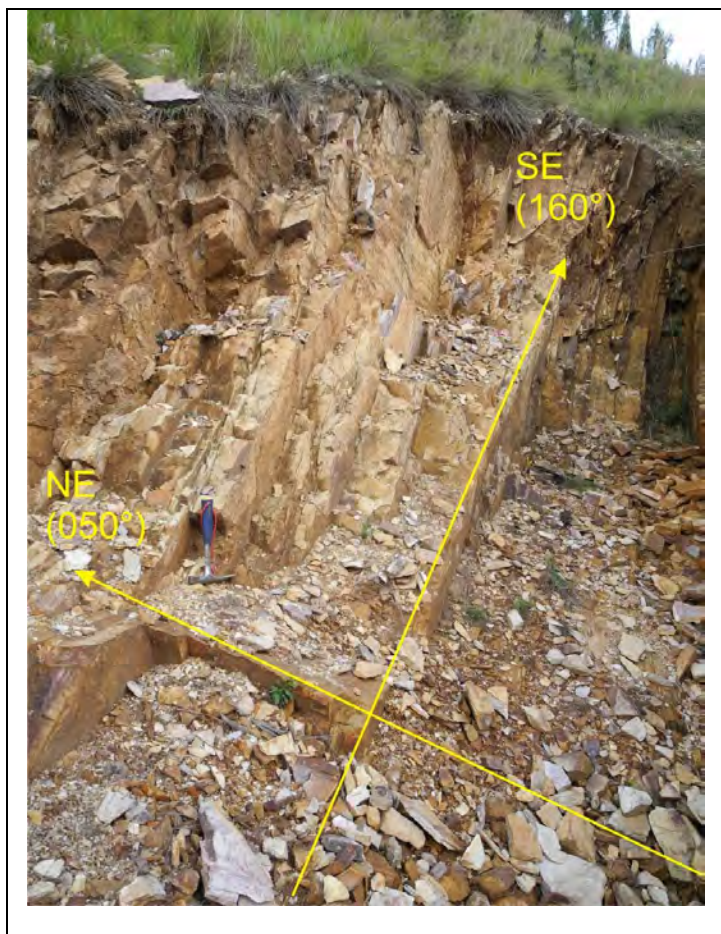
Figure 5.7: Steep dipping Precambrian quartzite (WP 53). Foliation and joints correspond to NE and SE striking lineaments.

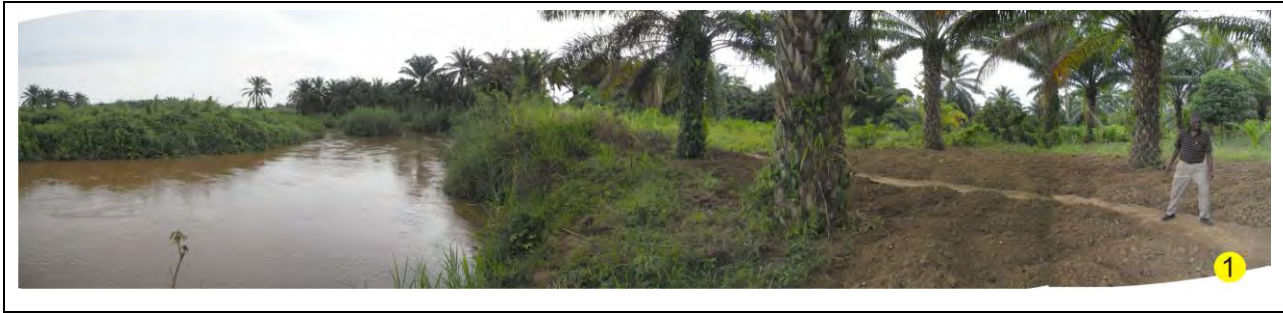
Figure 6.2: View from 180° to 320° (WP 80): The river bed corresponds to a lineament of Category 1. Other lineaments are not visible on the ground. The angular course of the river traces different lineament directions of the basement.

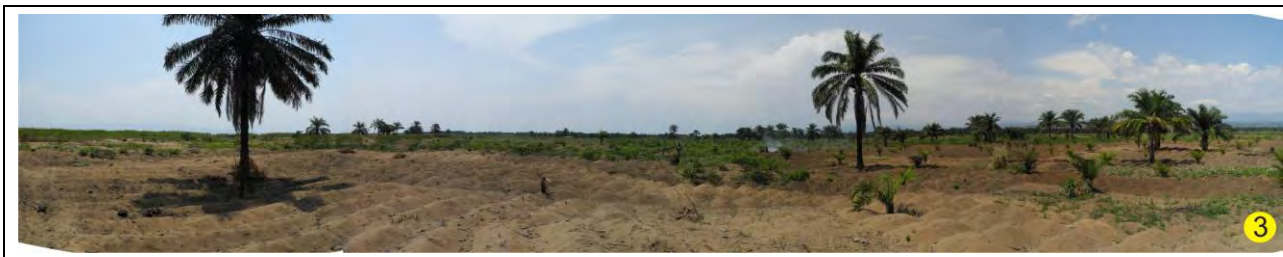
Figure 6.4: View from 230° to 360° (WP 79): No shore-parallel lineaments of Category 4 are visible in this plantation.

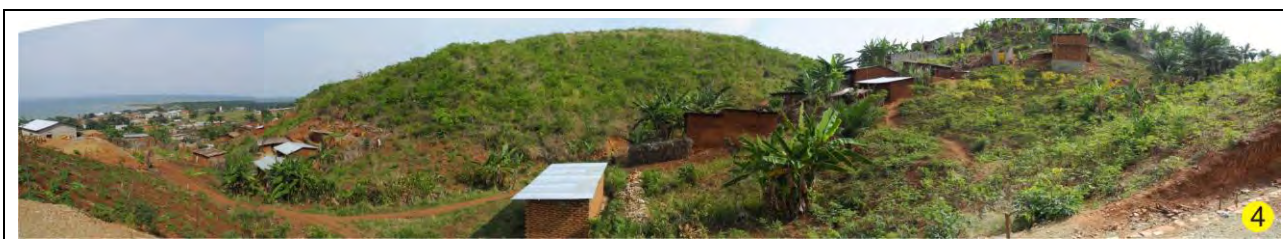
Figure 6.5: View from 260° to 090° (over North, WP 83): Lineaments of Category 3 form clearly visible valleys which are here corresponding to faults.

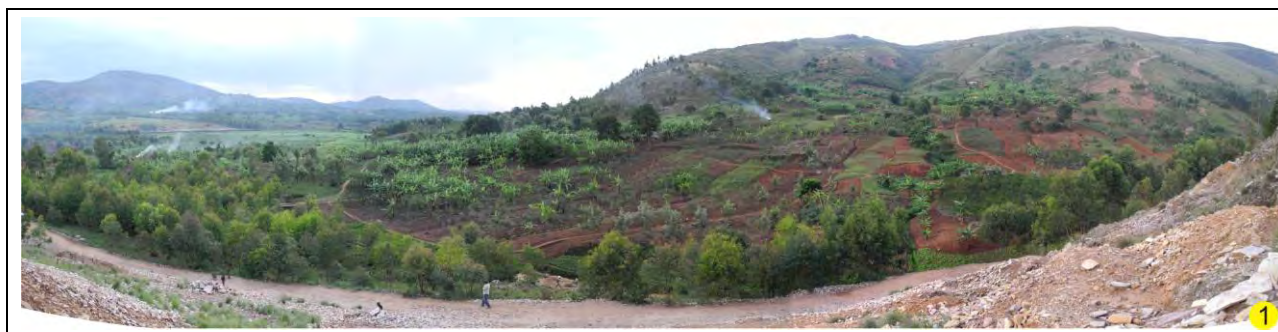
Figure 6.7: View from 260° to 030° (WP 54): Lineaments of Category 2 (side valley in foreground) and Category 1 (main valley in background) are represented by major valleys.

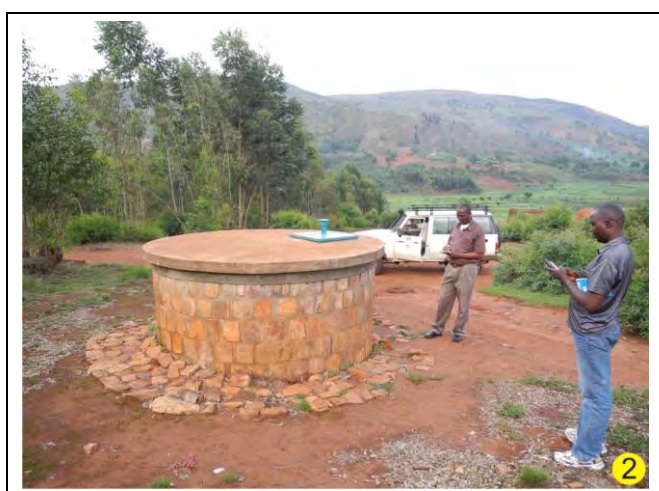
Figure 6.8: Well on a lineament of Category 3. View to NE towards a main valley of Category 1 (WP 56).

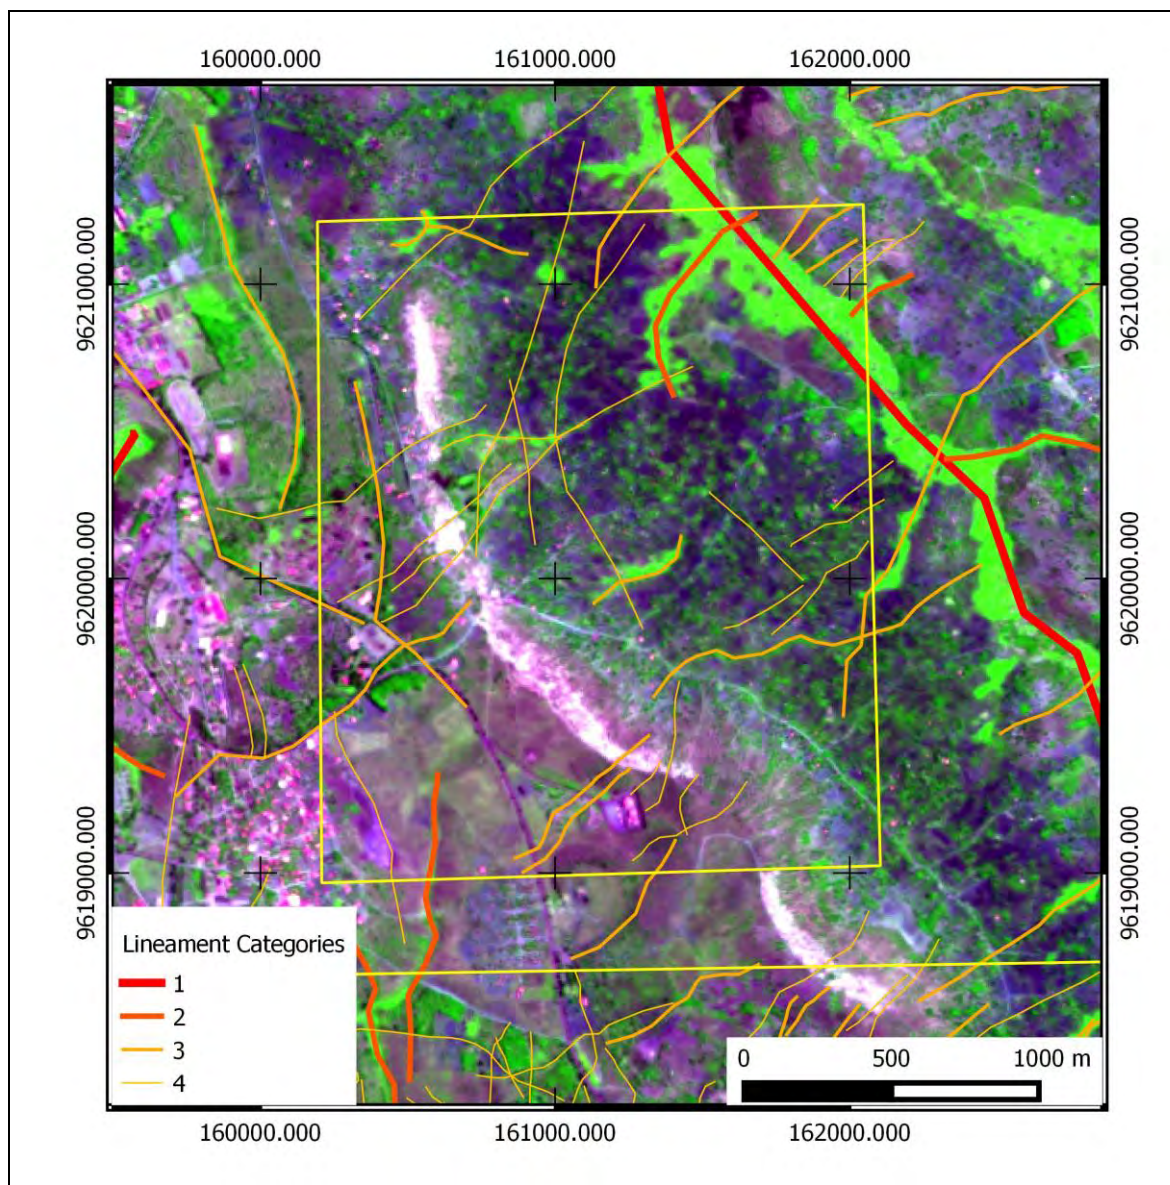
Figure 6.9: Lineaments of Gitega Area A. SPOT bands 2,3,1 (RGB).

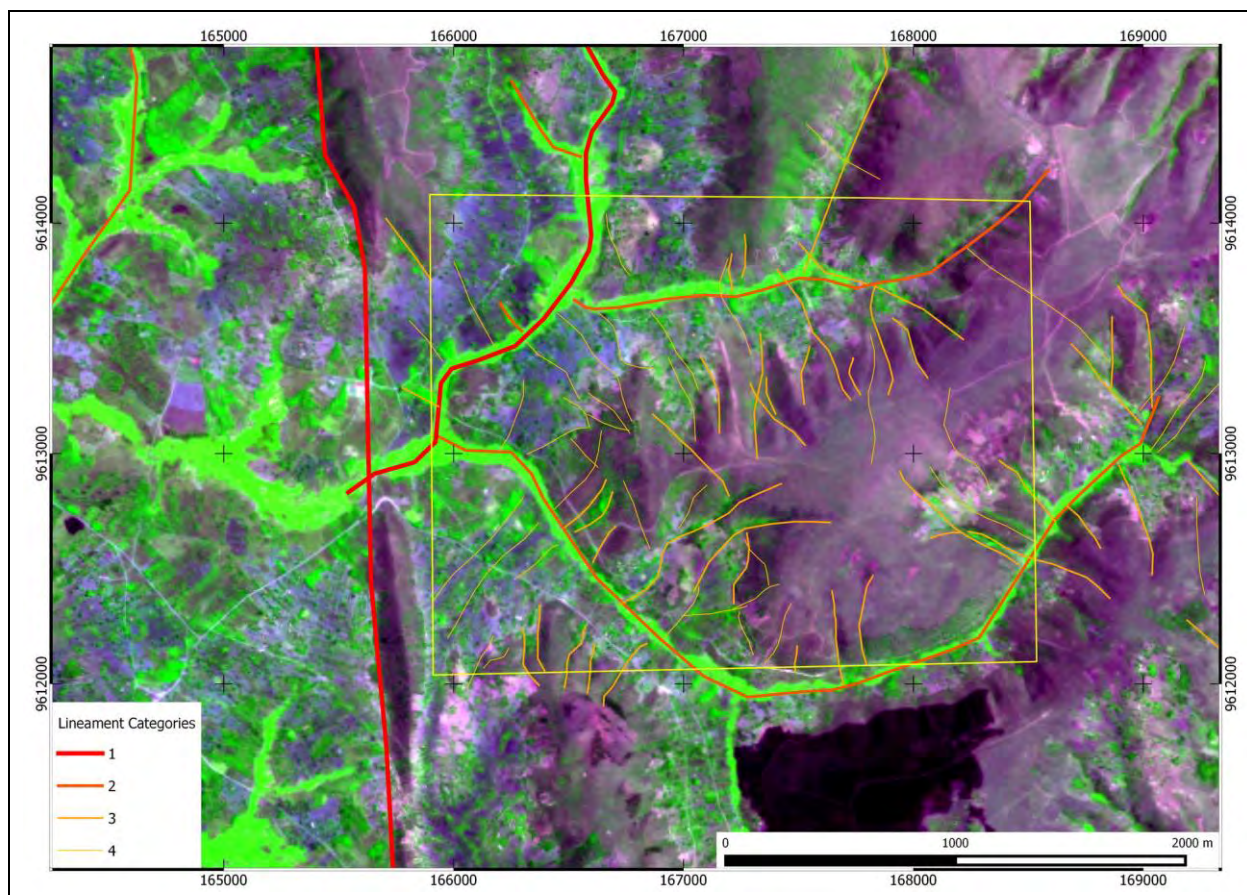
Figure 6.11: Lineaments of Gitega Area C. SPOT bands 2,3,1 (RGB).

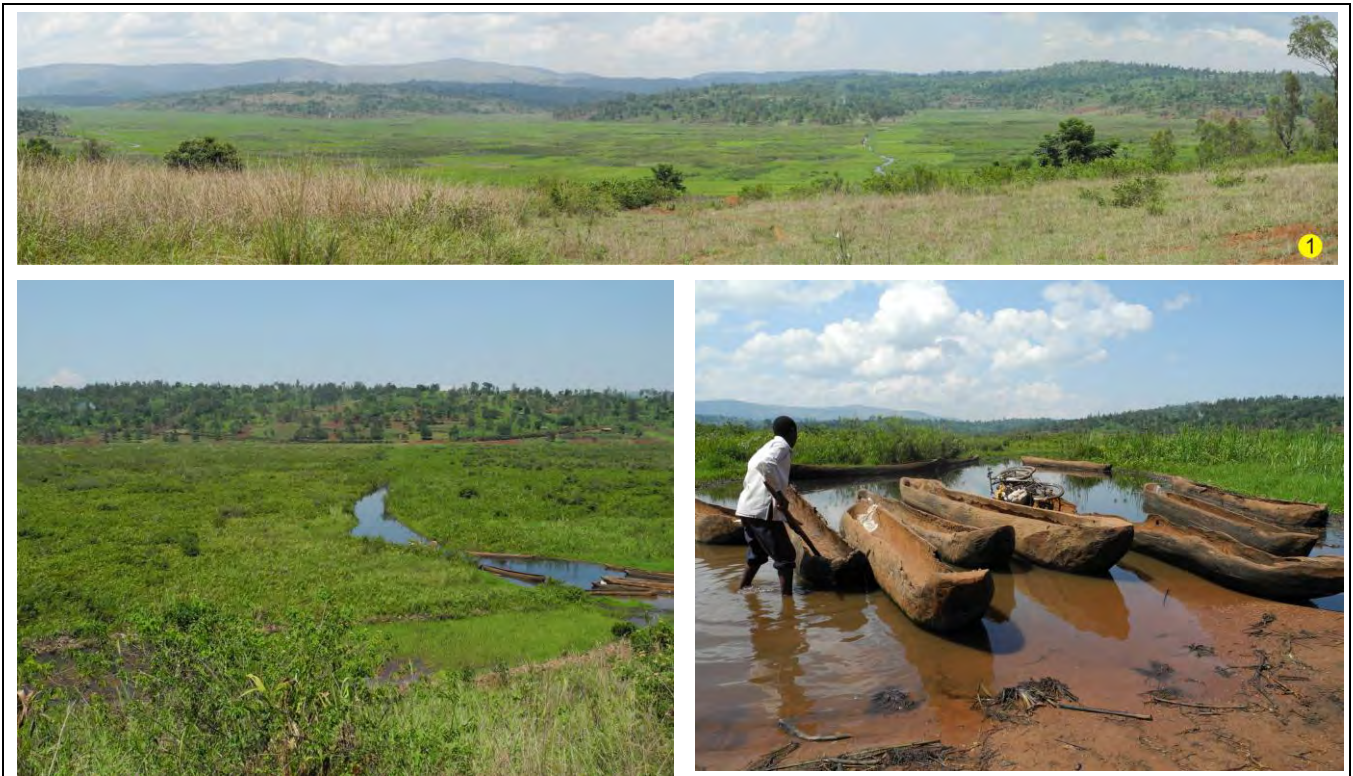
Figure 6.14: Above: View from 170° to 250° (WP 03): Valley bottoms follow lineaments of Category 1 and are filled with swamps. Lineaments of minor categories are not visible from this position. Below: Transportation between villages separated by swamps (WP 01).

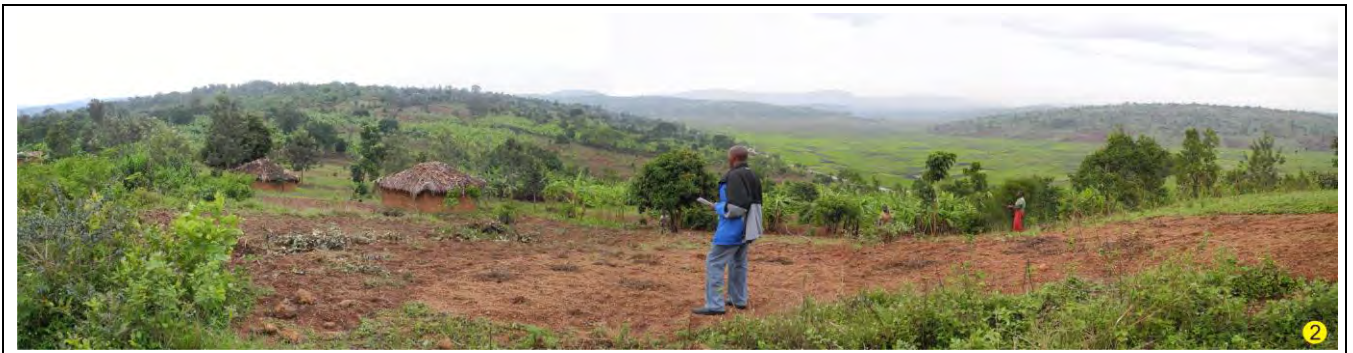
Figure 6.15: View from 120° to 230° (WP 16): Valley bottoms represent lineaments of Category 1. Lineaments of Category 3 are visible as minor depressions running towards the main valley.

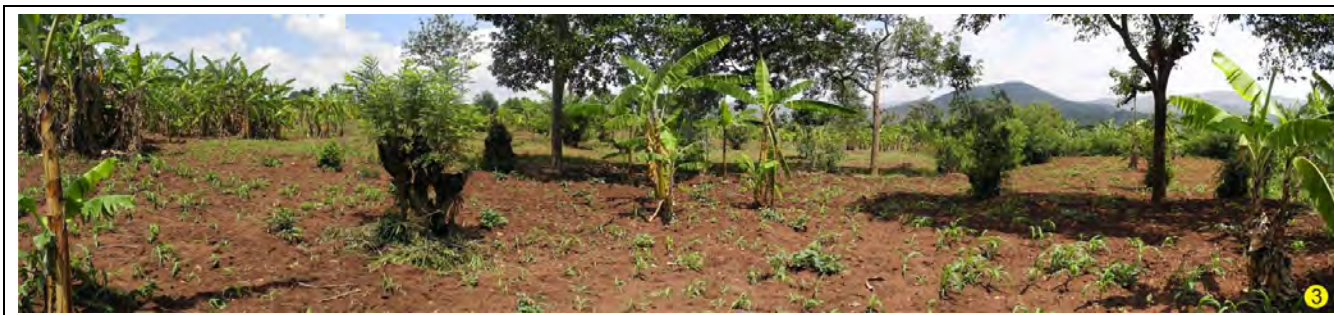
Figure 6.16: View from 050° to 170° (WP 09): Lineament of Category 4 is not visible in this plantation. Lineament of Category 3 is almost invisible and can be presaged by a minor depression in the background (right edge).
