# **Burundi – Management and Protection of Groundwater Resources**

Lineament mapping for the localisation of high groundwater  
potential  
using remote sensing

Dr. Kai Hahne

Hannover, December 2014

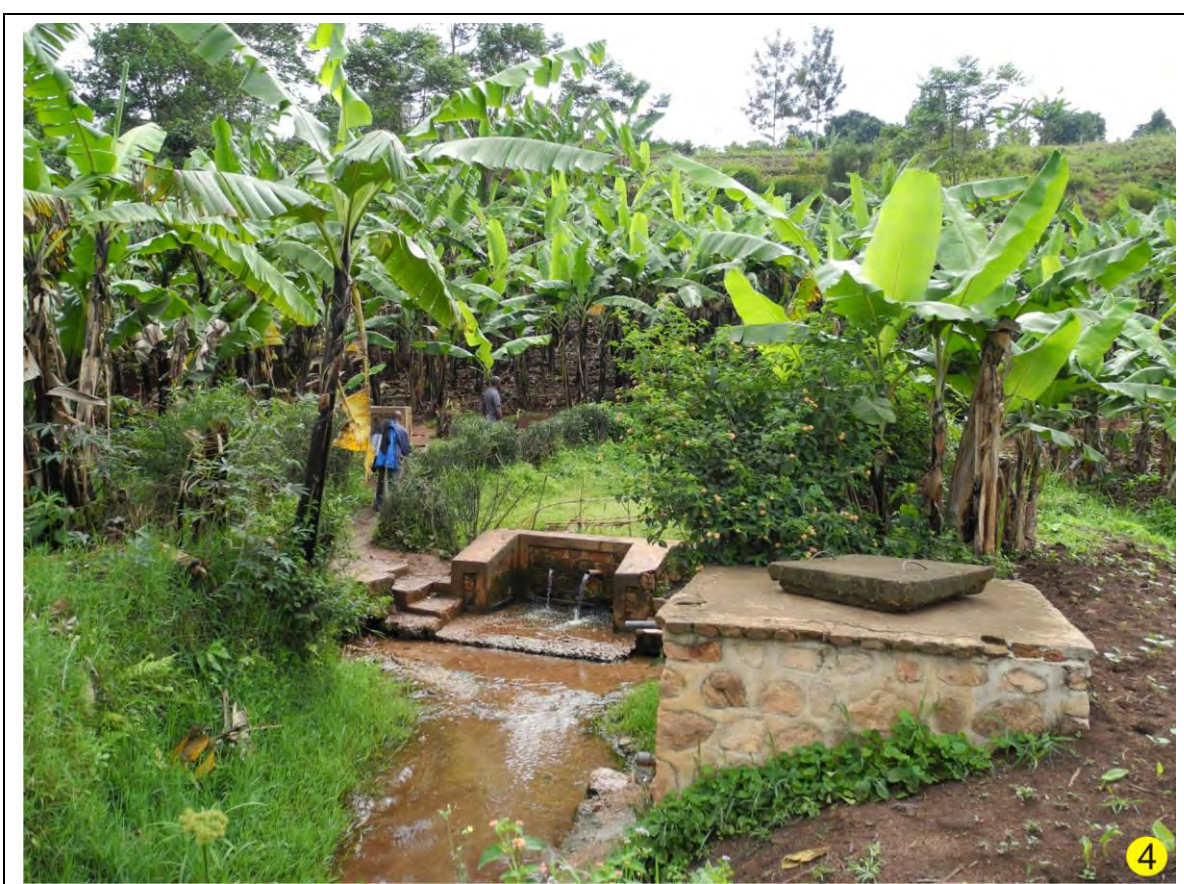
Figure 6.17: Wells at an intersection of minor lineaments (Category 3 and 4) prove that these lineaments are open for groundwater migration. WP 26, view to 060°.

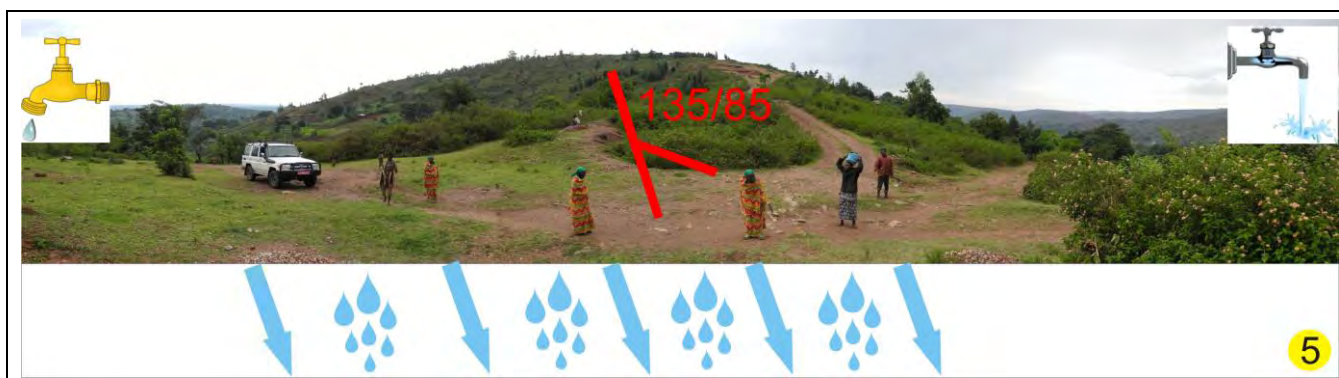
Figure 6.18: View from 320° to 110° (WP 21). A lineament of Category 2 is divided by a ridge. Schist foliation is dipping steep (85°) to SE. A well in the NW supplies only little- while a well in the SE delivers plenty of water. The most probable reason is additional groundwater contribution by open foliation in this area.

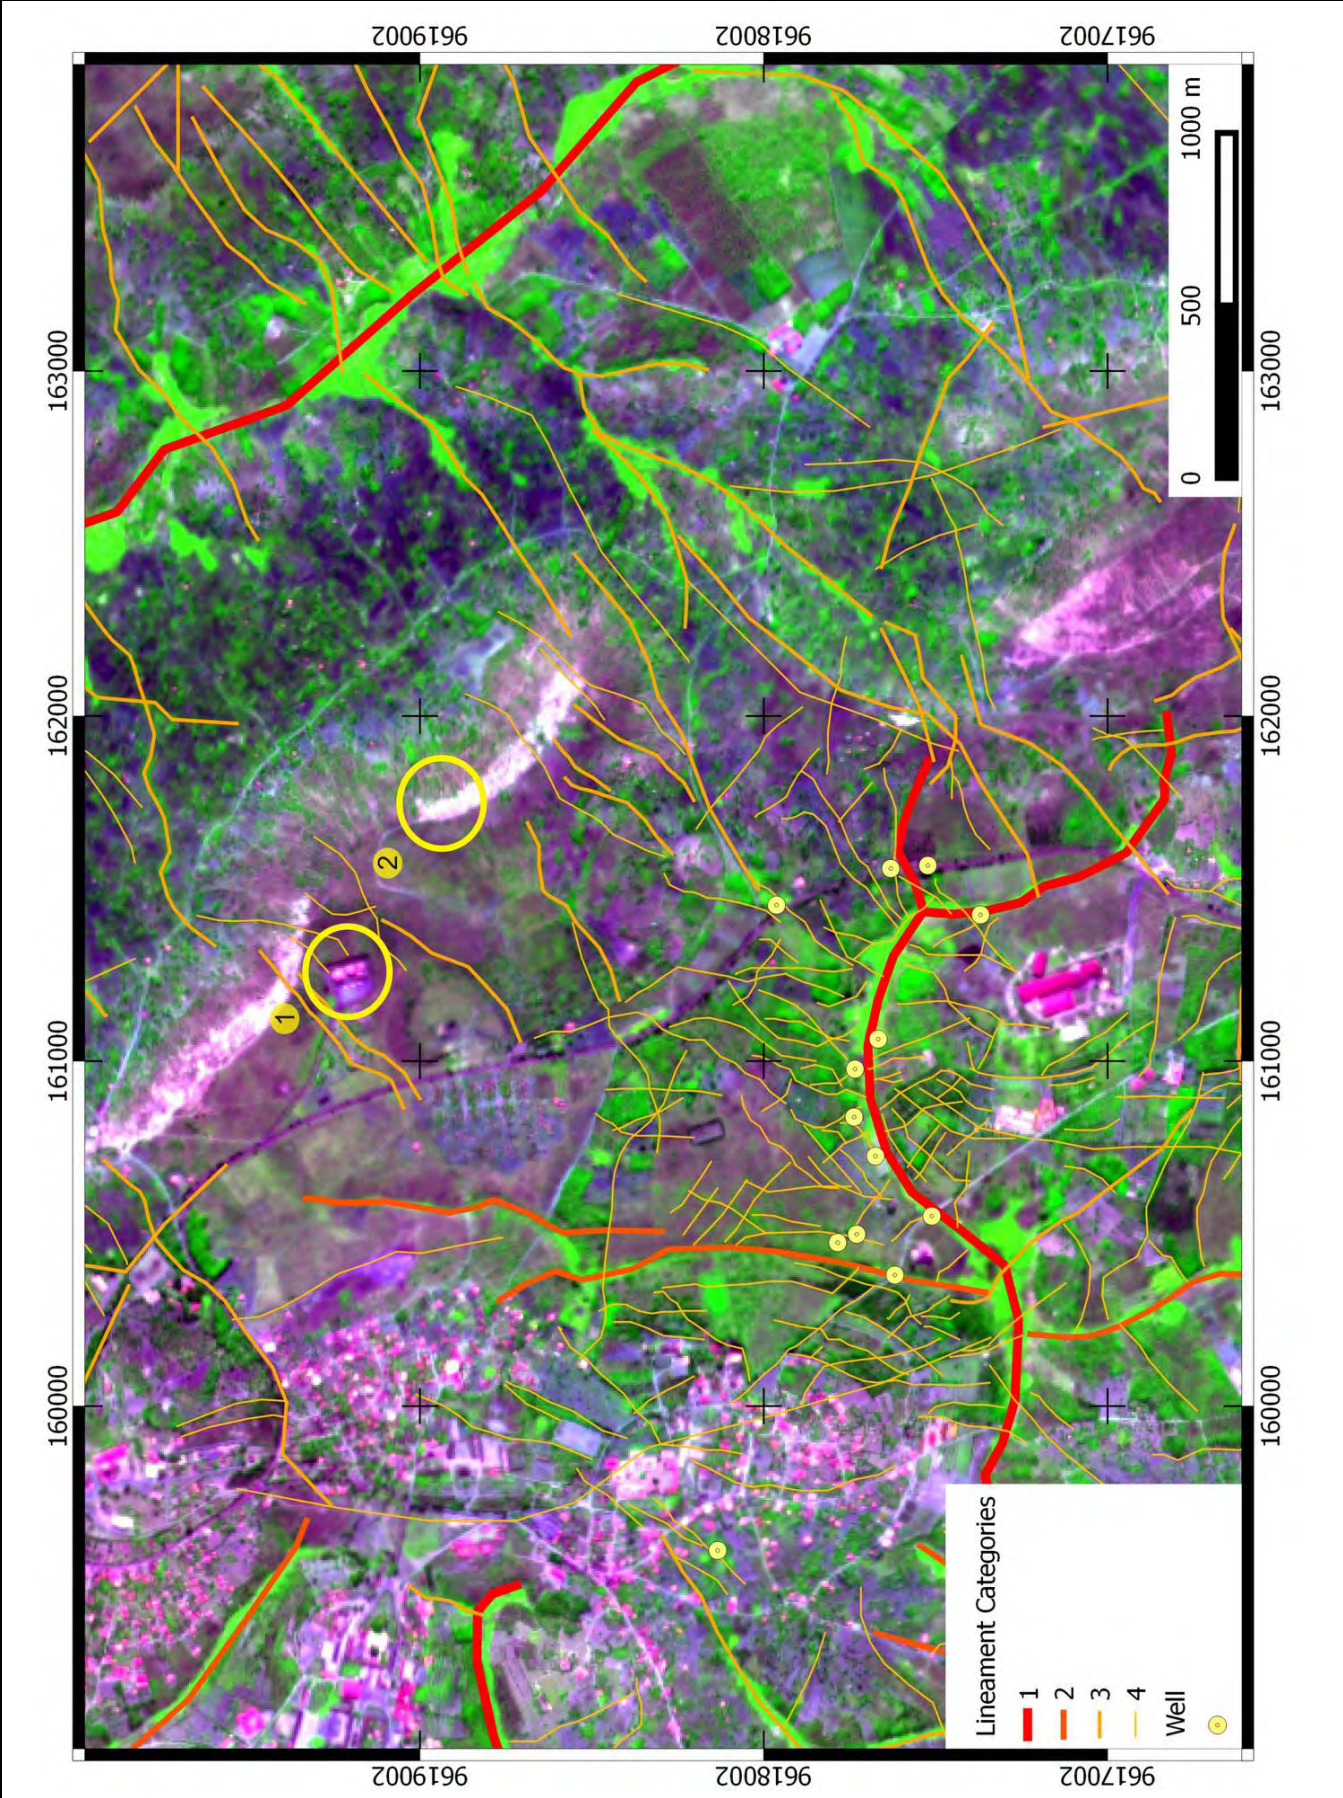
Figure 7.1: Sites of possible contamination at Gitega. Numbers 1 and 2 and yellow circles mark the locations of field photos. SPOT bands 2,3, (RGB).

Many of the detected lineaments can be considered as open pathways for groundwater migration. For this reason contamination can take place along these vectors. In the study areas pit latrines appear to be the most common source of contamination (Figures 7.4 to 7.7) resulting in high bacteria content of wells. Besides that, mining activities and petrol storage can also be a risk for water pollution at some places (Figures 7.1 to 7.3).

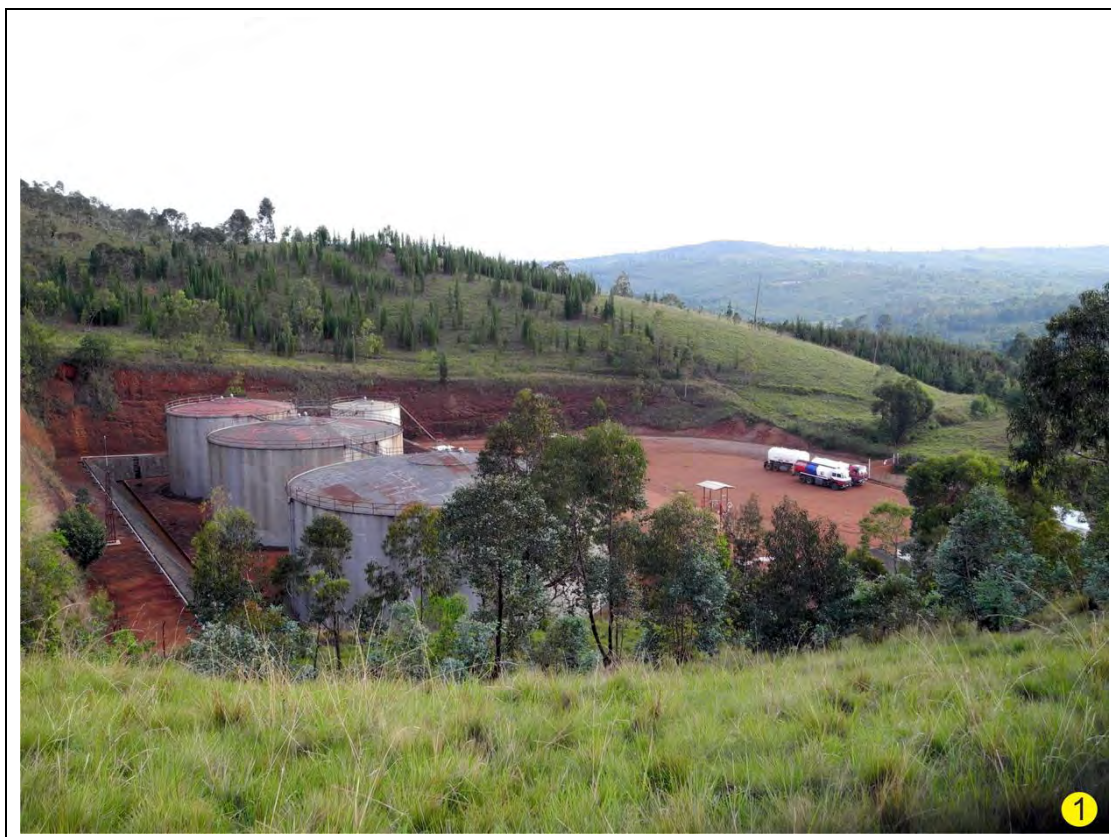
Figure 7.2: View to SE onto a petrol storage. Leakage could possibly cause contamination through open faults at wells downstream.

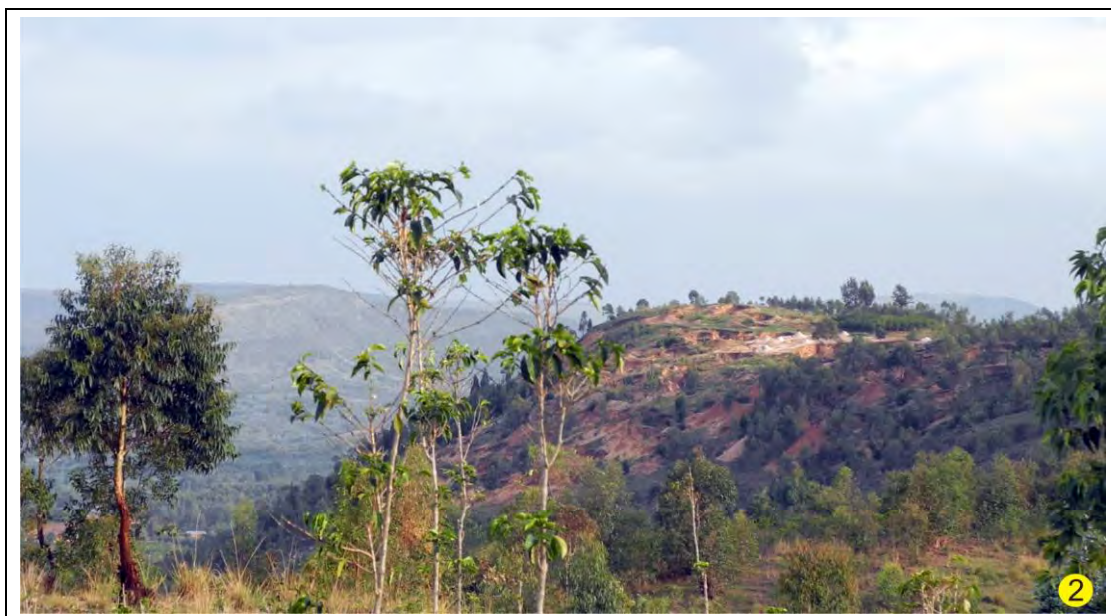
Figure 7.3: View to the east. Artisanal mining activities along the slopes are visible on satellite images as whitish areas. Sludge from the mines has the potential for water contamination of wells situated downhill.

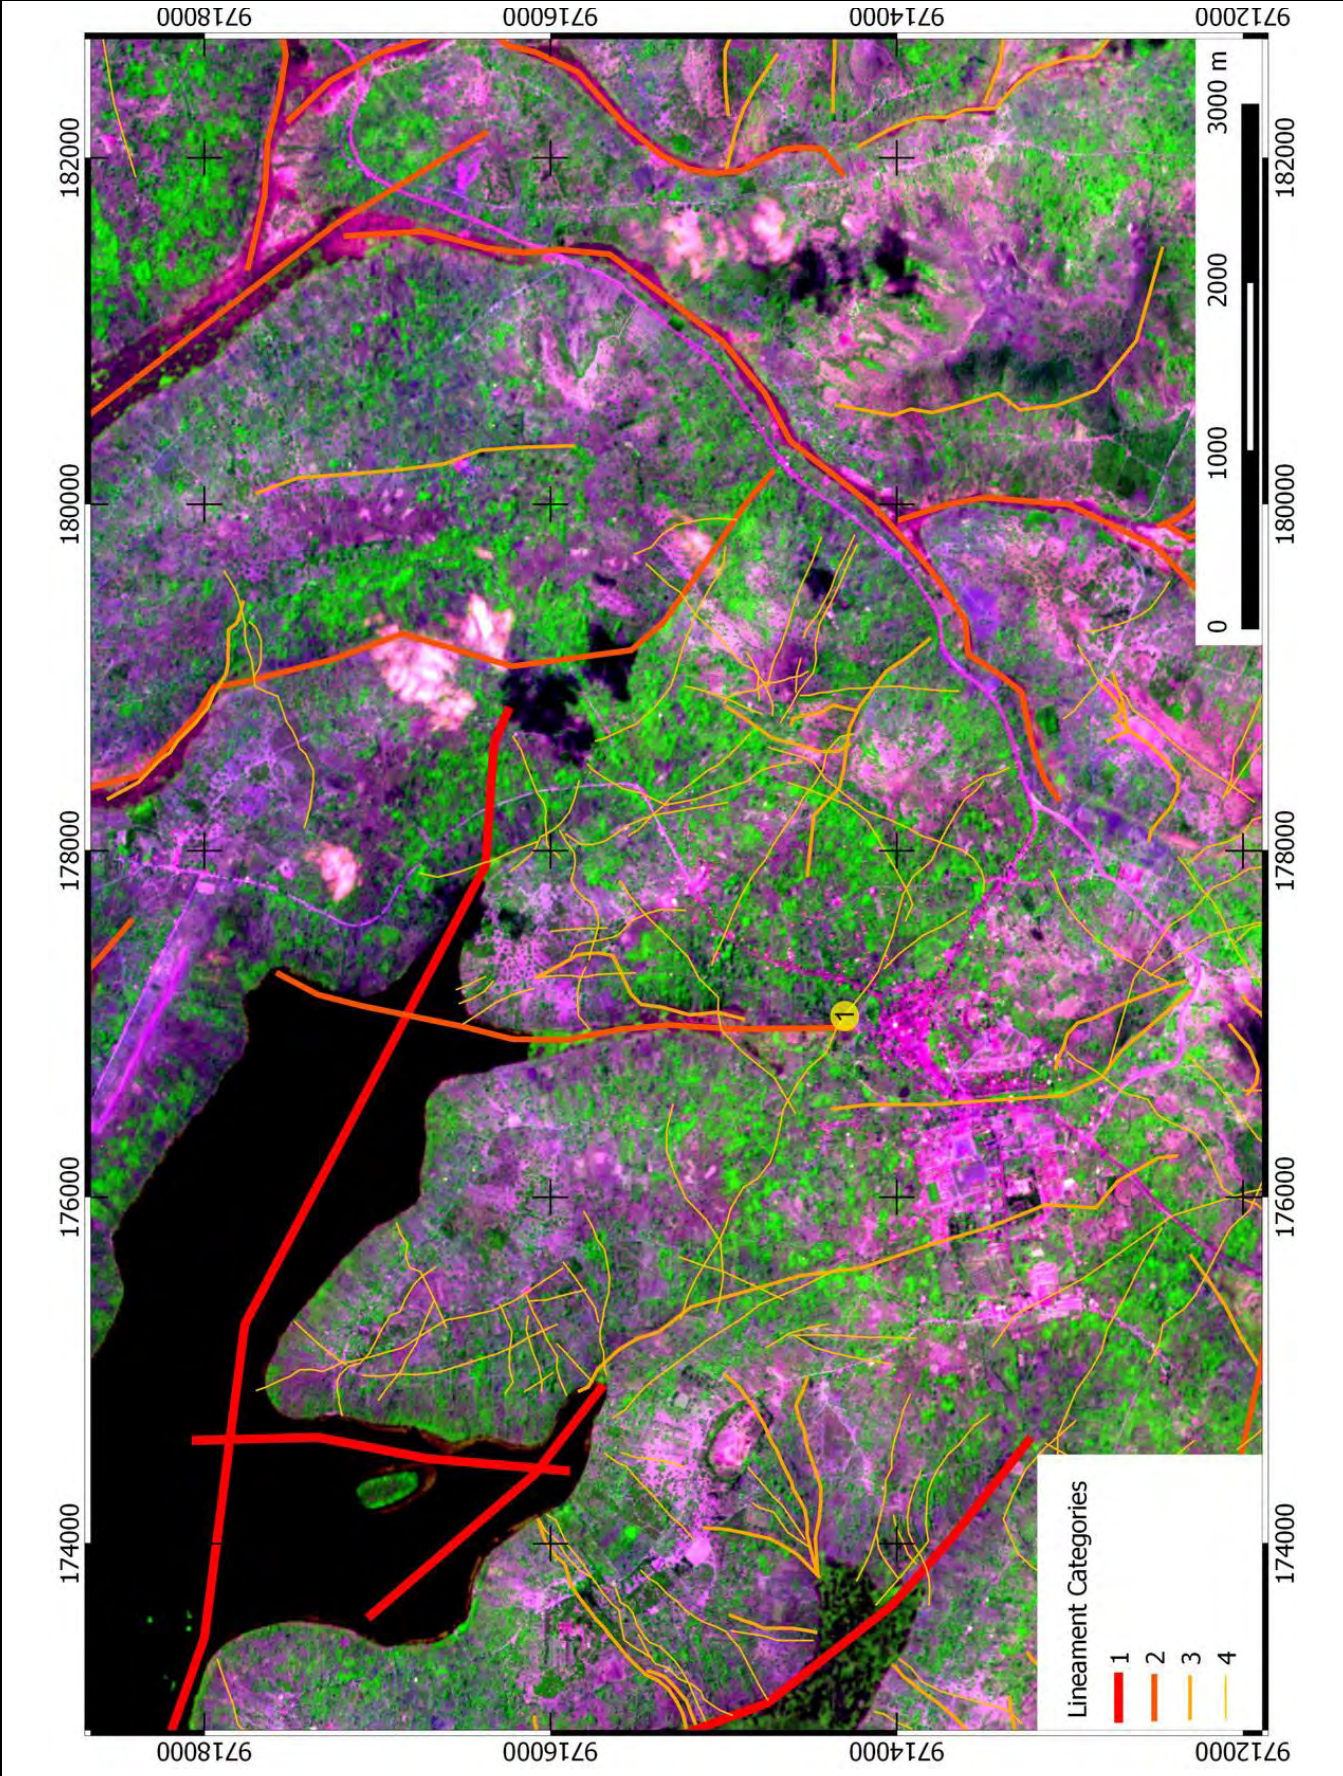
Figure 7.4: Possible water contamination site at Kirundo. Number 1 marks the location of field photo. SPOT bands 2,3,1 (RGB).

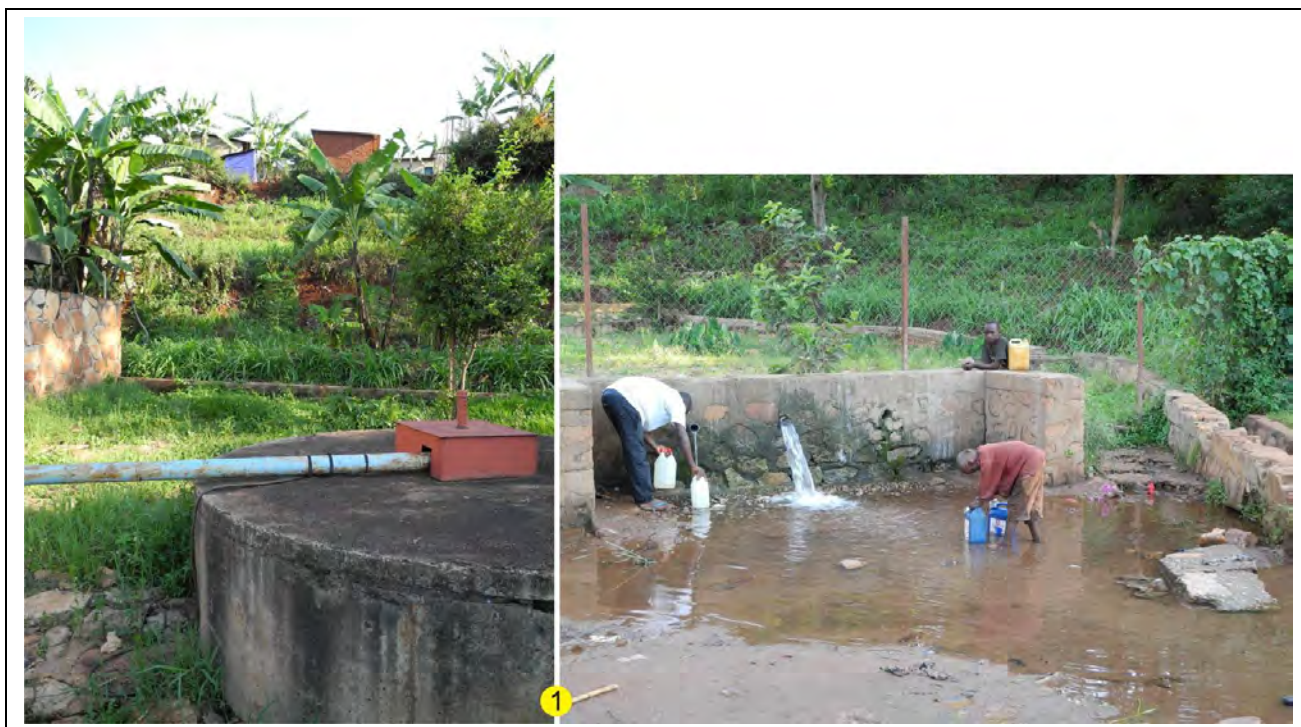
Figure 7.5: View to the south (WP 11). High bacteria content of these wells at this pump station may be caused by pit latrines directly uphill. The pond directly to the right functions also as a car wash. A small slaughterhouse nearby may cause further contamination.

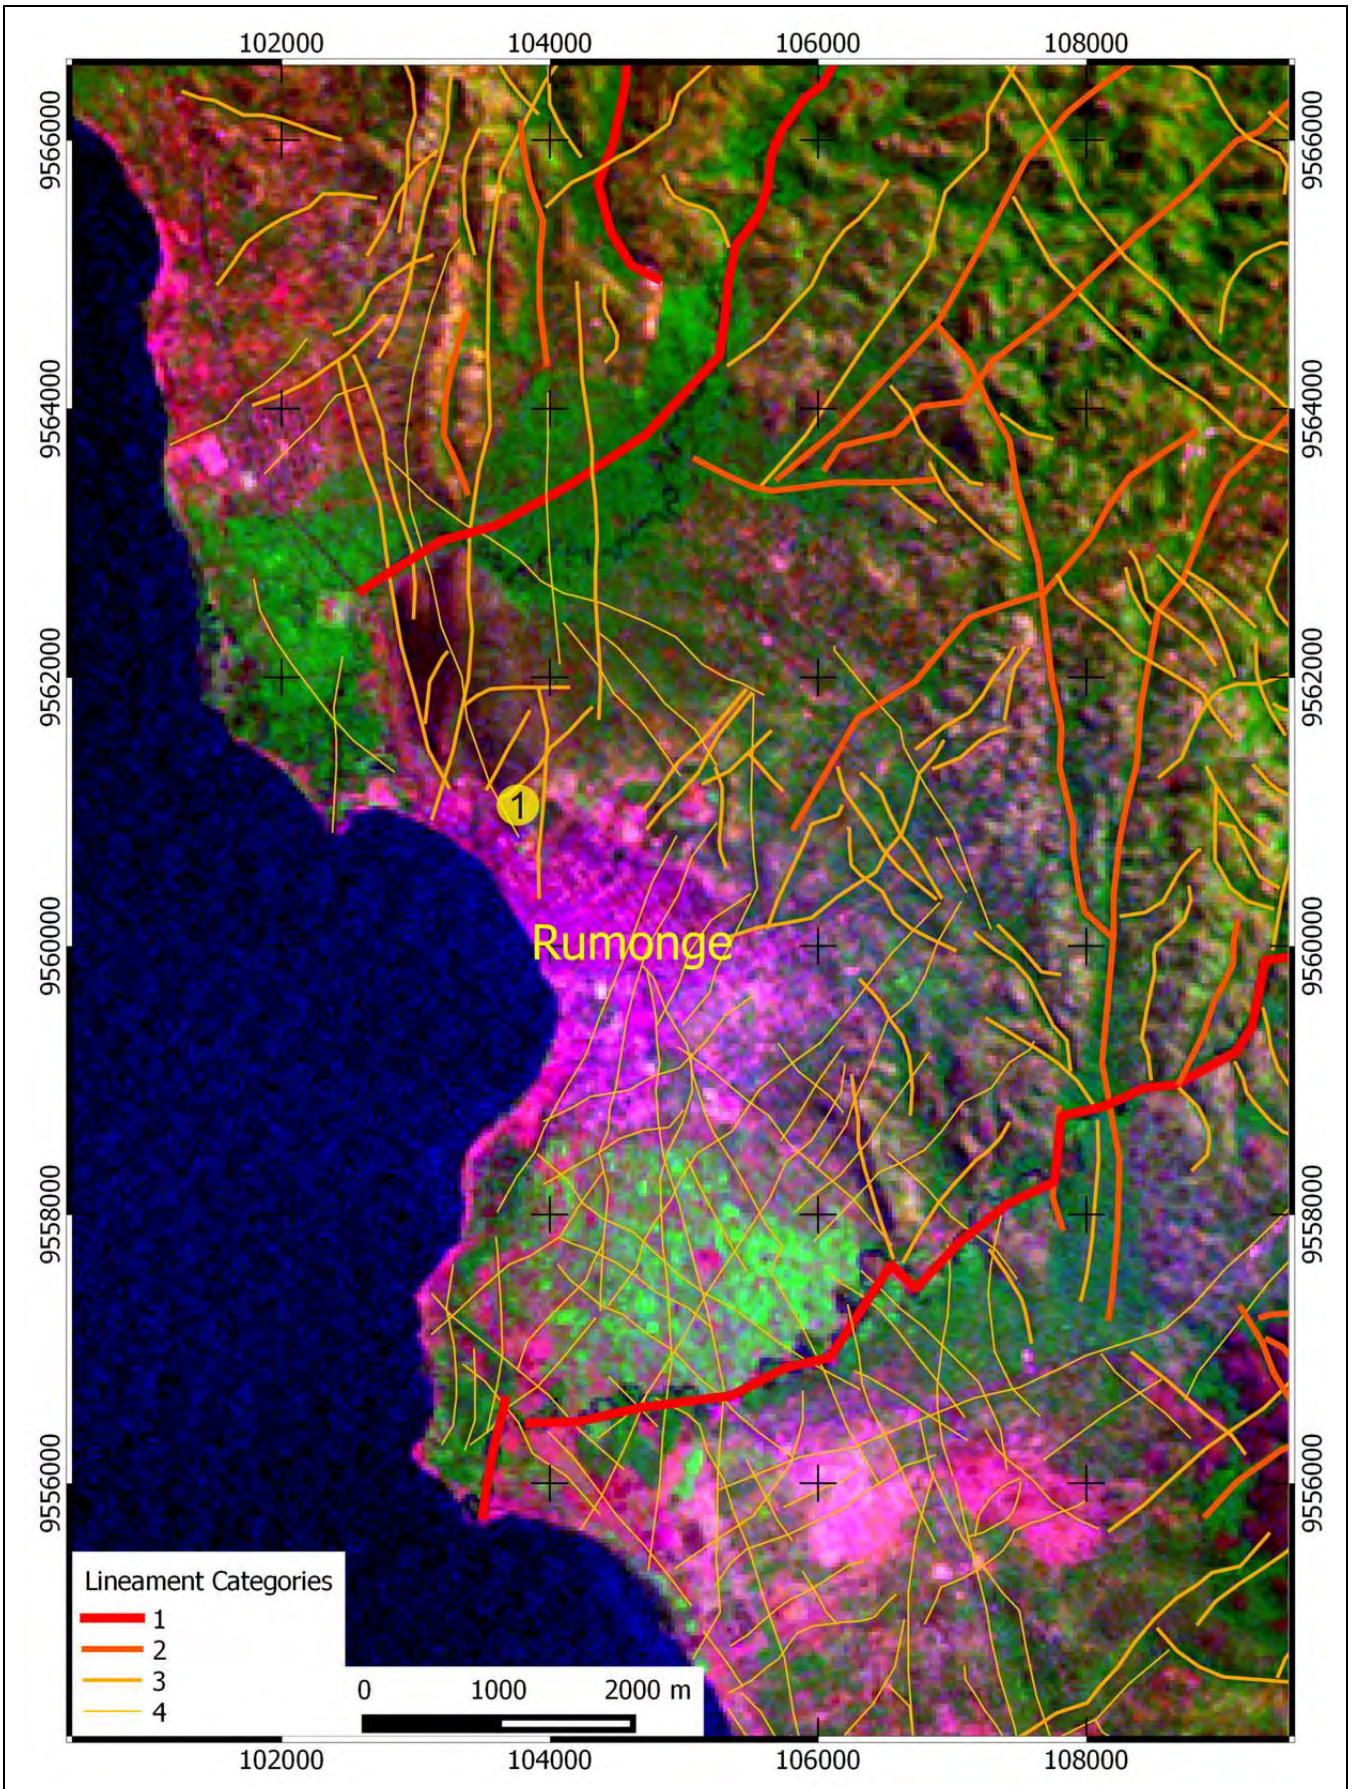
Figure 7.6: Site of possible water contamination at Rumonge. Number 1 marks the location of field photo. Landsat TM bands 7,4,1 (RGB).

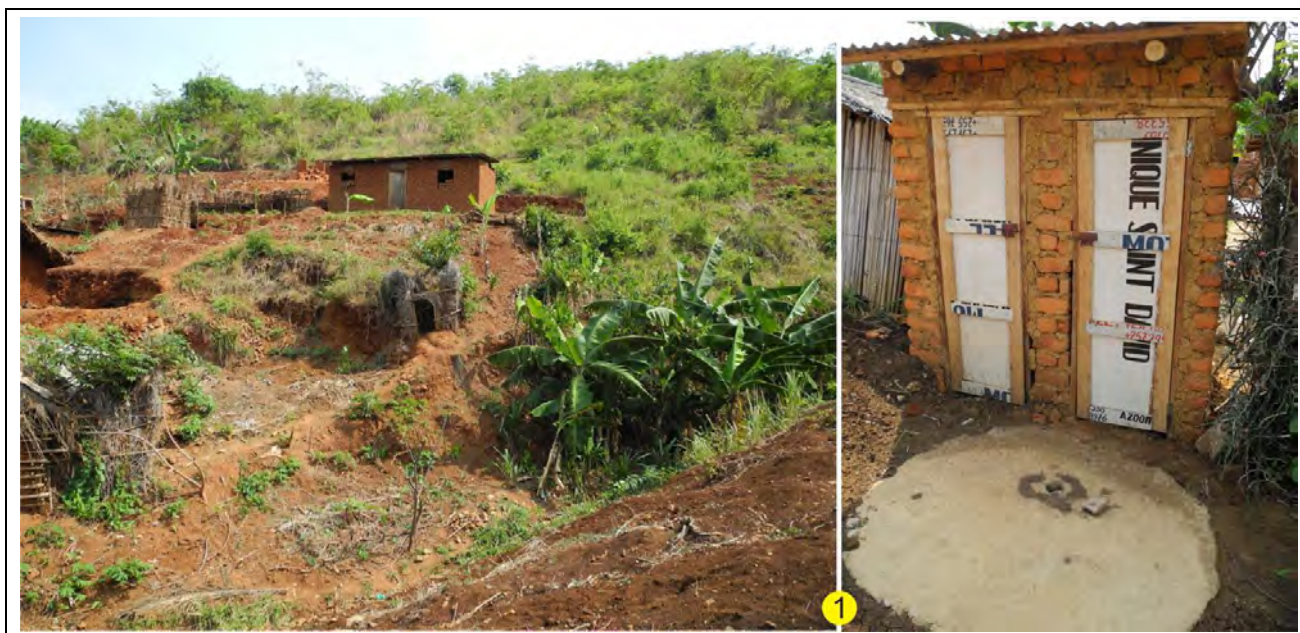
Figure 7.7: View to NE (WP 83). Pit latrines in this fault may cause water contamination. Right: sealed toilets nearby are a good step towards a better solution.
