Development of a Groundwater Information & Management Program for the Lusaka Groundwater Systems

REPORT NO. 3

Karstification, Tectonics and Land Use in
the Lusaka Region

Kai Hahne & Beauty Shamboko-Mbale

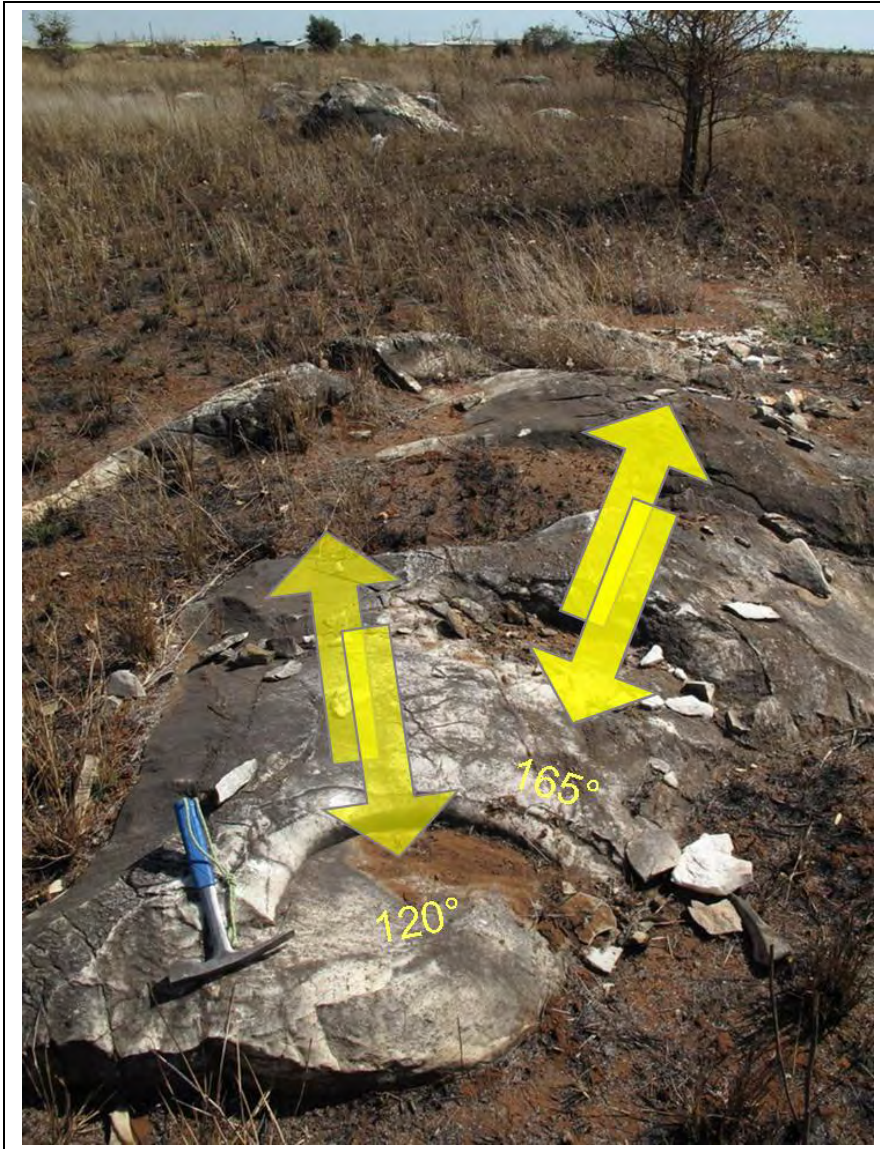
Figure 4: Low-angle-overthrusting with movement directions of the hanging rock towards 120° and 165° in the area of Lusaka South Local Forest, indicated by lunulate slicken sides. Waypoint (WP) 029.

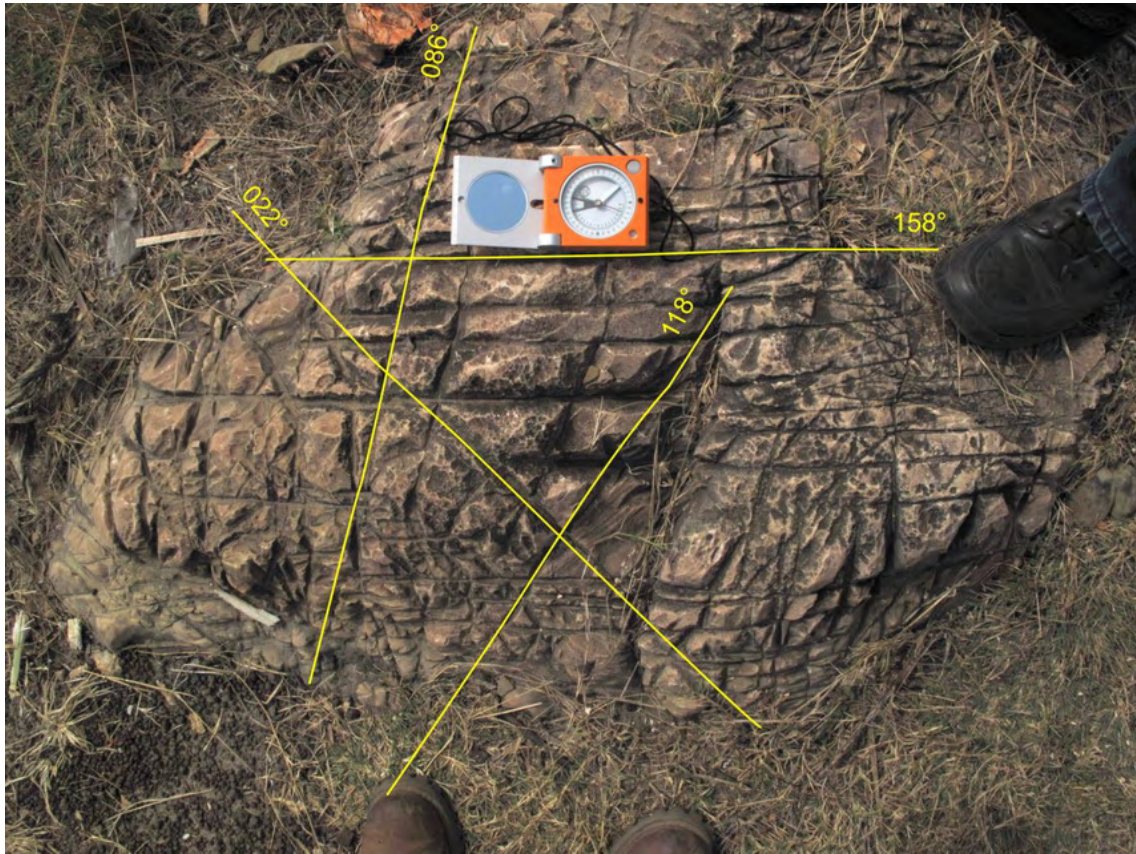
Figure 5 Above: steep joints in Lusaka Dolomite striking approx. parallel to fold trend (118°), diagonal (158°, 086°) and approx. perpendicular to main fold axes (022°) WP 016. Below: steep dipping cross- and longitudinal joints in a schist of the Cheta Formation with strike directions perpendicular (030°) and parallel (140°) to the main fold trend. Cleavage planes strike and dip towards 130-150/70-85 and 036-046/75-80 (WP 069).

This observation can be supported concerning strike directions, but must be completed, concerning the dip direction of longitudinal joints, as cleavage planes also dip steeply (75° to 80°) towards the NE (036° to 046°, figure 5).

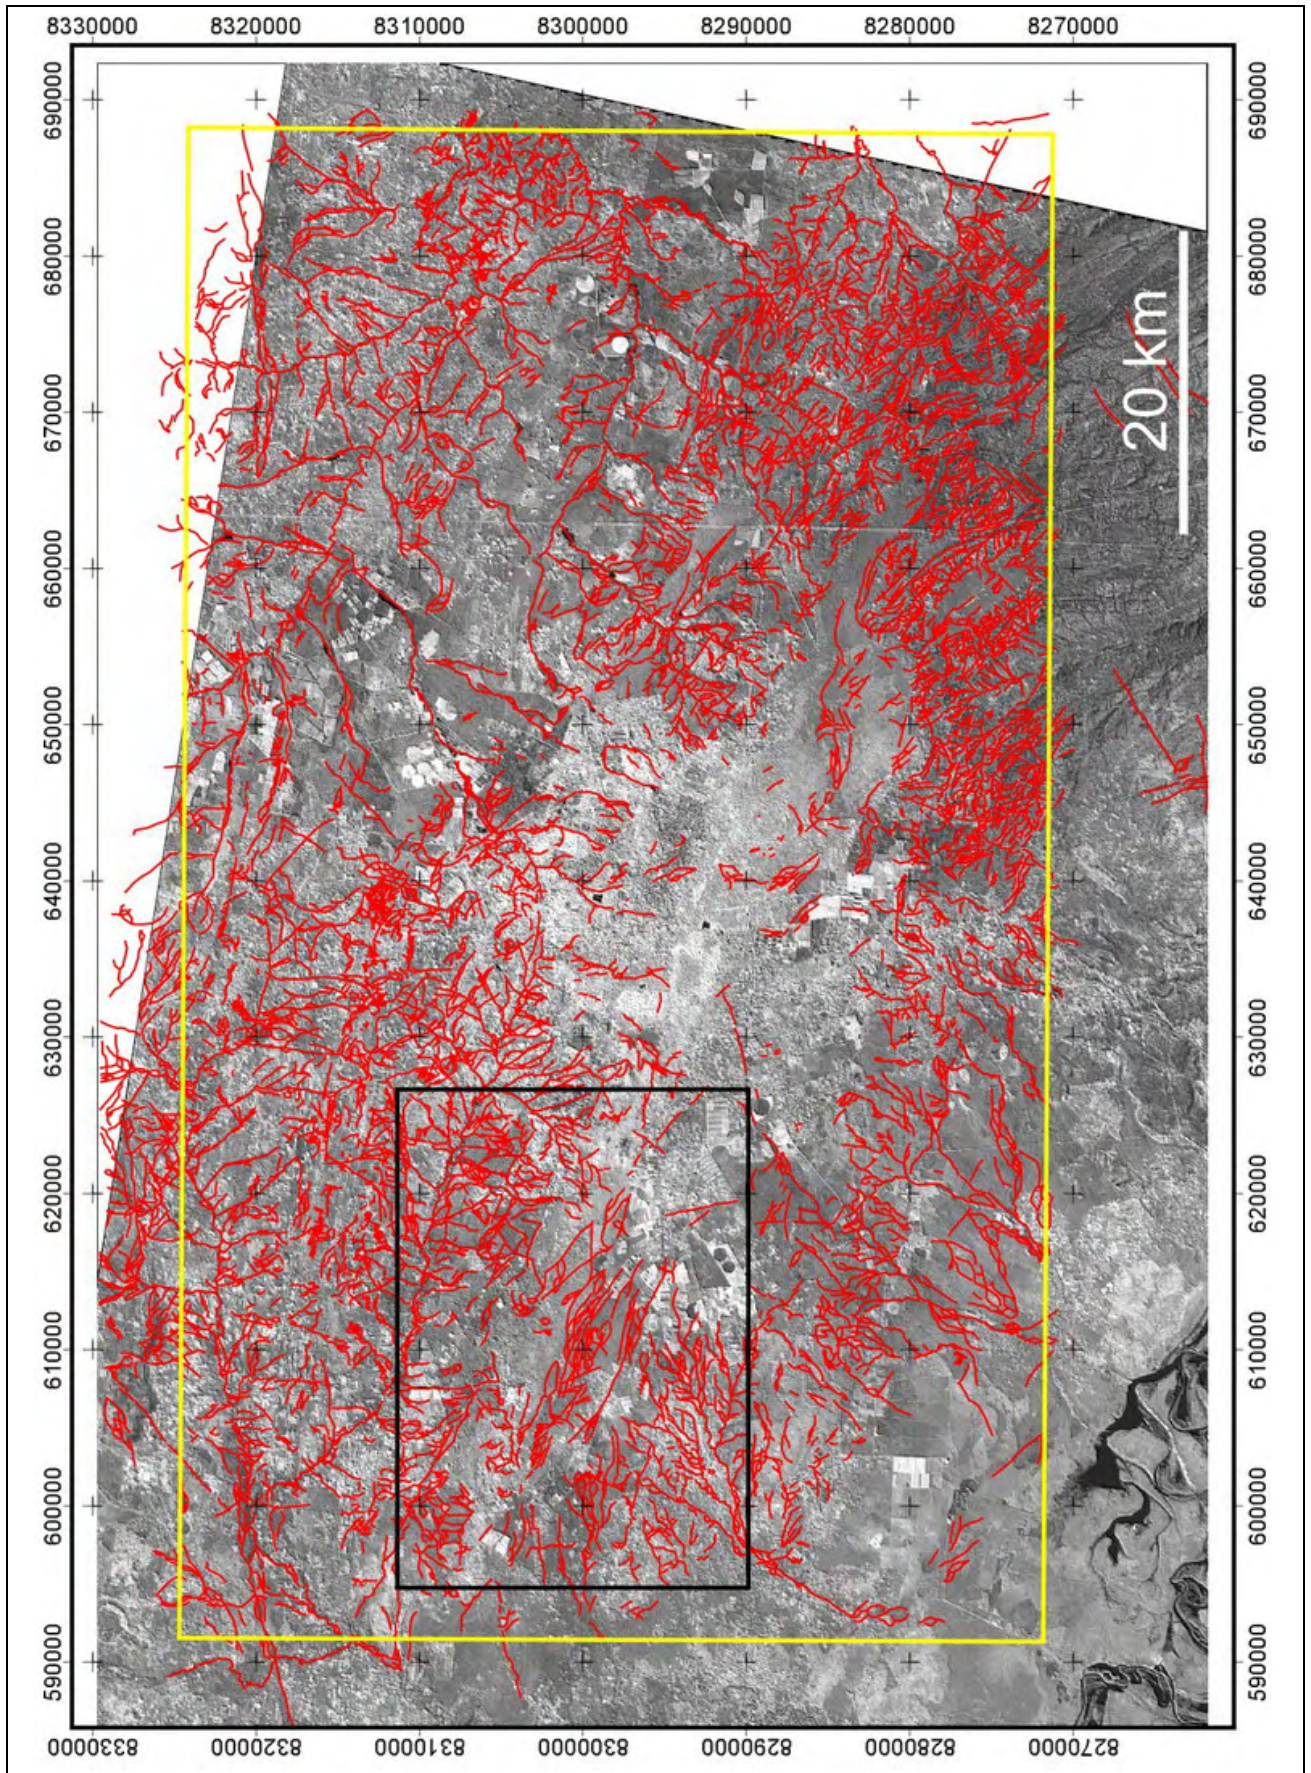
Figure 7: Examples for minor faults derived from satellite images projected into Landsat ETM band 5. Black rectangle marks area of shear lenses shown in figure 10.

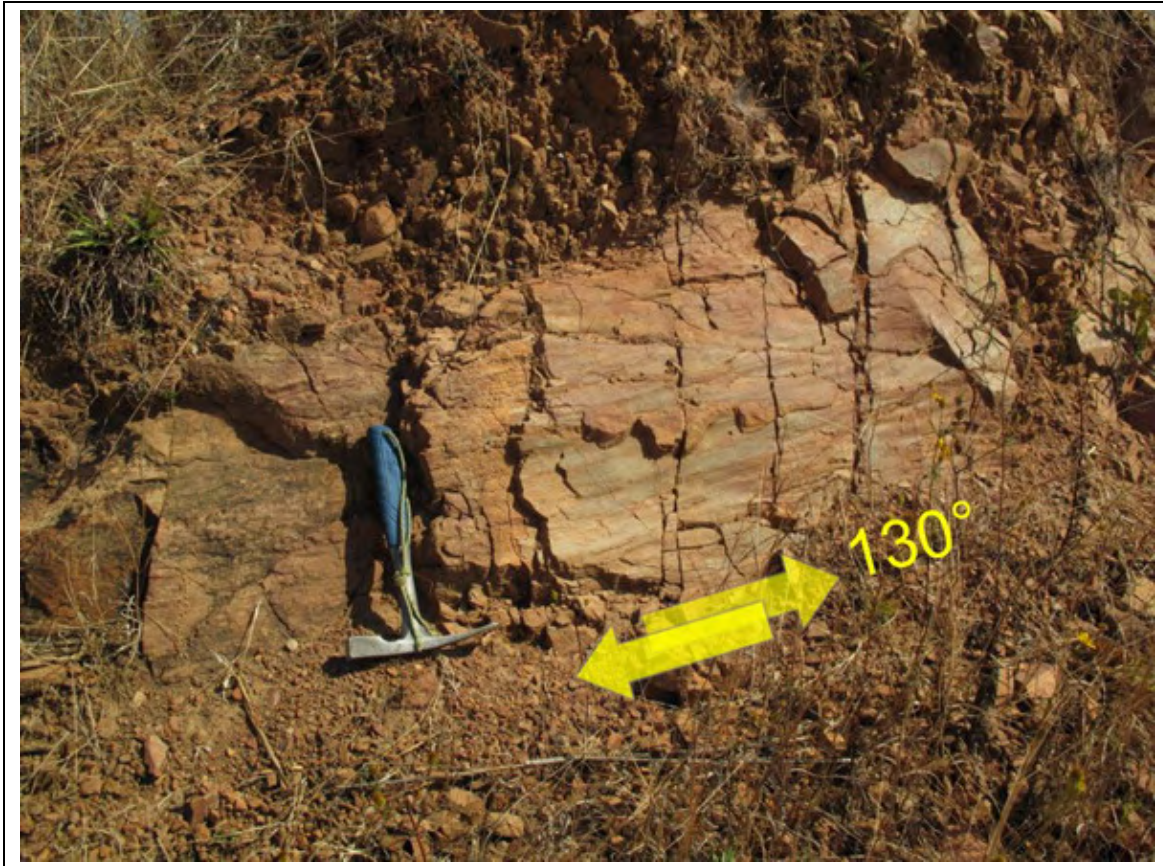
Figure 9: Fault plane in Cheta Formation striking 130° SE with slicken sides indicating a right-lateral movement. Vicinity of Momba School (WP 069).

The northwestern part of the Mwembeshi valley inside the working area represents a branch of the MSZ (figure 6). Adjacent to this branch, fault directions described before (types 2. and 3.) occur. They often form local and regional streams (e.g. the Chunga River turns from a parallel fault of type 1 into a NW-trending fault of type 2. Mwembeshi River turns from a NE-trending fault parallel to MSZ into a NW-trending fault of type 2. to the W outside the working area). These faults occur with left-lateral, as well as right-lateral displacements (figure 9).

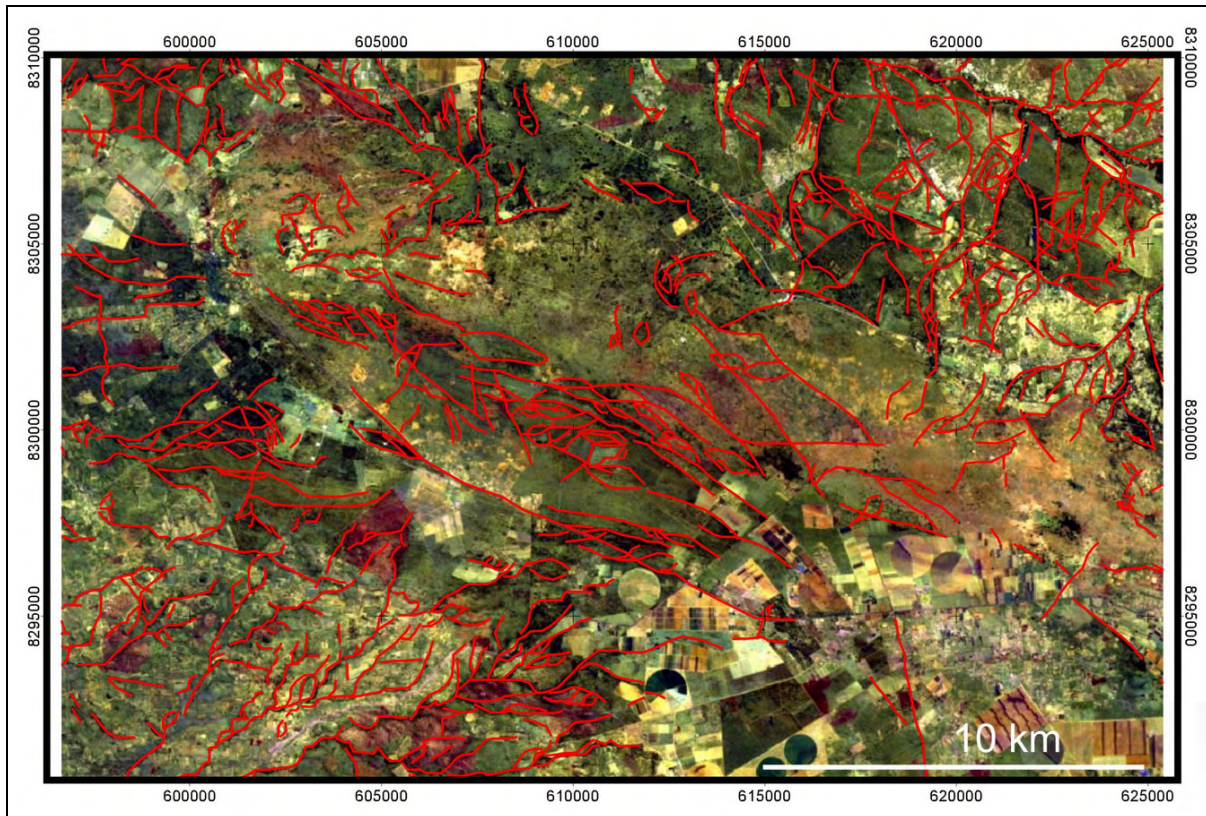
Figure 10: A fractal pattern of shear lenses bordered by faults (centre, red lines). An example from an area west of Lusaka within the influence of MSZ. Scale of the shear lenses ranges from 17 km to a few metres length. Faults defining shear lenses are commonly only visible by a change in colour contrasting with the surrounding area, unlike those faults that are enhanced by a pattern of streams and rivers. ETM bands 7,5,2 (RGB). Position within the working area is marked in figure 7 by black rectangle.

In satellite images to the West and NW of Lusaka – by influence of the MSZ – almost any fault of all three types shows shear lenses with a fractal pattern. E.g. lenses of 17 km length to a few metres length can be observed (figure 10).

In satellite images to the W and NW of Lusaka – by influence of the MSZ – almost any fault of all three types shows shear lenses with a fractal pattern. E.g. lenses of 17 km length to a few metres length can be observed (figure 10).

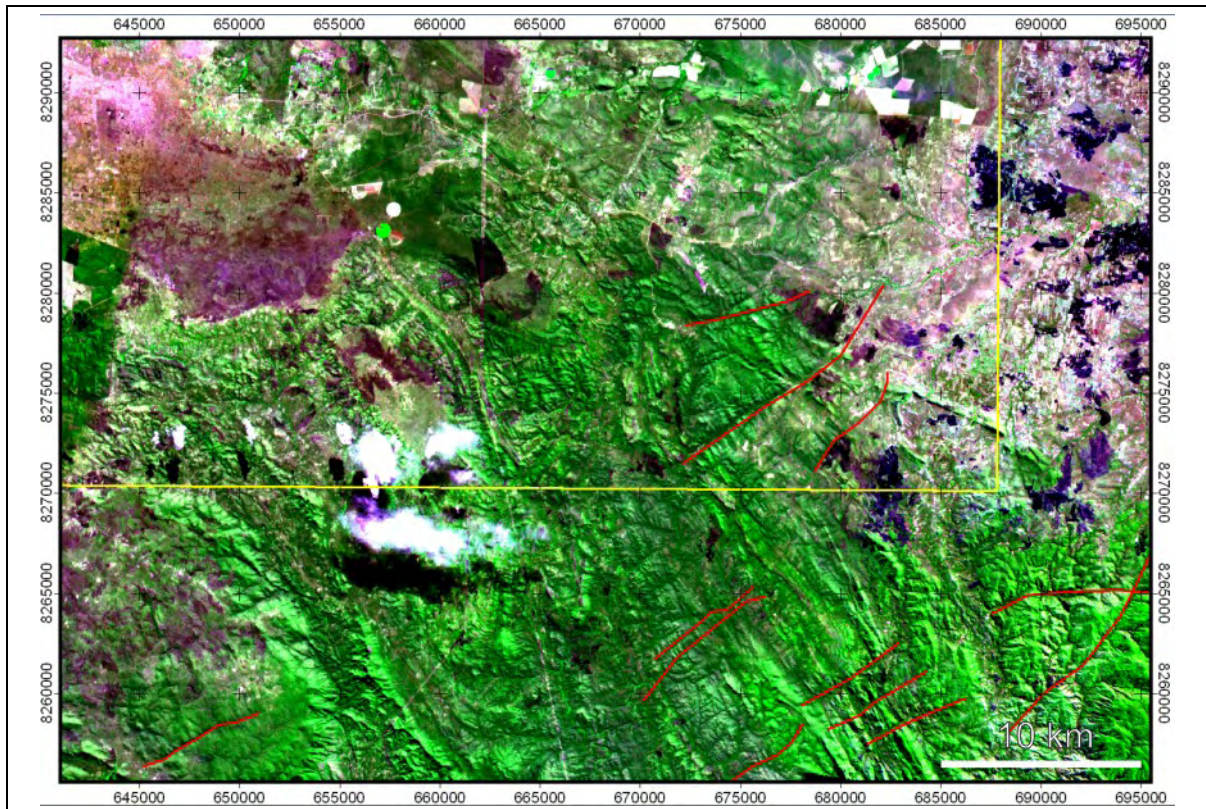
Figure 11: Increasing influence of the Zambezi Rift visible by normal faulting. Examples highlighted by red lines. SPOT bands 1,2,3 (RGB).

To the SE, increasing influence of the Zambezi-rift can be observed by NE-striking normal faulting and absence of shear lenses (figure 11).

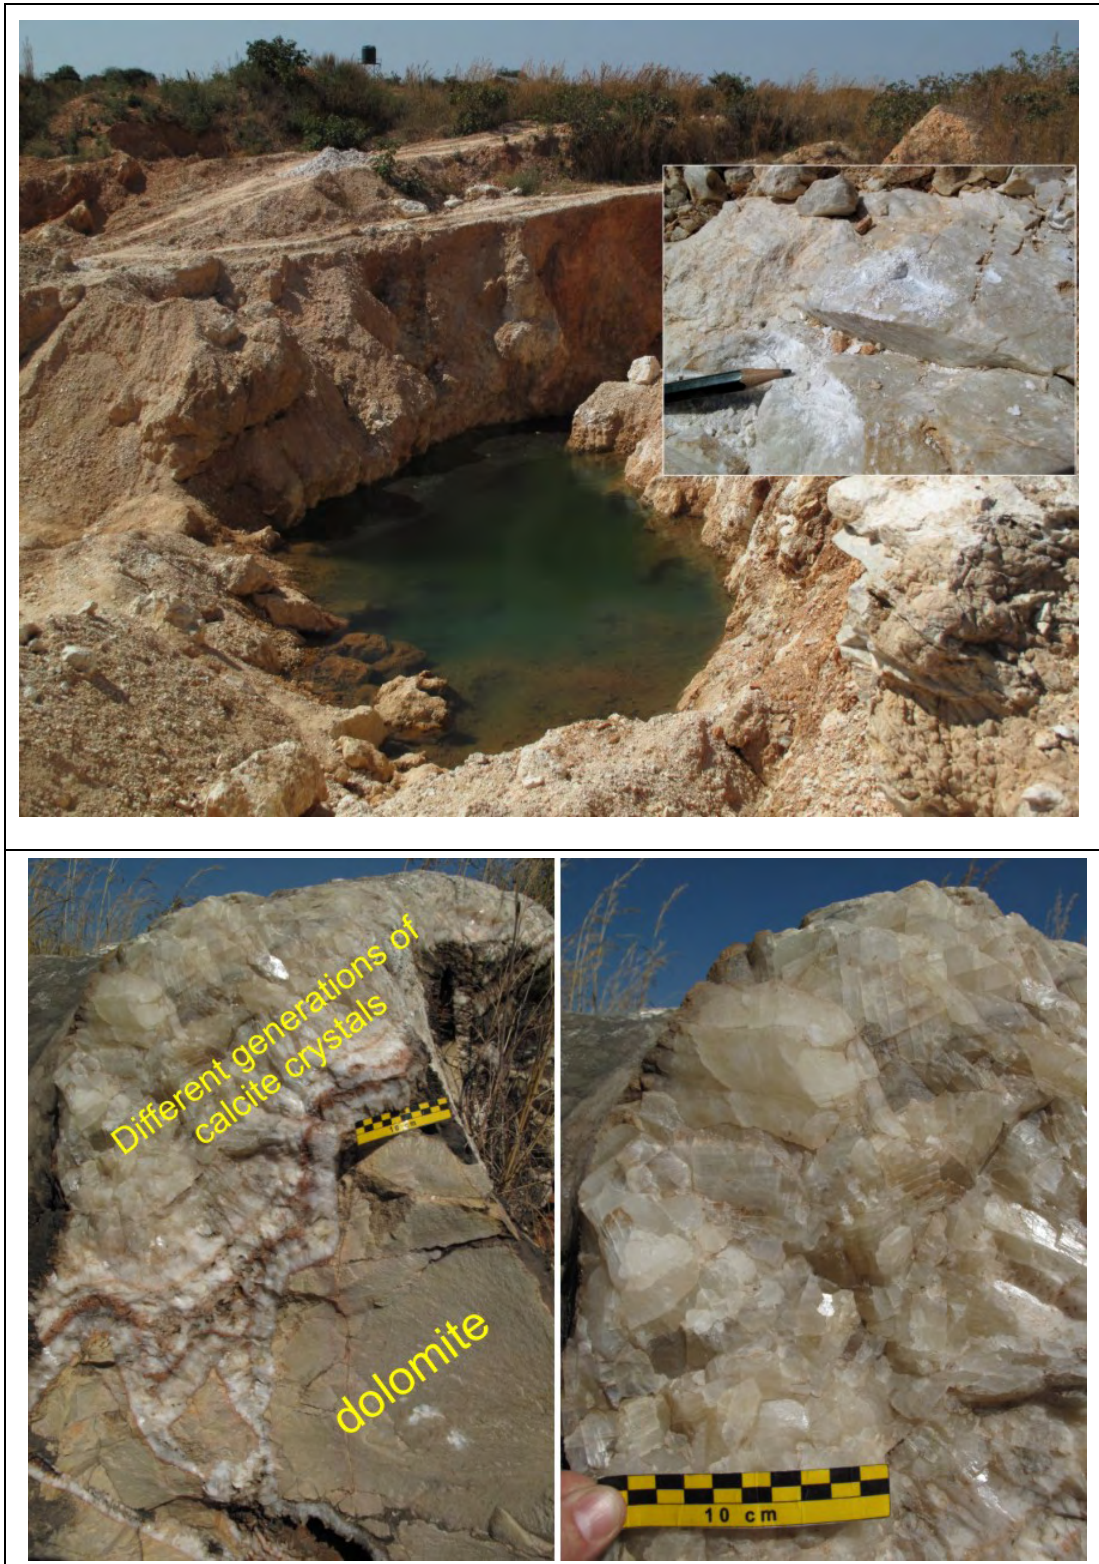
Figure 12 Above: quarry of a talc deposit gives evidence for former hydrothermal activity within deep faults. Inset shows soft material of talc or “soapstone” respectively (WP 030). Below: tall calcite crystals in direct vicinity of talc deposit formed within a hydrothermal fault (WP 032).

Examples of deep approx. vertical faulting can be found along a line of talc quarries within the Lusaka Dolomite Formation SE of the city. Talc deposits ($Mg_3Si_4O_{10}(OH)_2$) result from the transformation of existing rocks under the effect of hydro-thermal fluids carrying one or several of the components (MgO , SiO_2 , CO_2), needed to form the mineral. Tectonics play a major role in the genesis of a talc deposits (figure 12, above). Further hints for former hydrothermal activity can be found in direct vicinity along-strike of the quarries in an occurrence of tall calcite crystals (figure 12, below).

Evidence of deep approx. vertical faulting can be found along a line of talc quarries and occurrence of tall calcite crystals within the Lusaka Dolomite Formation SE of the city.

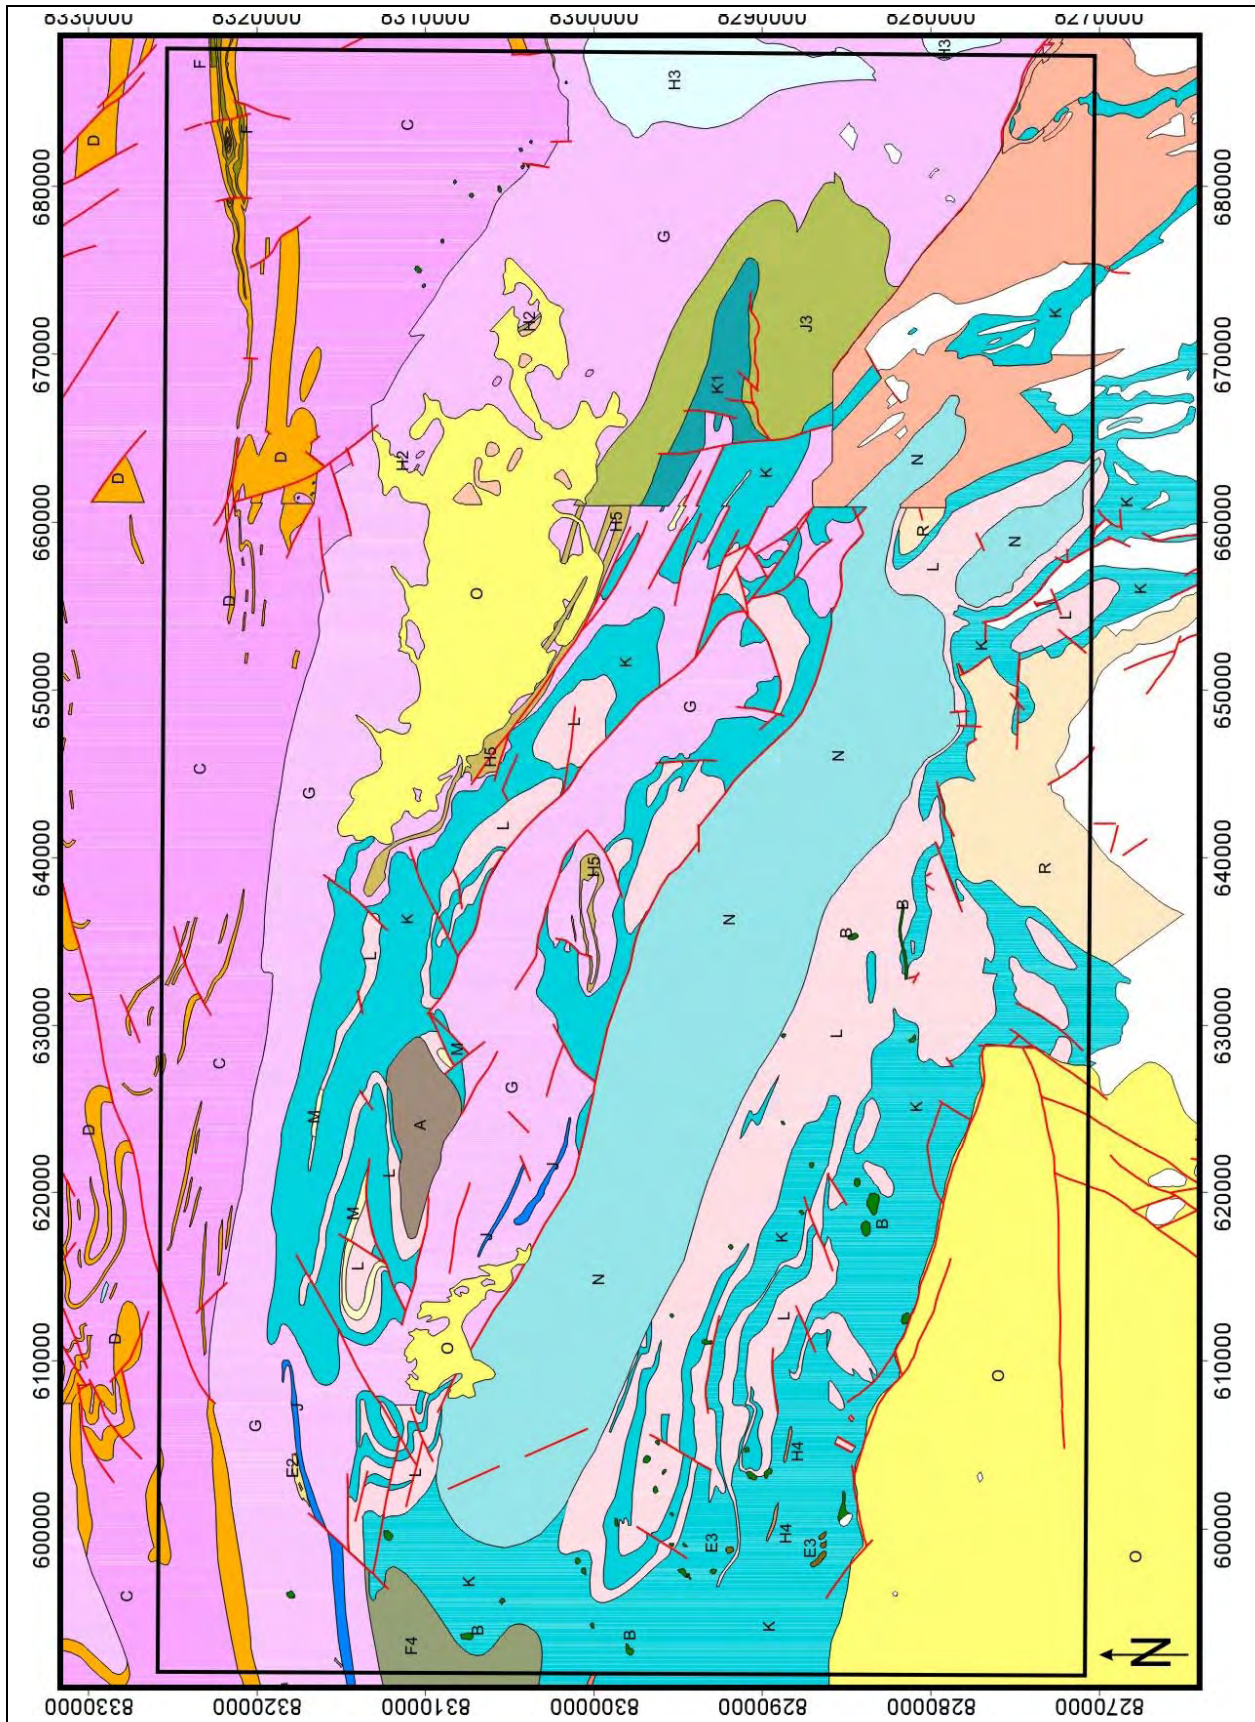
Figure 14: Adjusted and slightly simplified geological maps after Simpson et al. (1962, 1963) and Garrard (1968). The map sheet borders still show an insufficient fit due to different interpretations / terminologies for geological units.

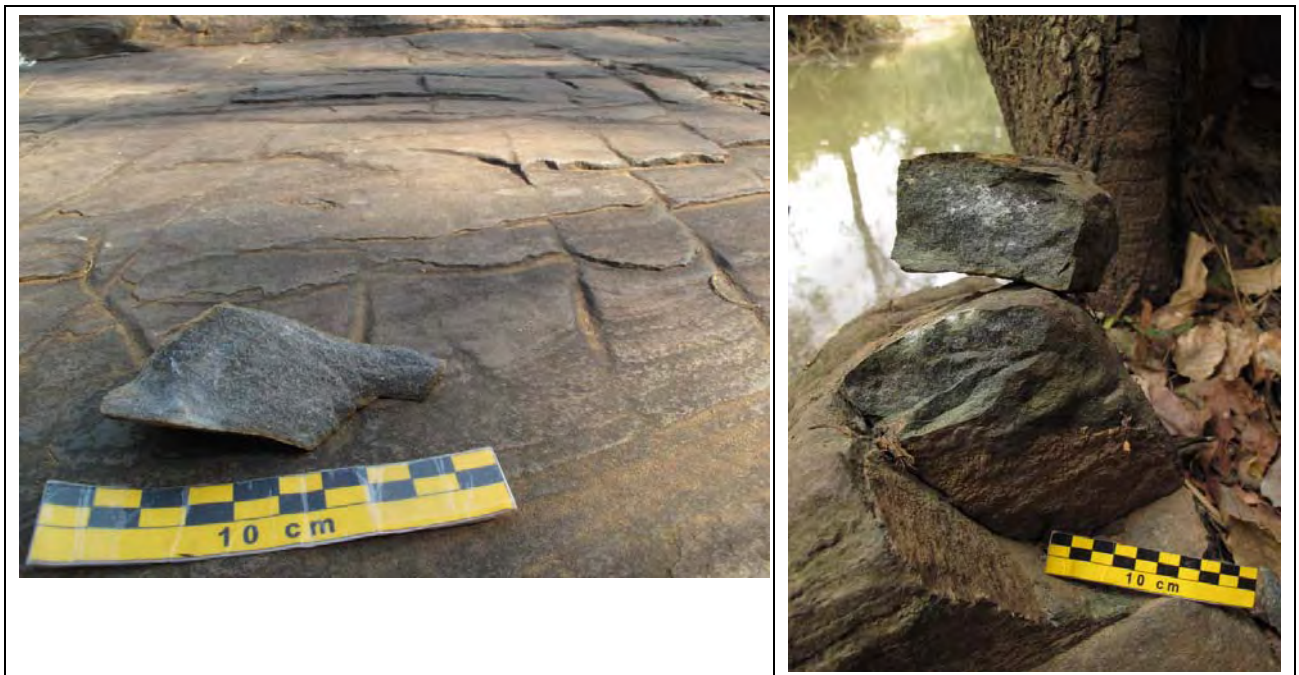
Figure 16 left: Meta-basalt-like rock type of Chunga Formation at Kapwelyonga River (WP 132). Right: the same rock type at Chunga River shows a strong chloritisation (visible by green colour of new formed chlorite), which is typically for hydrothermally altered mafic rocks (WP 027).

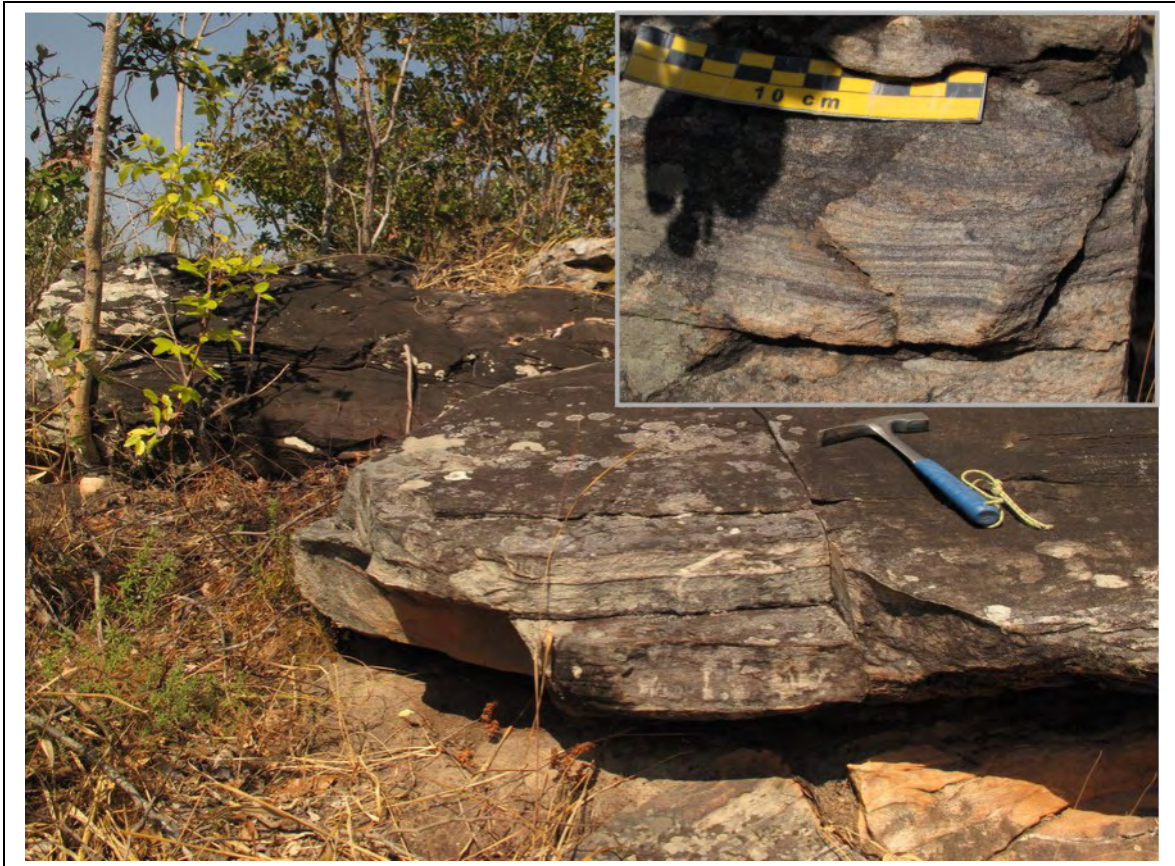
Figure 17: Typical quartz-muscovite-biotite schist of Chunga Formation. Inset shows a fine lamination (WP 123).

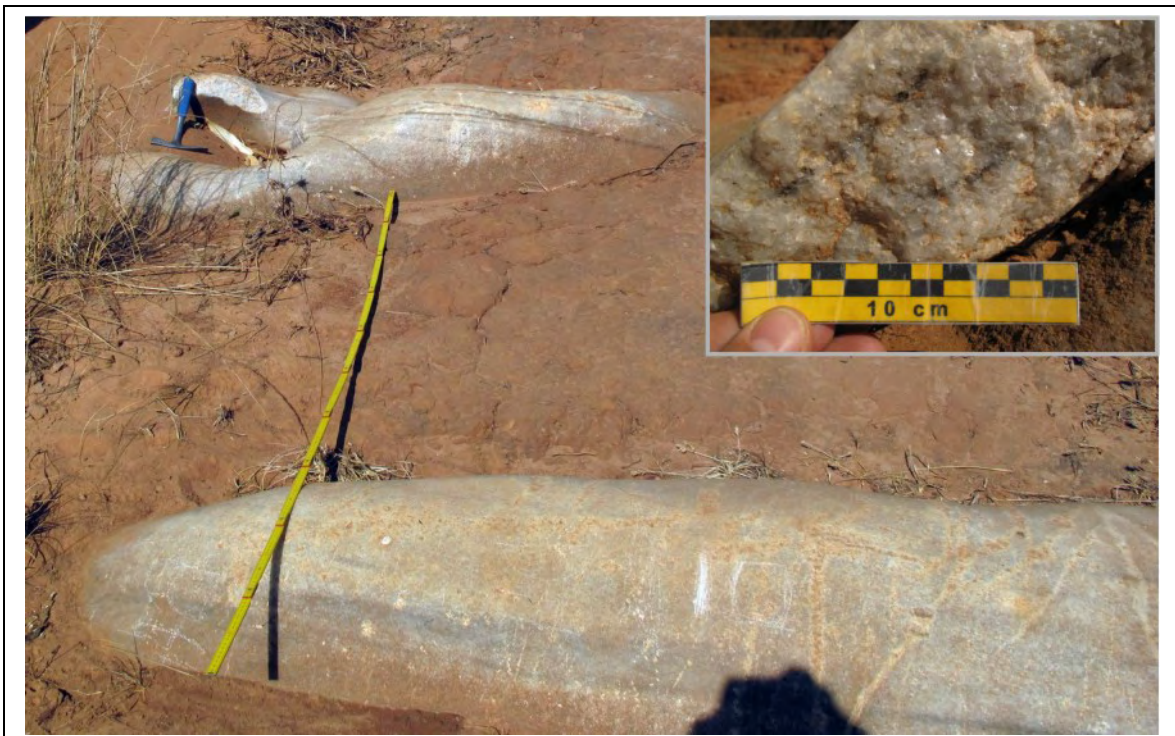
Figure 18: Calcareous horizon within Chunga quartzite. Inset shows a coarse grained crystalline limestone (WP 121).

Calcareous horizons within Chunga quartzite have the same shape as most calcareous units in the Cheta Formation (figure 18).

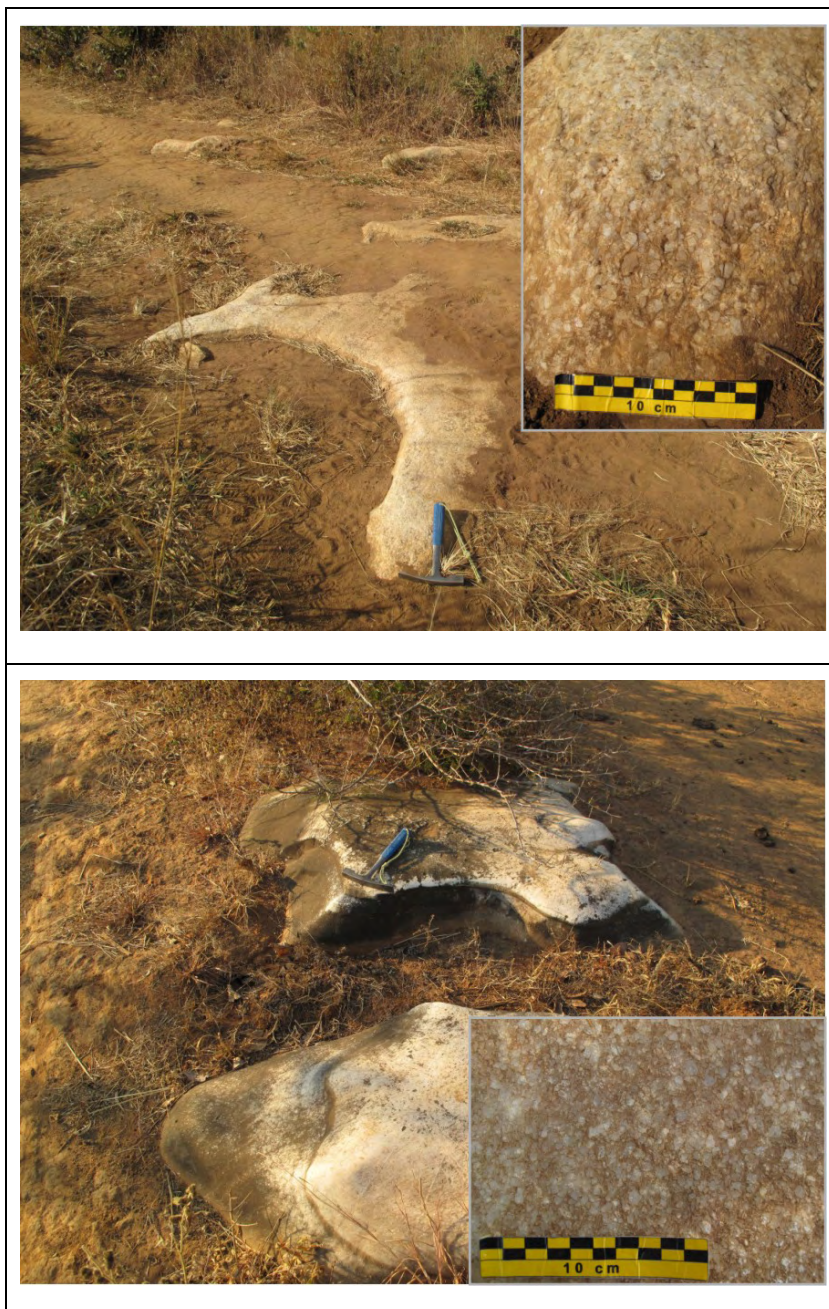
Figure 19:
Karstified limestones of the Cheta Formation. Insets show coarse grain sizes with crystals up to 10 mm (WP 104 above and WP 078 below).

In the working area their colours range from white to grey and grain sizes from fine (< 1 mm) to very coarse (5 mm to 10 mm, figure 19). Coarse grains seem to occur, where stronger deformation and/or vicinity to the granite body may have initiated recrystallisation and grain growth. Within the calcareous horizons, layers of more siliceous content occur. They are grey and white laminated and contain muscovite (figure 20).

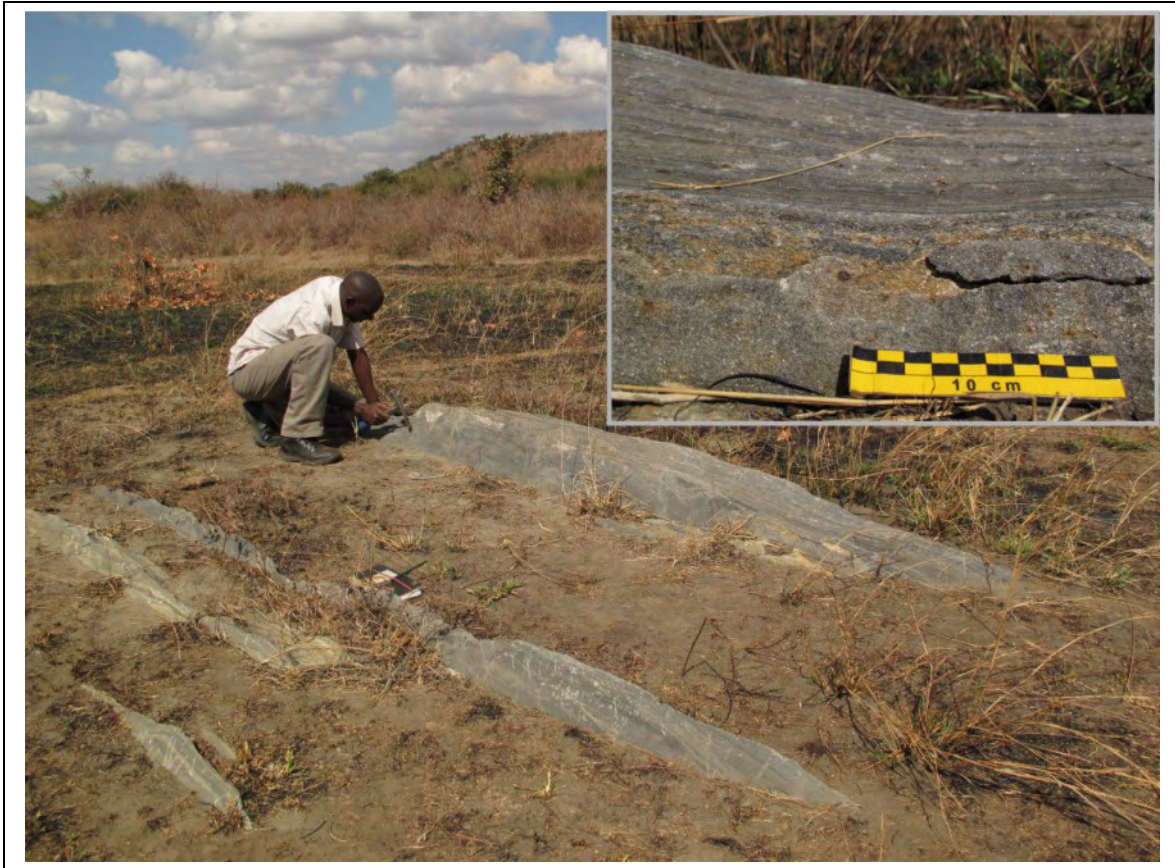
Figure 20: Hard siliceous horizon within limestone unit of Cheta Formation with no visible karstification. Inset shows altered muscovite in brownish colour (WP 098).

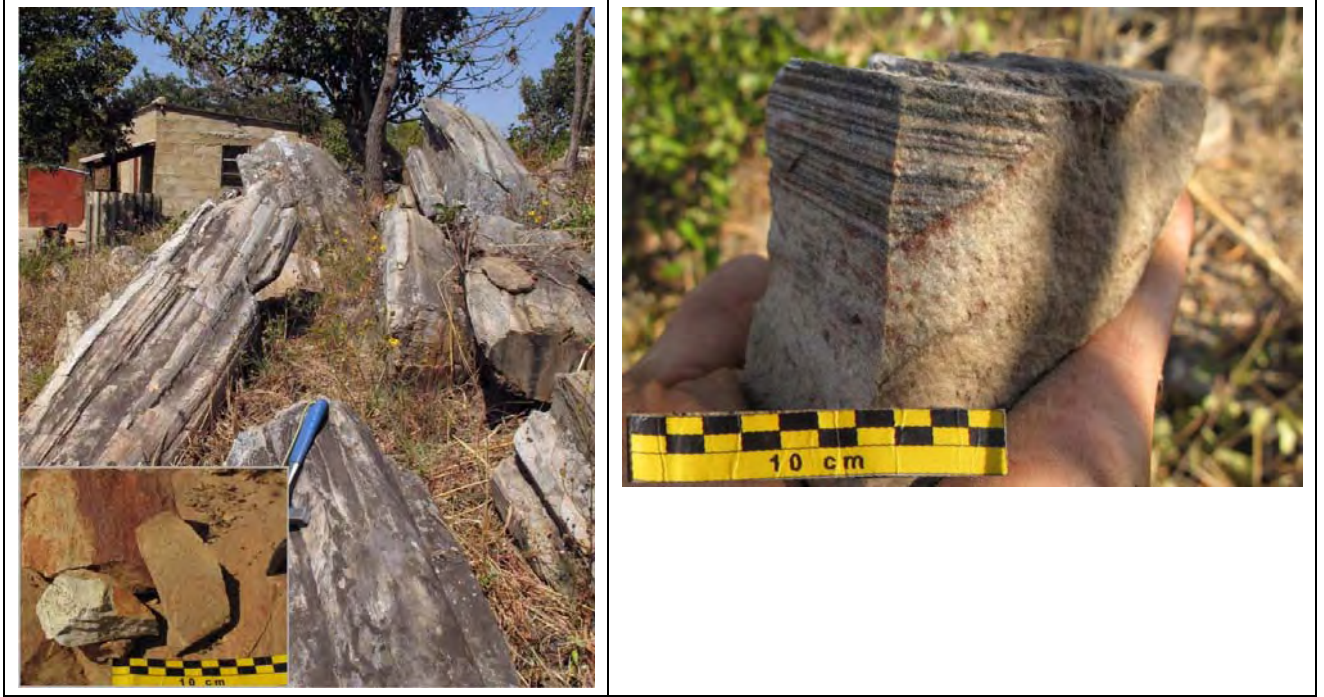
Figure 21: Left: schists of the Cheta Formation. Inset shows white fine grained quartz-muscovite schist with muscovite accumulated on cleavage planes. (WP 066 and inset WP 069). Right: fine laminated channel deposit with spots of iron-oxide (WP 075).

The schists typically form prominent ridges. They include rock types like quartzites, quartz-muscovite-chlorite schists and quartz-muscovite schists. The quartz-muscovite schists found in the working area were fine grained with muscovite accumulated on cleavage planes (figures 5 and 21, WP 066 and WP 069) and with primary sedimentary structures like channel deposits (figure 21, WP 075). The colours range from white and pink to grey, at some locations with iron-oxide-spots. The schists are similar to those of the underlying Chunga Formation.

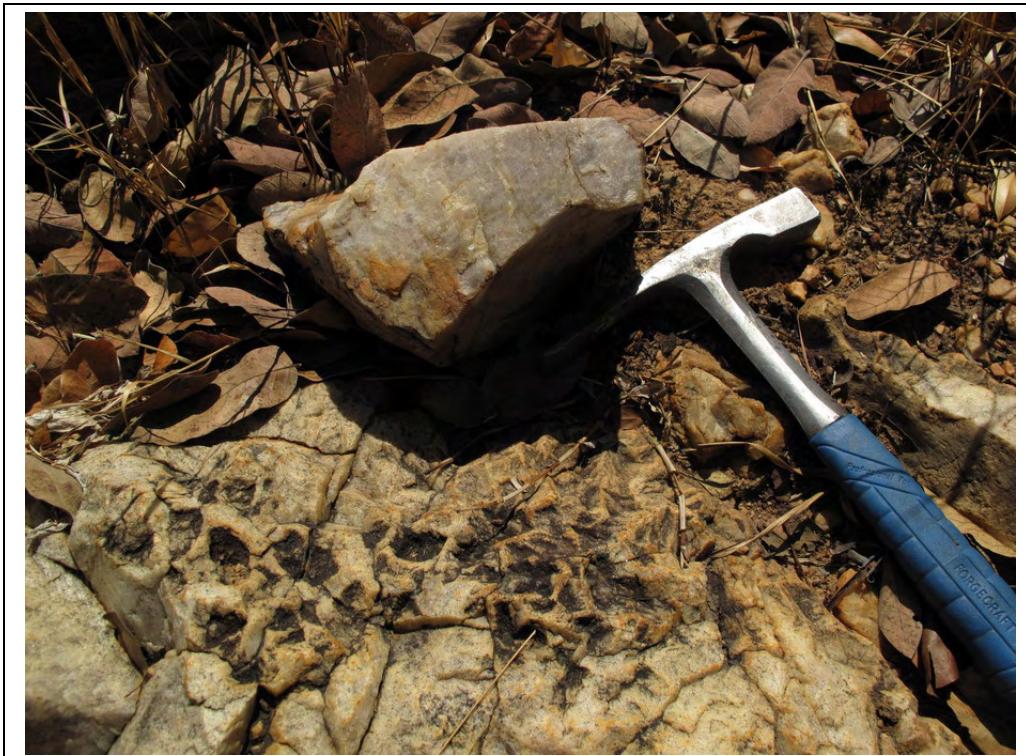
Figure 22: At some locations pure milky opal forms thick horizons which underlie the schists (WP 081).

At some locations, the laminated schists are directly underlain by horizons of pure milky opal (figure 22).

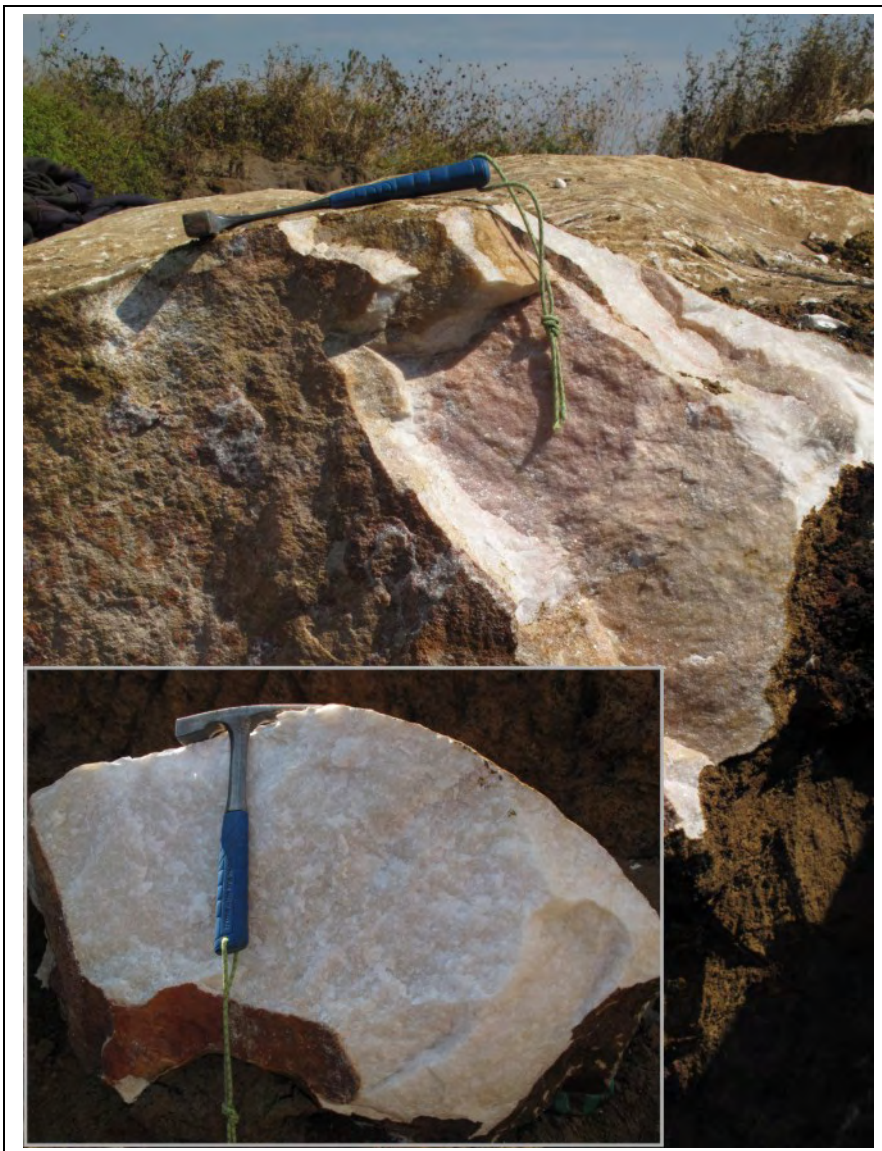
Figure 23: Fine grained pink and white Lusaka Dolomite (WP 001).

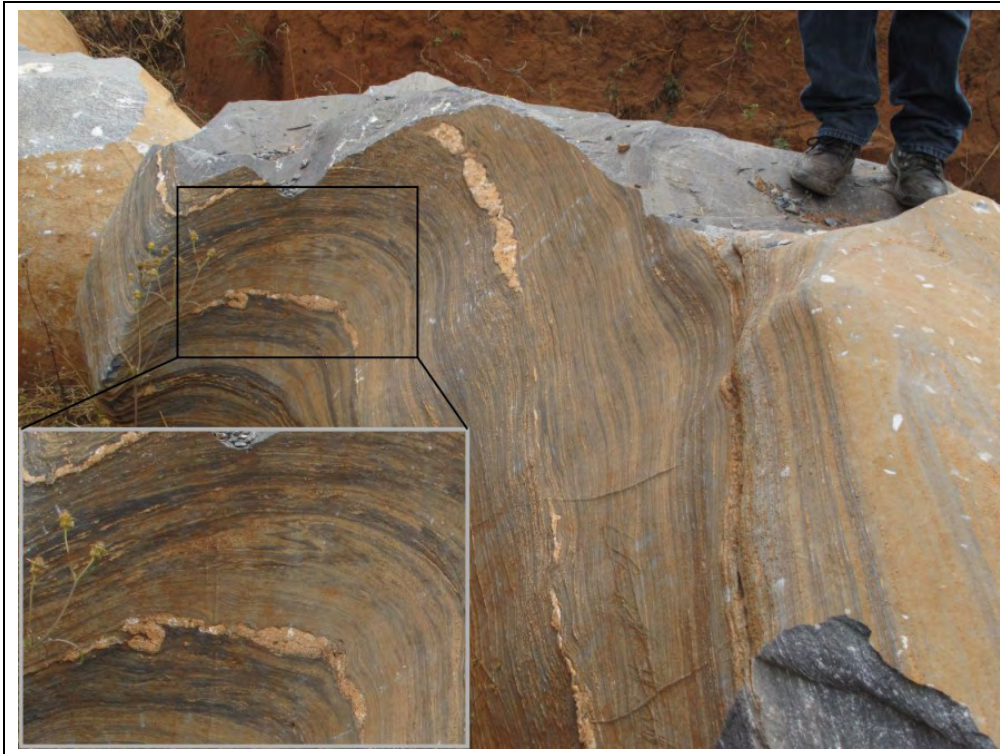
Figure 24: Grey and white laminated Lusaka Dolomite with internal folds (WP 022).

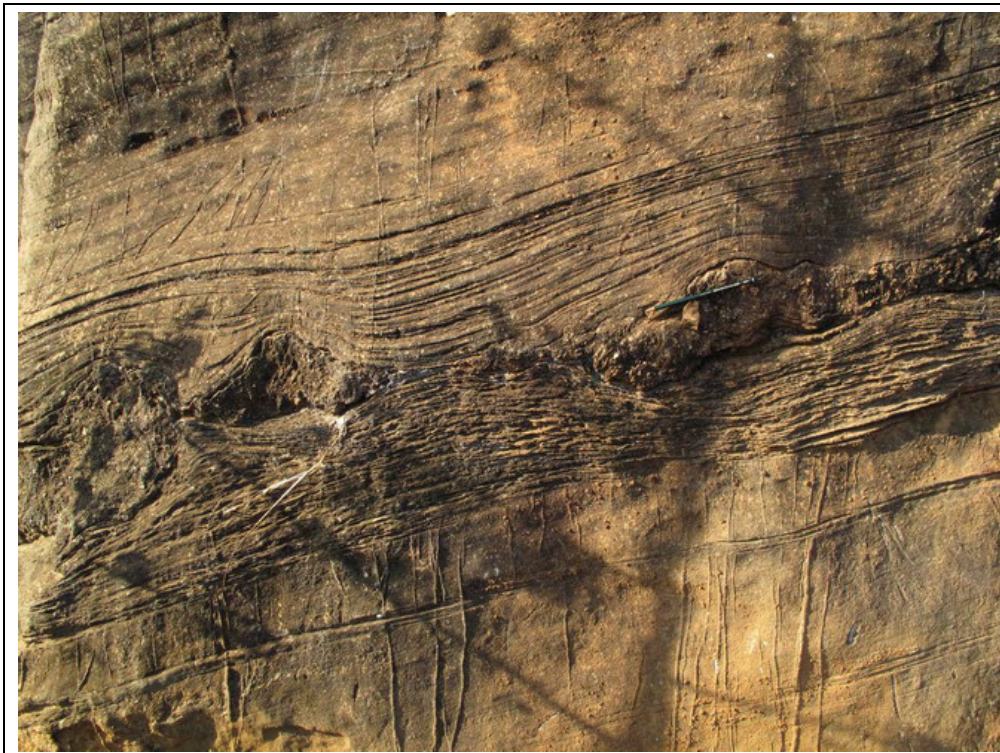
Figure 25: Grey and white laminated Lusaka Dolomite with internal folds consisting of siliceous material (WP 063).

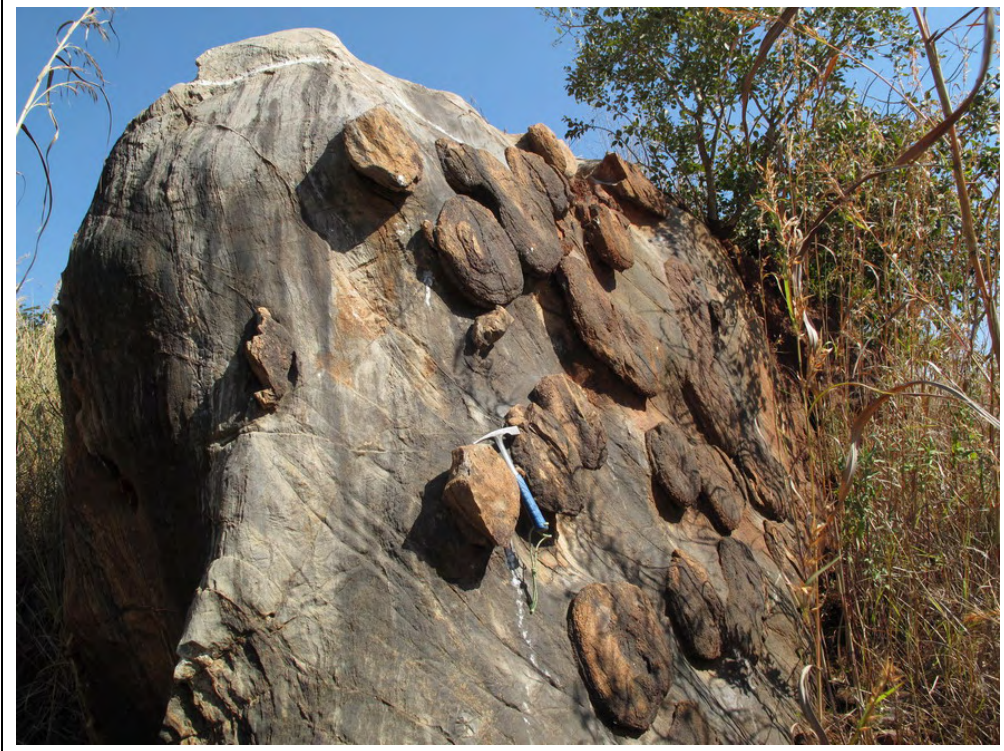
Figure 26: Steep dipping grey and white laminated Lusaka Dolomite with lenticular remains of siliceous material (WP 032).
