Development of a Groundwater Information & Management Program for the Lusaka Groundwater Systems

REPORT NO. 3

Karstification, Tectonics and Land Use in
the Lusaka Region

Kai Hahne & Beauty Shamboko-Mbale

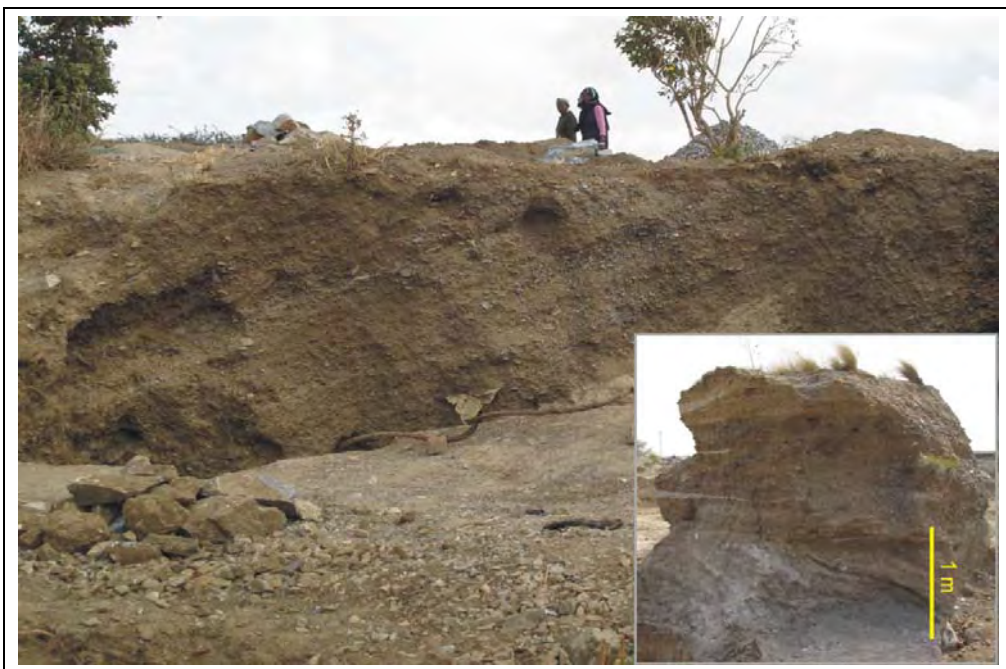
Figure 27: Inclined and horizontal breccia-like colluvial deposits at Lake Ngwenya (WP 012).

Colluvial deposits overlie the area around the prominent quarry of lake Ngwenya south of the city centre.

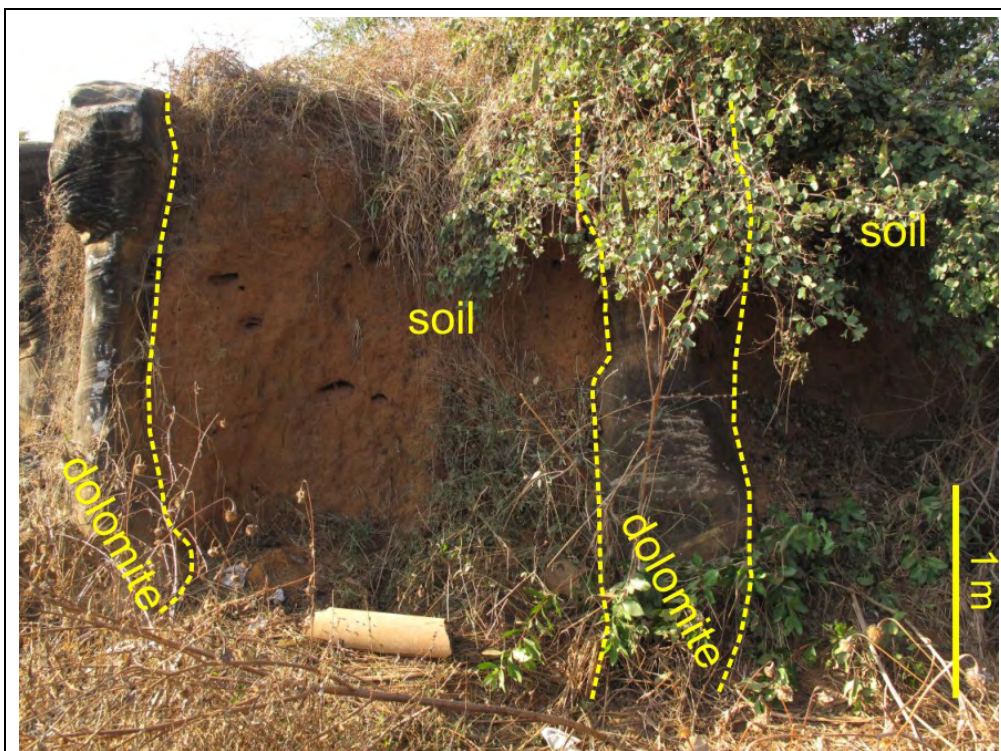
Figure 28: Plinthic soil between solution pillars of Lusaka Dolomite (WP 063).

A variable thickness from a few decimetres up to \pm three metres of pisolitic plinthosol, which developed on the Lusaka Dolomite Formation and calcareous horizons of the Cheta Formation, can be observed (figures 28 and 29). The soil colour ranges from red to brown and mainly depends on the content of iron oxides.

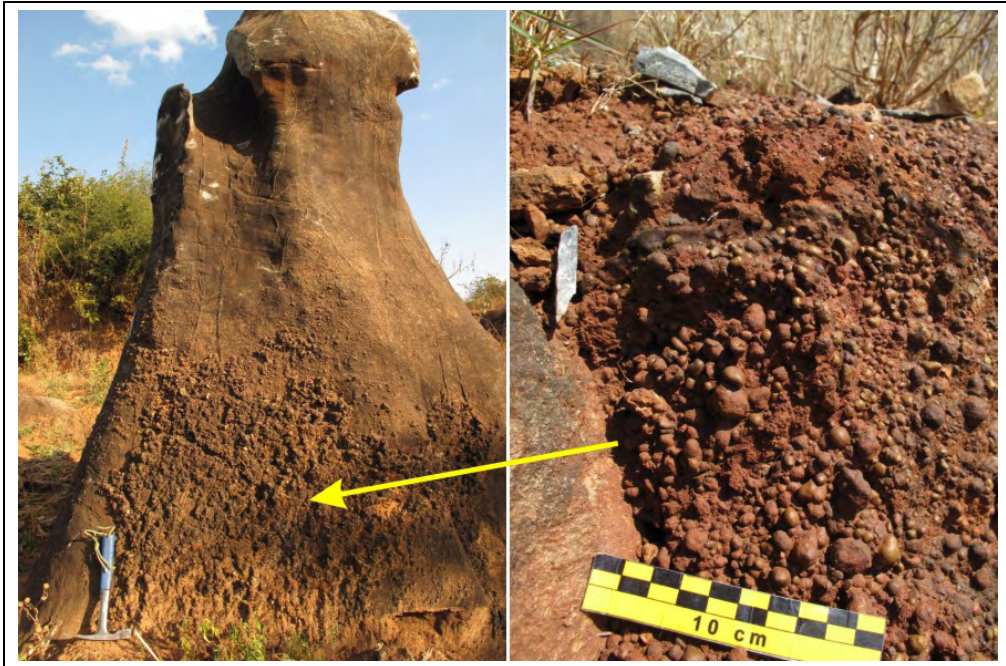
Figure 29: Left: Solution pillar of Lusaka Dolomite with remains of pisolitic plinthosol (WP 063).
Right: close up of similar pisolitic plinthosol from location of WP 031.

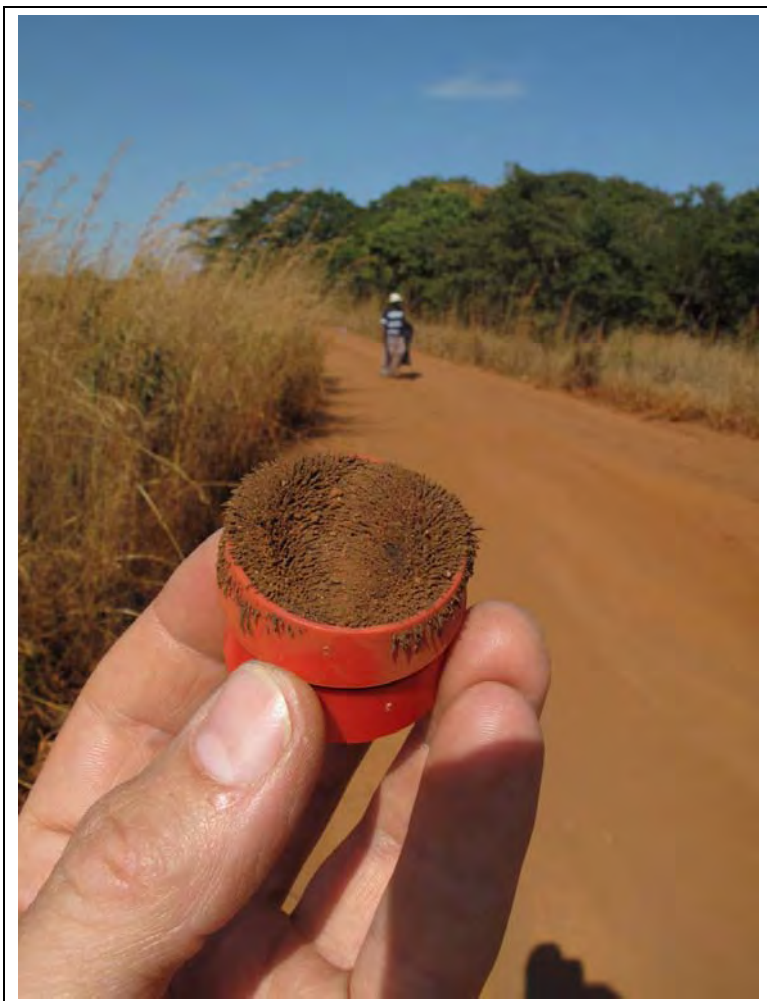
Figure 30: Dispersed magnetite in plinthic soil sticking to a magnet (WP 034).

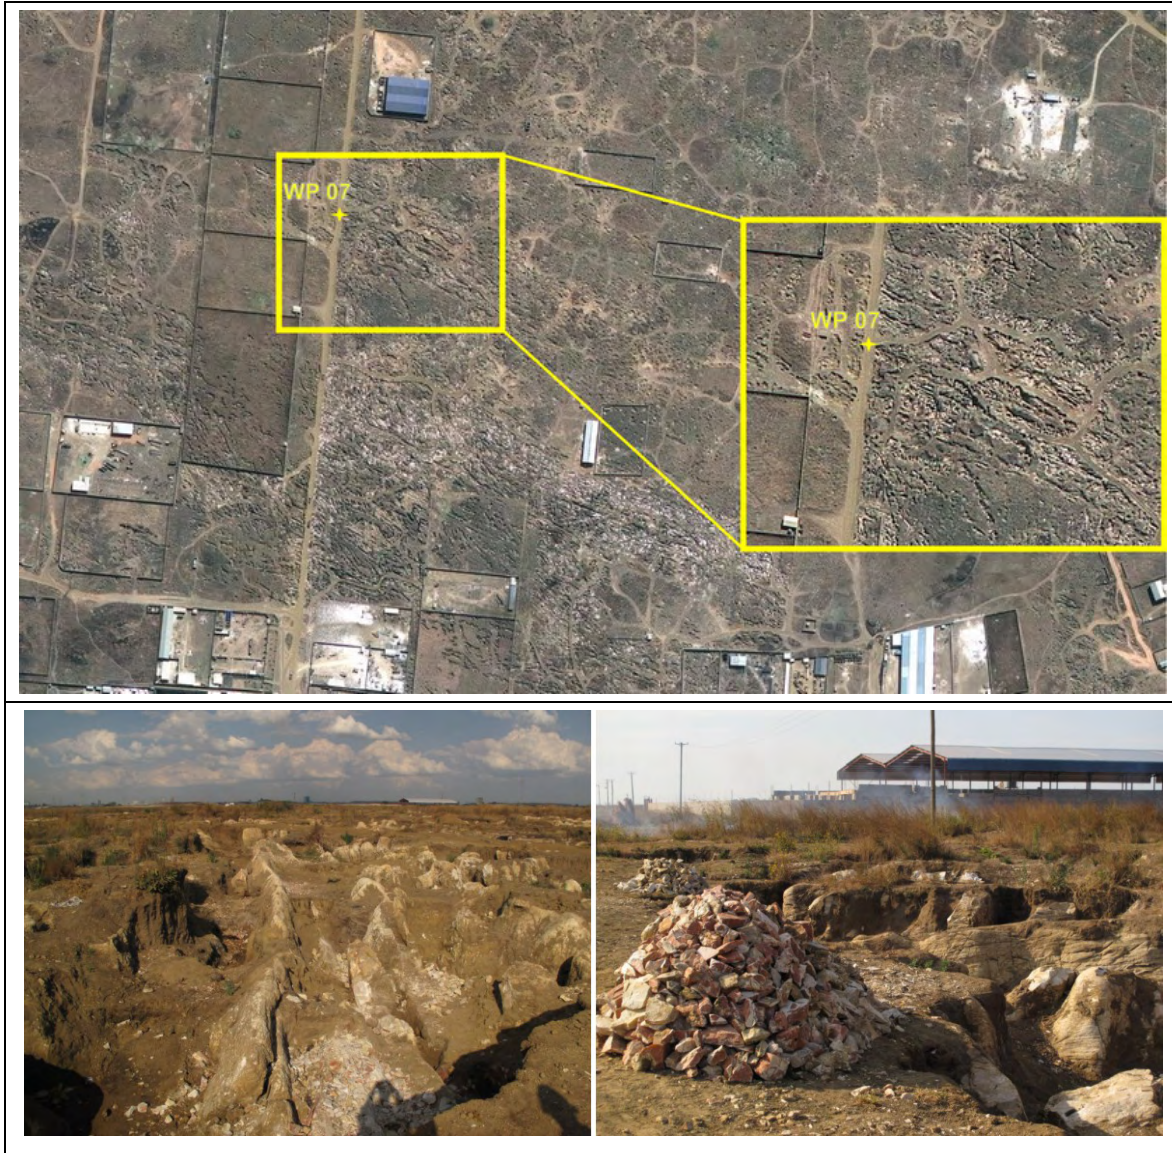
Figure 34: Above: removed soil from Lusaka Dolomite enhances the karst structures of that formation. Inset shows a close up of the area of ground check at WP 007 west of the city. High resolution Quickbird Image from “Google Earth”, acquisition date: July/12/2009. Below: Field photos of that area show karst features. Left: view to SE along structural trend. Right: small unofficial limestone quarry to fetch material for construction purposes.

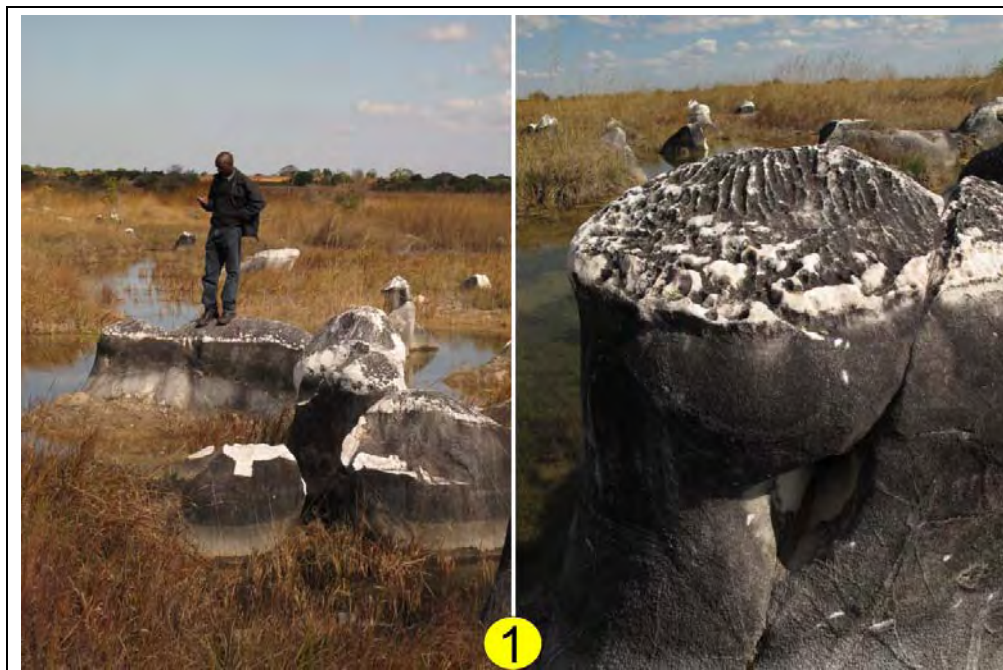
Figure 38: Solution pillars with micro karst on surfaces confining small ground water-filled ponds where soil was removed (WP 062).

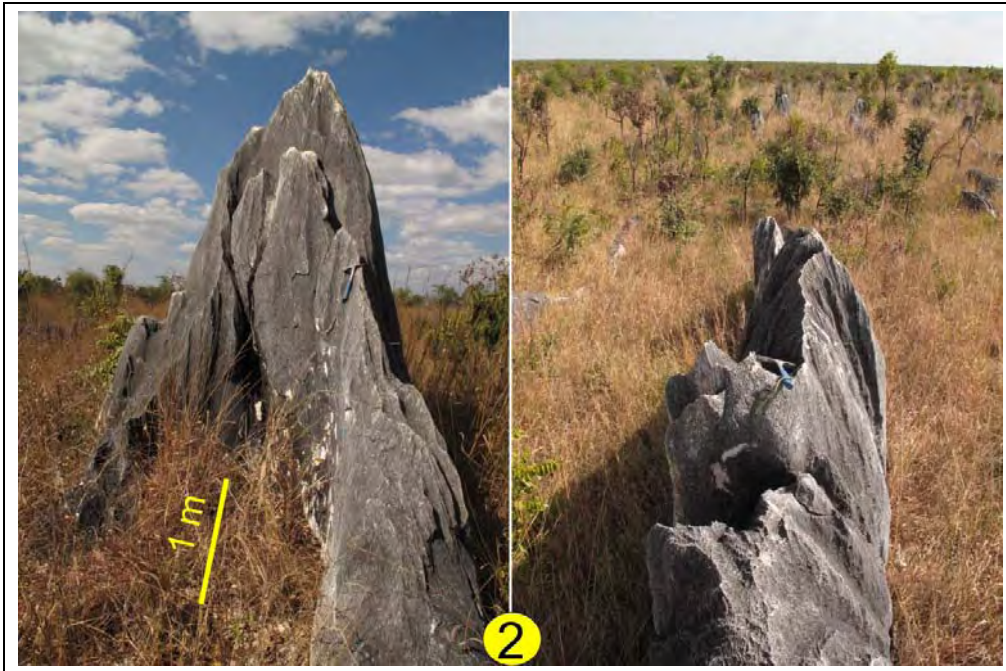
Figure 39: Pinnacle karst up to 5 metres high in the area of Lusaka South Local Forest (WP 060).

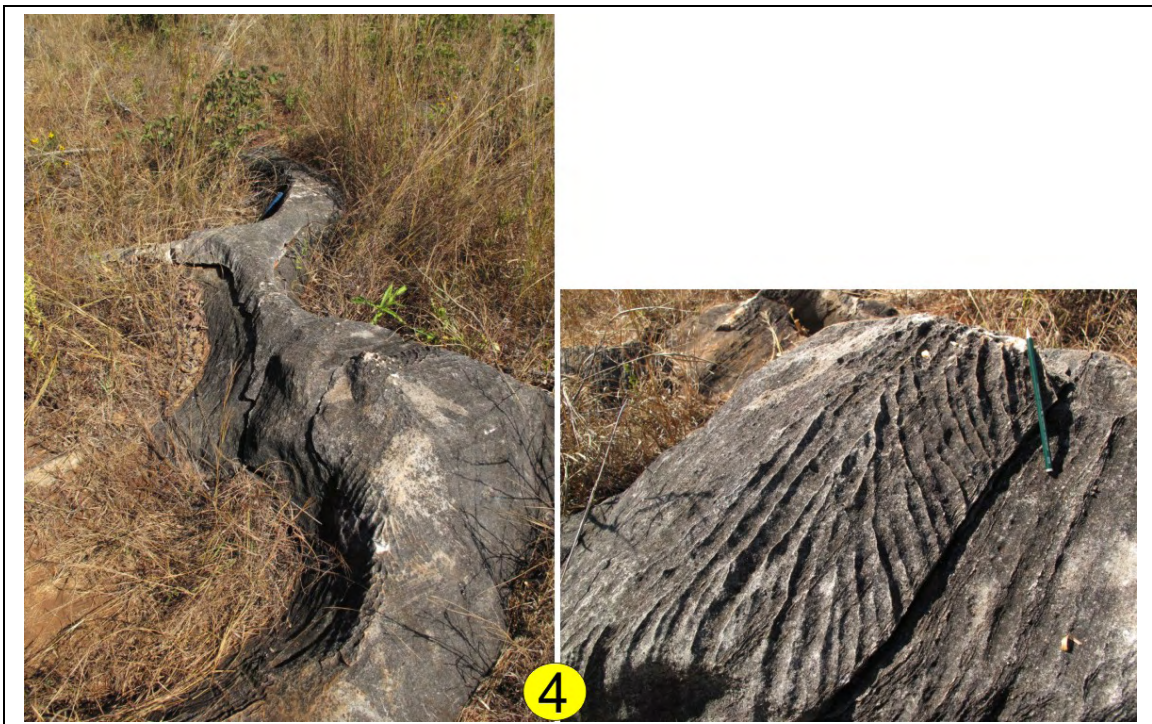
Figure 42: Soil-filled karst holes and micro karst on surface of Lusaka Dolomite (WP 053).

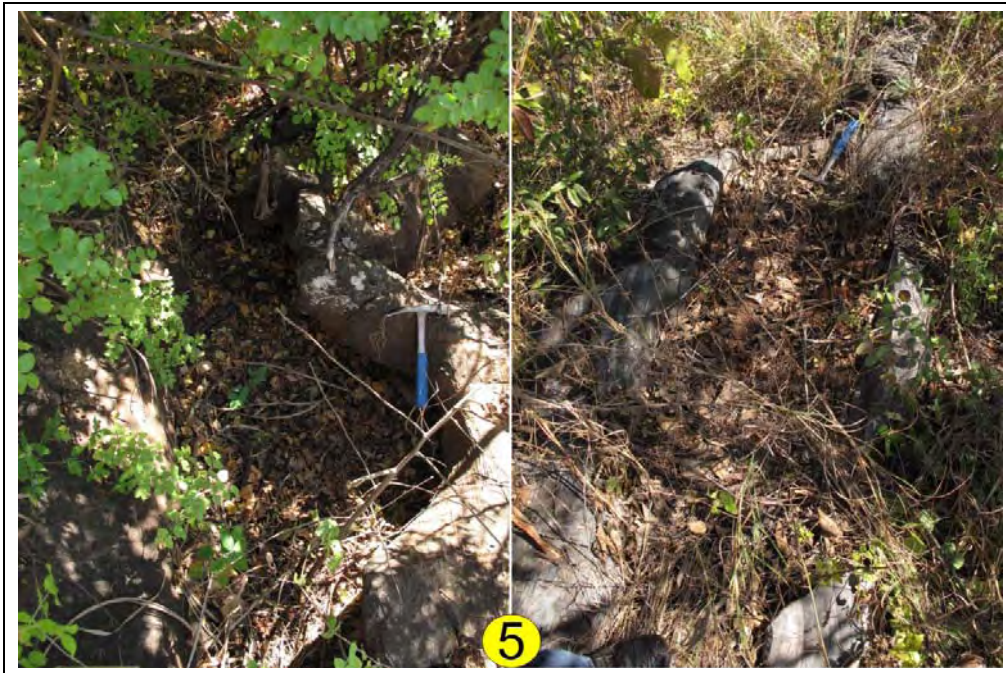
Figure 43: Soil-filled karst holes (WP 043).

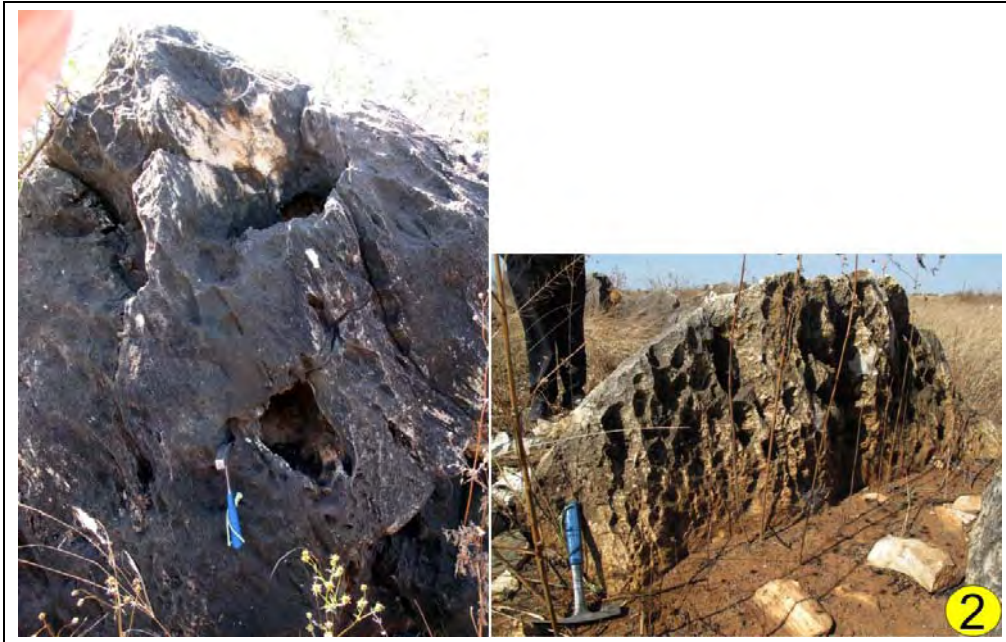
Figure 47: Small karst holes and micro karst in Lusaka Dolomite. Pinnacle karst with heights from 0.3-2.5 metres (WP 029).

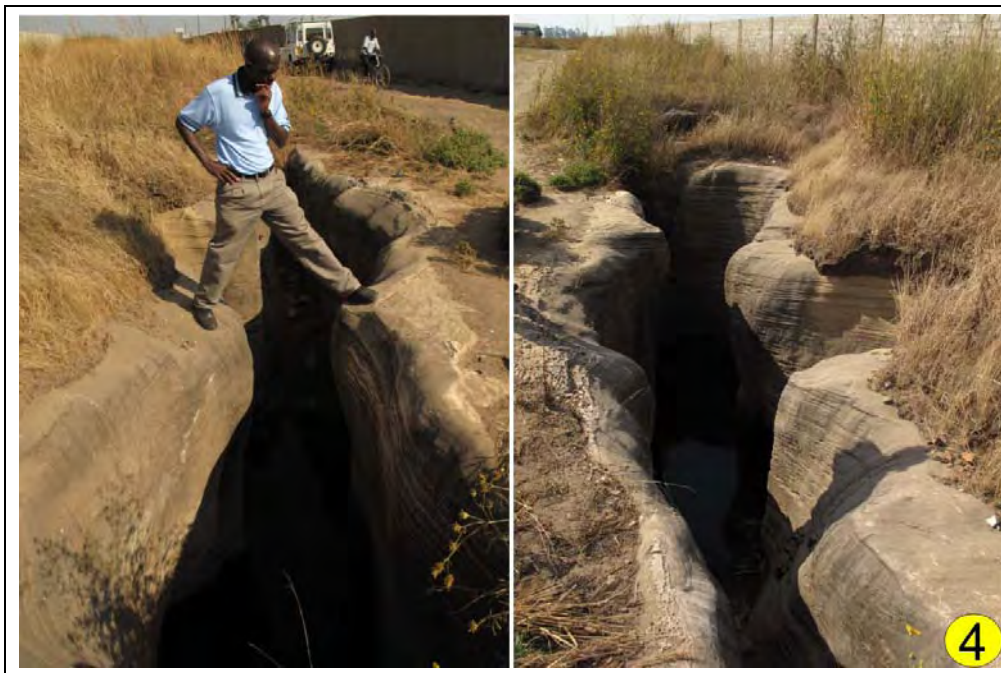
Figure 50: Water-filled karst hole; 2.5 metres deep (WP 006).

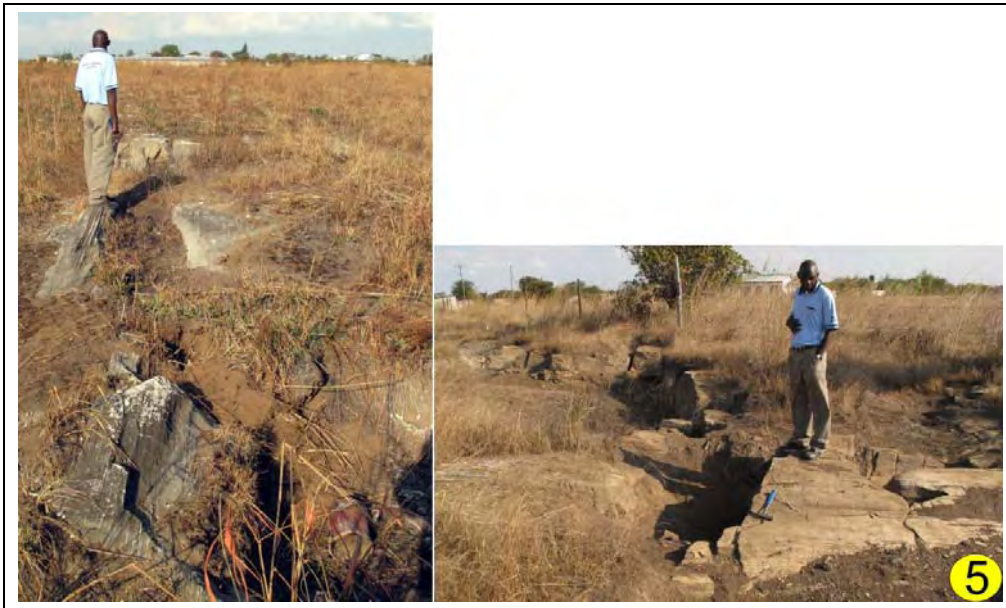
Figure 51: Soil-filled karst holes between steep layers of Lusaka Dolomite in development area (WP 008).

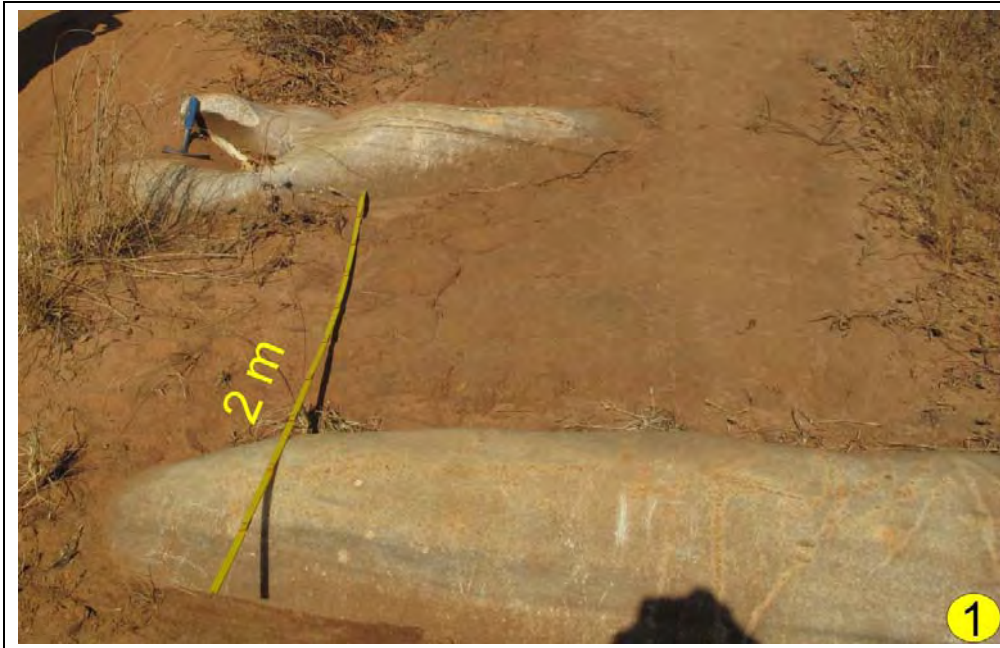
Figure 53: Soil-filled karst holes in calcareous horizon of Chunga Formation (WP 121).

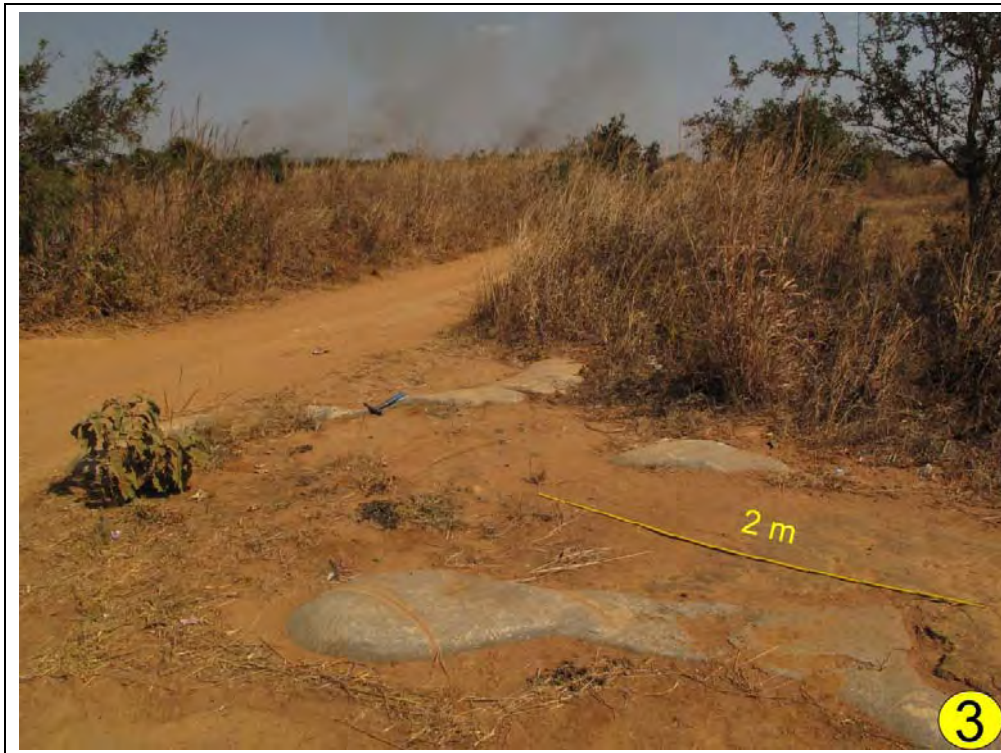
Figure 55: Soil-filled karst hole of Cheta Formation (WP 128).

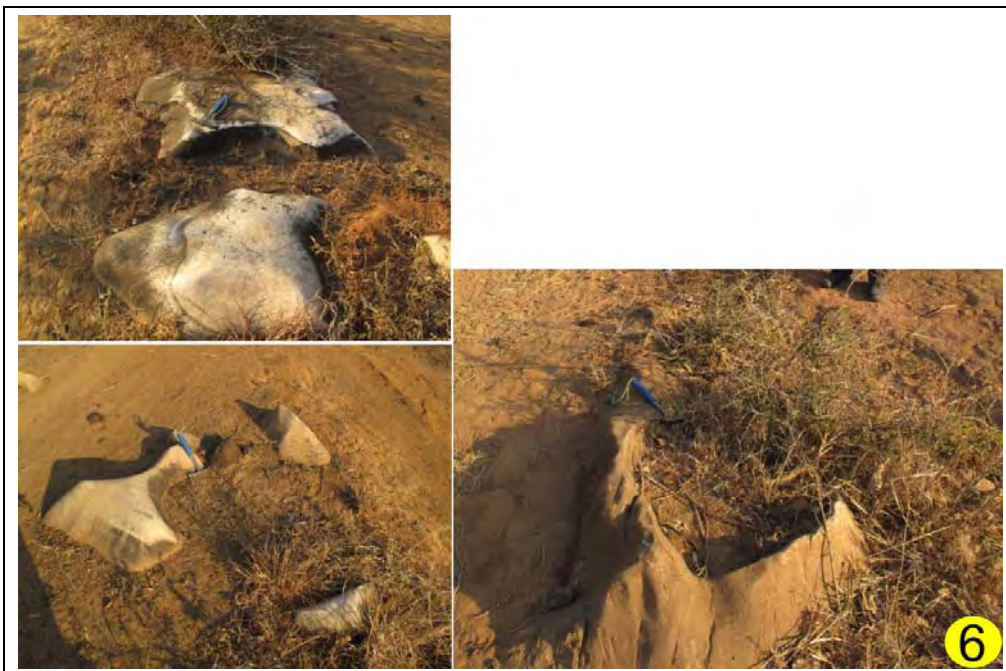
Figure 58: Soil-filled karst hole of Cheta Formation (WP 078).

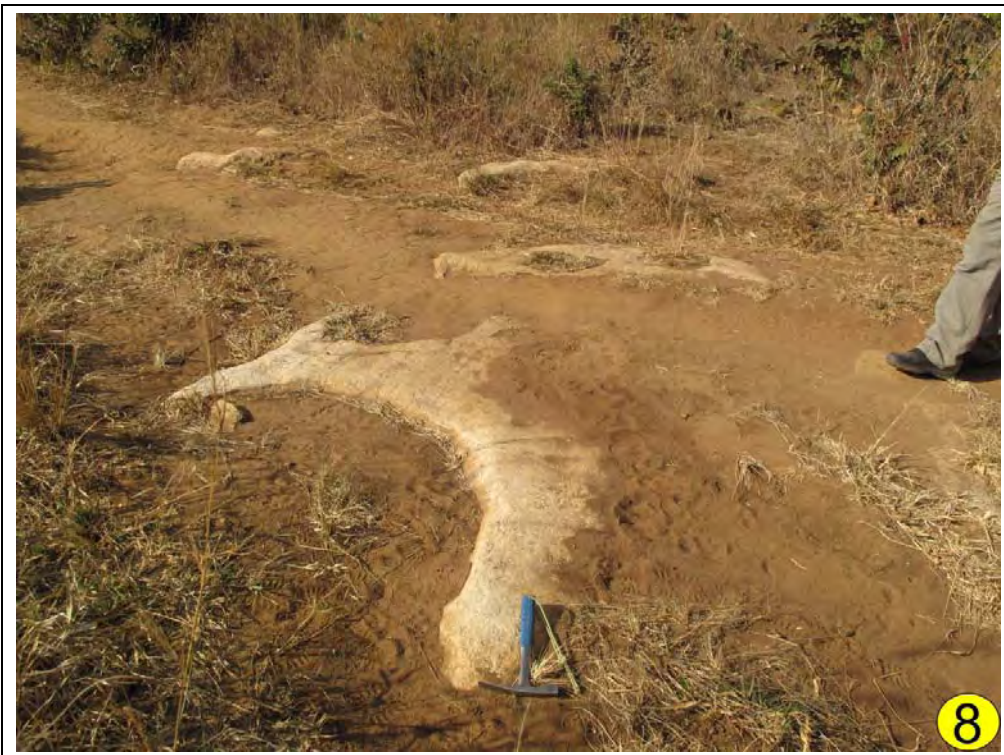
Figure 60: Soil-filled karst hole of Cheta Formation (WP 104).

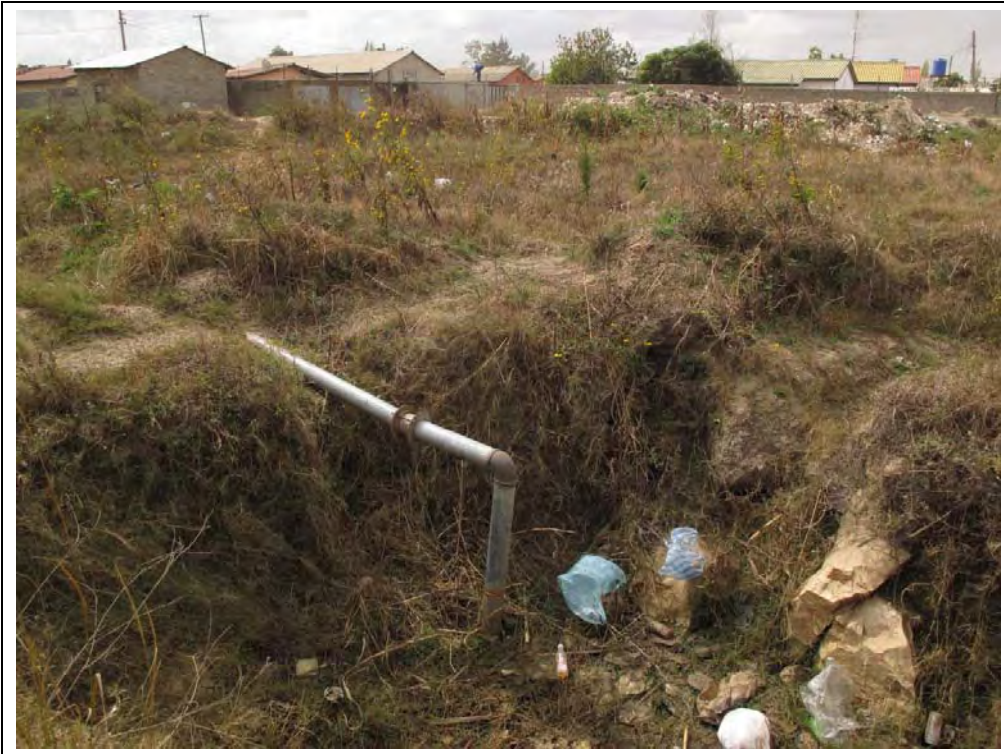
Figure 62: Local water supply of a compound may be affected by ground water contamination from dumping and pit latrines nearby (WP 013).

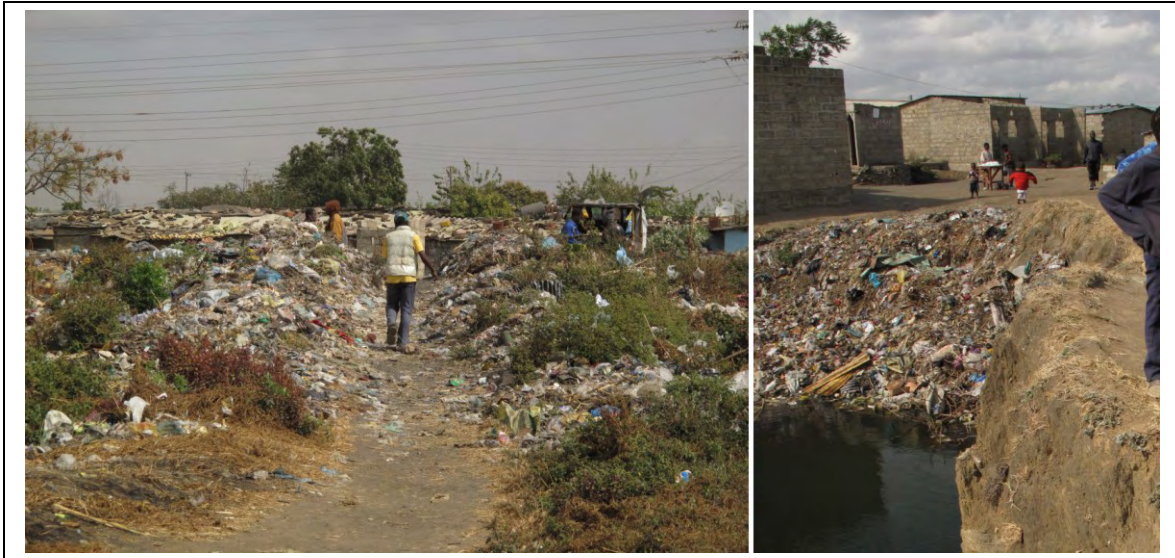
Figure 64: Dumping in karst area of Lusaka Dolomite can cause ground water contamination. Left: WP 016, right: WP 009.
