# Development of a Groundwater Information & Management Program for the Lusaka Groundwater Systems

TECHNICAL NOTE NO. 1

PRELIMINARY ASSESSMENT OF THE  
HYDROGEOLOGICAL SITUATION AROUND LUSAKA  
SOUTH LOCAL FOREST RESERVE NO. 26

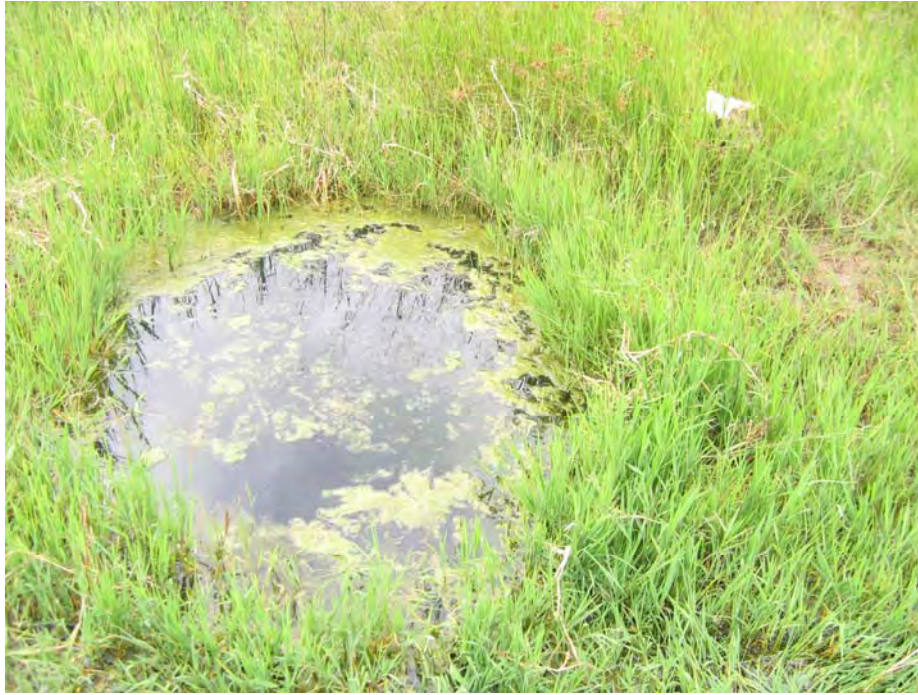
Figure 1: Spring near Shantumbu Basic School (28°22'26"E 15°33'48"S) located South of Forest No. 55

Springs and seepage zones typically occur along the margins of the elongated body of the Lusaka Dolomite Formation at the contact between the carbonate rocks and the surrounding schists or other less permeable rocks (e.g. Spring near Shantumbu Basic School, Fig. 1). Many of the springs are seasonal with an average discharge rarely exceeding 5 L/s. (Schmidt 2001).

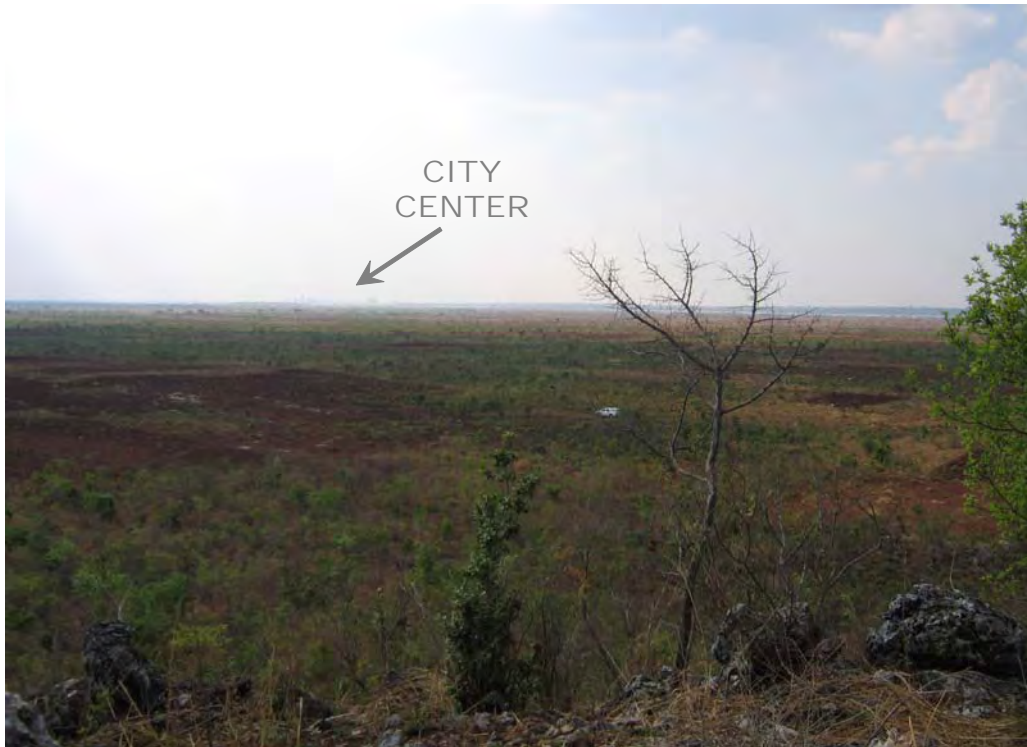
Figure 2: View from an outcrop on the northwestern parts of the Forest Reserve (near DWA monitoring borehole). In the background to the North, the City Centre can be seen

The original woodland of the Forest Reserve area has undergone severe deforestation, bush burning and clearing and now only covers an area with often shallow soils between local outcrops of dolomitic rock. Today, the area is widely used for informal farming and pasturage. Areas under cultivation are found next to open bush and tree grassland (Fig. 2).

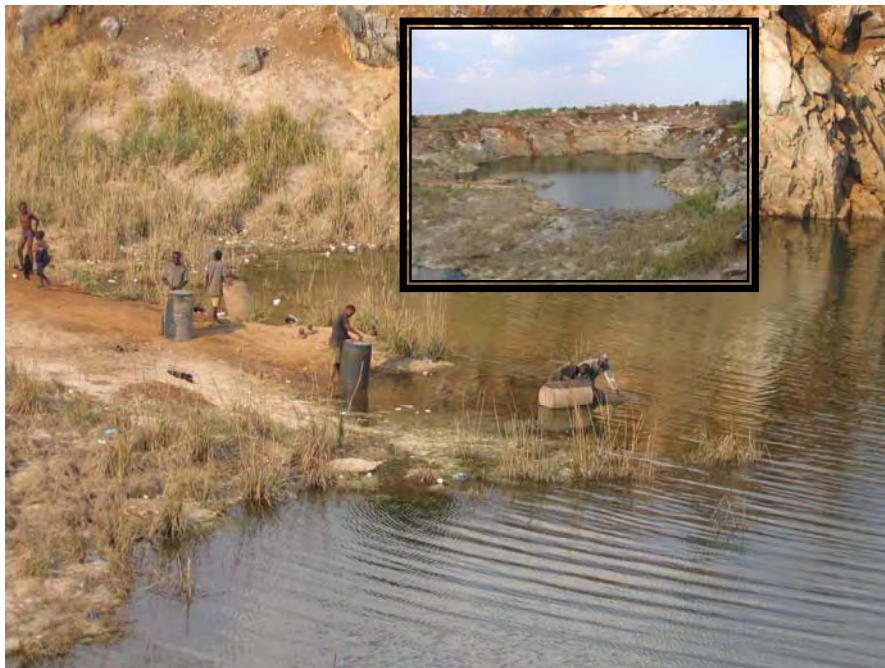
Figure 4: Abandoned quarry with open groundwater along the track from Chilenje Compound southwards to the Local Forest Reserve.
