# Development of a Groundwater Information & Management Program for the Lusaka Groundwater Systems

TECHNICAL NOTE NO. 8

RESULTS OF DRILLING AND TEST PUMPING AT SELECTED SITES IN KAFUE AND CHIBOMBO DISTRICTS

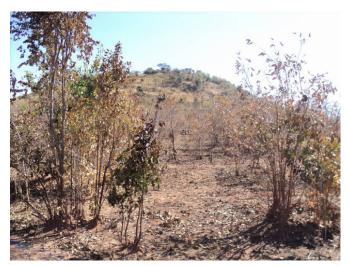
Figure 6: Chisombola Hill: Metamorphic Schist / Psammite / Quartzite

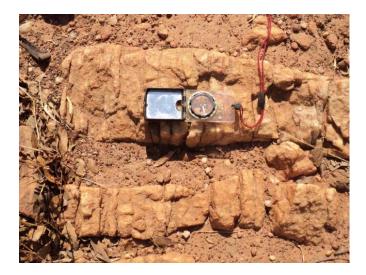
Trending along the southern break of slope of the hill is a prominent thick band of outcropping pale to white quartzite. This is interpreted as the infilling of a fault or thrust zone which separates the described prominent psammite and schist from low lying crystalline limestone. It is also observed crossing the limestone as a low amplitude but prominent ridge about 2km to the north east. During the various formative tectonic events the brittle quartzite was repeatedly fractured producing at least two distinct cleavage sets:-

- a) 0-10° tight and intense cleavage set every 50 to 100mm
- b) 90-100° open and less intense cleavage set every 300-500mm

Figure 9: Quartz fault zone infill – with two prominent cleavage sets

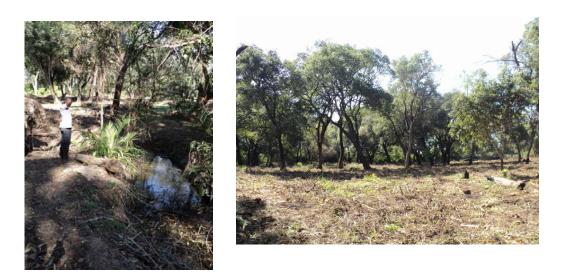
Figure 11: Mature vegetation and very shallow groundwater in the P-2 target area

The vegetated area floods each rainy season particularly after heavy storms. Some old drainage ditches and holes left by falling trees show groundwater at just 0.5m below surface (June 2011). There are no existing boreholes within this feature. The closest boreholes are to the west and within the compound of the Rosedale Police Post (Table). This compound is supplied by a productive borehole, drilled to about 60m depth and just west of the vegetated feature on ground prone to flooding. No outcrop is observed. The borehole is inaccessible within an overgrown and dilapidated shed but is the main supply borehole to the compound. Two further boreholes located slightly further west are less productive and shallower. Further south and west but within 800m boreholes drilled both

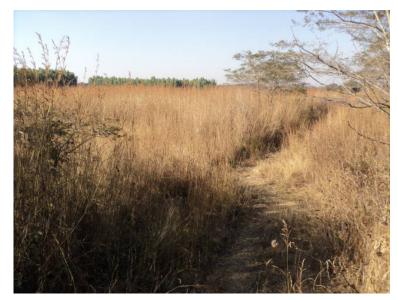
Figure 13: Looking east across the Chilongolo Dam from top of earth dam wall

The center point of the target area lies just inside an old earth dam constructed across the Chilongolo Stream. The dam was breached some years ago and no longer fulfills its intended purpose. The area is covered by tall reed grass. To the south and south west of the dam scrubland undergrowth occurs for several hundred meters before irrigated cropland belonging to Sunrise Farms. To the northwest, north and east are small holdings belonging to various individuals. The soils are reddish brown and no outcrop, subcrop is observed anywhere in the vicinity. There is sparse quartzite float observed at the crop edge but it cannot be concluded that this is representative of the subcrop as it may have brought in from elsewhere. The terrain is completely flat apart from the mentioned man-made earth dam and the narrow, eroded depression of the mentioned stream.

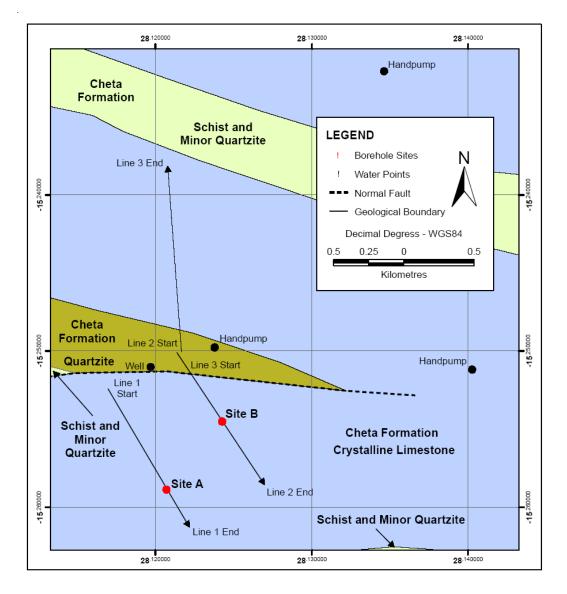
Figure 14: Site Map – Target Area P-1 (Katete)

The map above shows the geophysical lines and borehole sites in relation to mapped geology. Limestone outcrop is observed on all lines coincident with and producing a resistive EM signature. Wherever the EM signature is more conductive then the limestone outcrop is not seen (suggesting a different, more weathered, geology). Conductive portions often have in-situ quartz dyke material at outcrop. The two drill sites (A and B) are selected differently. Site A is within the mapped limits of limestone but only a thin quartz dyke is observed and no limestone – this may be the faulted edge of the limestone and a zone of groundwater channeling / circulation. Schist may also be indicated. Site B is chosen on a definite outcrop of limestone which exhibits miniature karstic features despite having a very resistive EM response, (see the text box next page for more details and also Annex 1/Appendix 1).

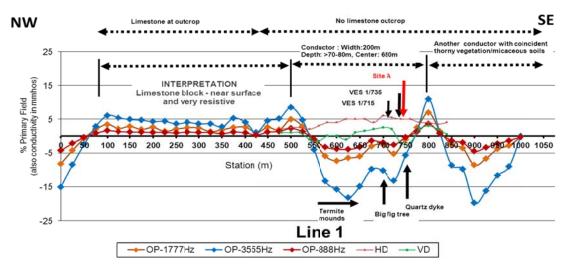
Figure 15: Profile Line 1, Target Area P-1 (Katete)

From Max-Min profiling (flat response) and visual observation - a block of limestone is interpreted between stations 75 and 500meters. From station 550 meters to line-end, at station 1050 meters no limestone outcrop or float is observed at all - but this is well within the area of limestone on the geological map. This zone is coincident with a striking change in the EM profile with two significant conductors centered at 650 and 900 meters. The questions that can be posed are: Are the conductors caused by faulting and thrusting producing a weathered edge to the limestone? Or, are they caused by an unmapped change in geology? Both scenarios are possible and both could have enhanced groundwater potential. The conductor at the start of this line (0-75m) and those seen on Lines 2 and 3 all exhibit outcrops of highly cleaved quartz dyke material at or near the center points. Indeed a thin quartz dyke is observed within this conductor (750m). This seems to support a dislocated limestone interpretation. Superimposed on this conductor is a short EM-34 profile. This shows the deeper dipole conductivity flicking to negative central to the feature - a response often seen over faulted rock zones. A resistivity sounding (VES) and profile were also conducted and these vielded a narrow resistivity low of 225 Ohm-m at a probing depth of +/- 80-90 meters (Site A). Piezometer positions can be selected on the basis of the drill results. Site B has been chosen on an area of definite limestone outcrop - on Line 2 (Annex 1/Appendix 1).

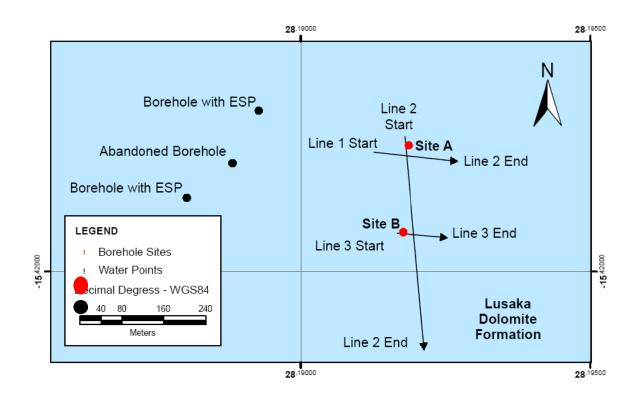
Figure 16: Site Map - Target Area P-2 (Kasanova)

The map above shows the geophysical lines and borehole sites in relation to mapped geology (blue = Lusaka Dolomite Formation). Dolomite was only observed at outcrop toward the end of Line 2. The two drill sites (A and B) are selected mostly in relation to the morphology and vegetation of the feature under investigation although the conductivity profiles allowed the fine tuning of the drill sites onto zones of thickest weathering.

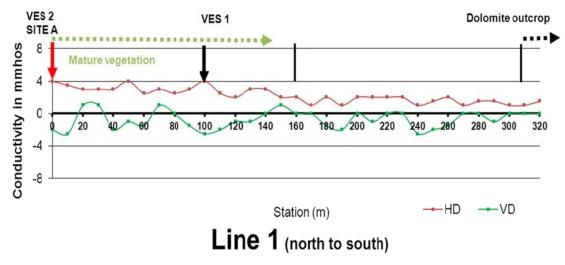
Figure 17: Profile Line 1, Target Area P-2 (Kasanova)

The observed E34 conductivity profile line 1 – can be split roughly into two equal portions. Portion A (0 to 160m) has mature vegetation, elevated horizontal dipole (H<sub>D</sub>) and jagged, frequently negative, vertical dipole, (V<sub>D</sub>). Over portion B, (160 to 320m) which is not vegetated, the two dipoles converge about the y-axis i.e. highly resistive conditions at shallow depth are indicated. It is interpreted that portion B has dolomite at subcrop, as seen at outcrop at the extreme southern end. This might also explain the lack of vegetation. Portion A, on the other hand, has a deeper weathering zone producing the higher H<sub>D</sub> values. Resistivity soundings (VES) indicate that the weathering could go down to  $\pm$ - 20 meters. The negative V<sub>D</sub>, although not very convincing, is indicative of ground which is dislocated at depth. Thus Site A may intersect soils and weathered dolomite to the 20m level followed by fractured, possibly karstified, dolomite thereafter. The big mature trees support this interpretation. Having stated this – dolomite drilling is notorious for springing surprises. A similar feature is chosen at the west end of Line 3 (Site B). The drilling order is A then B (if required). Piezometer positions can be selected on the basis of the drill results. Piezometer 1 will be along profile 20-25m from the borehole and Piezometer 2 will be 40-50m from the borehole in perpendicular sense.

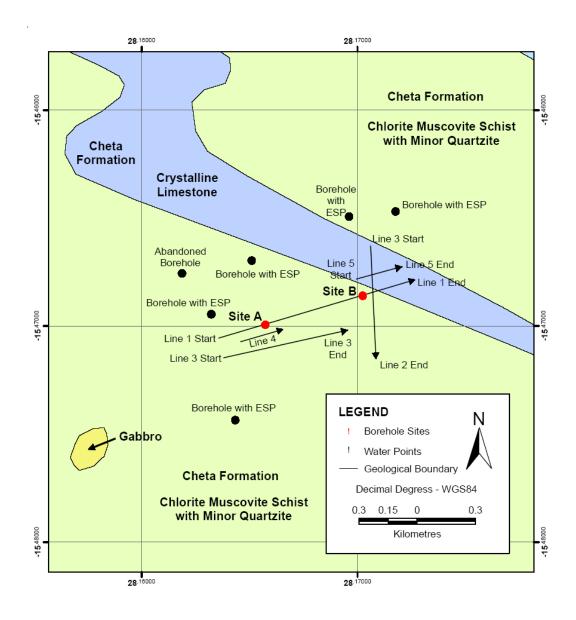
ESP = Electric Submersible Pump Figure 18: Site Map – Target Area P-3 (Makeni)

The map above shows the geophysical lines and derived borehole sites in relation to mapped geology. It should be noted that no outcrop was observed on any of the lines or within the area generally. Sparse quartz vein float was observed toward the end of line 2 – which may or may not be representative of the underlying rock formation at this point. The two selected drill sites (A and B) are geophysically derived (text box next page).

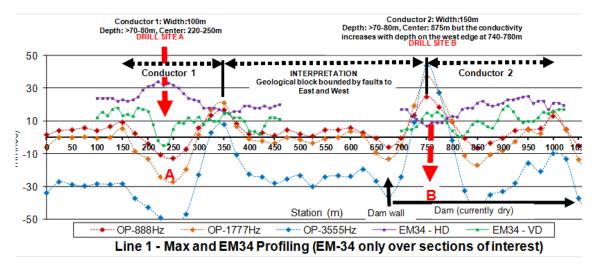
Figure 19: Profile Line 1, Target Area P-3 (Makeni)

From Max-Min profiling two significant conductors are interpreted centered at +/- L1/225-250 and L1/850-900m. A smaller one is seen at station L1/675 coincident / beneath the earth dam wall. The first half or another large one is seen at the east end of the line (it could not be fully profiled due to an intervening brick wall). All of these are most likely the response of fracture trends / geological trends in the bedrock which have been weathered outward and below the general level of weathering - by circulating groundwater. Superimposed are two shorter EM-34 profiles. These show the deeper dipole conductivity (probing to +/- 50 meters) in the range of 5-15 mmhos (or 60-200 Ohm-m) which is an ideal range for groundwater intersection more or less at any point along the profile. Two sites have been chosen. Site A is in the center of Conductor 1 and Site B is on the western edge of Conductor 2 where conductivity is seen to increase with depth. The two targets have differing responses but both indicate deeper zones of weathering - possibly associated with faulting or fracturing and above average ground water potential. The drilling order is A then B (if required). Piezometer positions can be selected on the basis of the drill results. Piezometer 1 will be along profile 20-25m from the borehole and Piezometer 2 will be 50-75m from the borehole in perpendicular sense. Some parallel EM34 lines (Lines 4 and 5) were executed to help position the 2<sup>nd</sup> piezometer in each instance.

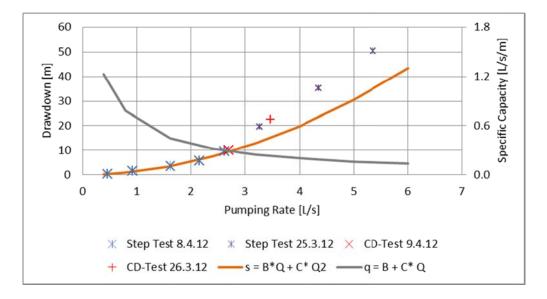
The non-linear well losses at the pumped well must be considered very high resulting in an overall very low well efficiency in particular at higher pumping rates. The proposed discharge from the well is therefore only about 3.0 L/s which is presumably well below the sustainable yield from the formation. According to the drilling records the yield of the boreholes P1-4 is estimated at over 20 L/s.

There is generally an excellent correspondence between the results obtained from the Hantush-Bierschenk and the Eden-Hazel methods (Annex 3-1). Values of the nonlinear well-loss coefficient *C* obtained from the two separate tests correspond also very well. The parameter set for *B* and *C* obtained from the main test underestimates to some extent the drawdowns for pumping rates exceeding 3.5 L/s (Figure 2).

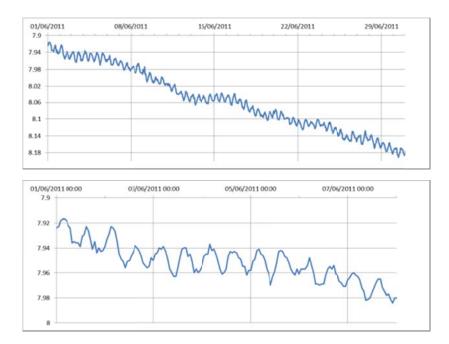
Figure 4: Semi-diurnal pressure head oscillation probably induced by the earth-tide at monitoring well Musopelo BH-38 (E 28.08602, S 15.26030).

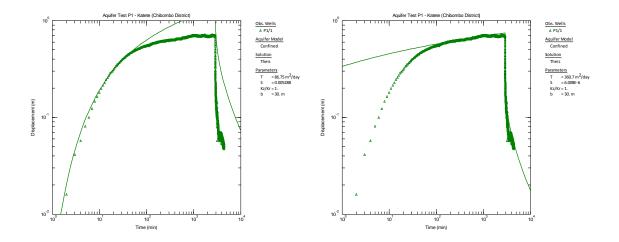
Figure 5: Best fit of observed drawdown vs. time to the Theis solution using early-time data (left) and late-time data (right) at observation borehole P1-1.

At observation wells P1-1 and P1-2, early drawdown (for elapsed time up to about  $\frac{1}{2}$  hour) and late drawdown (time > 1 $\frac{1}{2}$  hour) can be fitted to separate Theis curves for homogeneous confined aquifers. The two sections are divided by a short transition period (Figure 5). The match to early-time drawdown produces a moderate transmissivity (T  $\approx 80 \text{ m}^2/\text{d}$ ) and high storativity (S  $\approx 0.005$ ) whereas the late data result

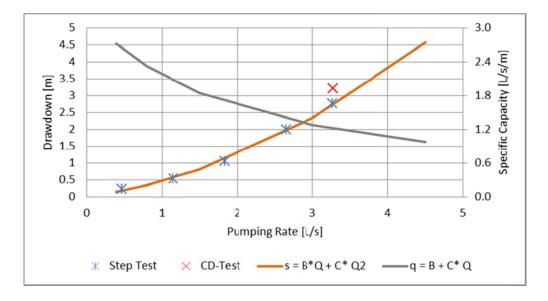
Figure 7: Drawdown and specific capacity for step test at site P2-2 (Kasanova). Dotted symbols indicate observed drawdown. Orange curve shows drawdown, *s* and grey curve depicts specific capacity, *q* as a function of pumping rate, *Q* as predicted by Hantush-Bierschenk method.

The observed non-linear well loss at the pumped well is considerable resulting in an overall low well efficiency. Unfortunately, the well could not be pumped at higher rates because the water level would suddenly plummet to pump intake level. The presence of very shallow water strikes that fall partially dry during pumping hence appear to contribute to the apparent well loss. The proposed discharge from the well is 3.5 L/s but the karstified limestone formation in this area is likely to produce much higher yields.

There is an excellent correspondence between the results obtained from the Hantush-Bierschenk and the Eden-Hazel methods (Annex 3-2), i.e. values of the nonlinear wellloss coefficient *C* obtained from the two methods are very similar. The parameter set for *B* and *C* obtained from the analysis fits observed values very well (Figure 7).

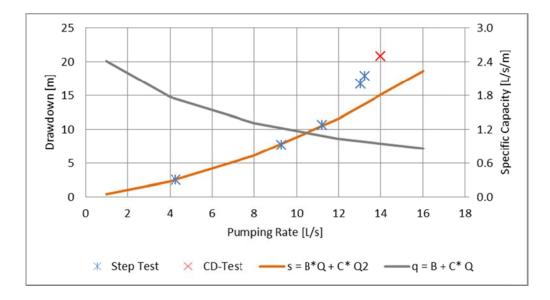
Figure 10: Drawdown and specific capacity for step test at site P3-1 (Makeni). Dotted symbols indicate observed drawdown. Orange curve shows drawdown, s and grey curve depicts specific capacity, *q* as a function of pumping rate, *Q* as predicted by Hantush-Bierschenk method.

The observed non-linear well loss at the pumped well is considerable but overall less prominent compared to sites P-1 and P-2.

Besides, the results for the non-linear well coefficient C obtained from the Hantush-Bierschenk and the Eden-Hazel methods are very similar.

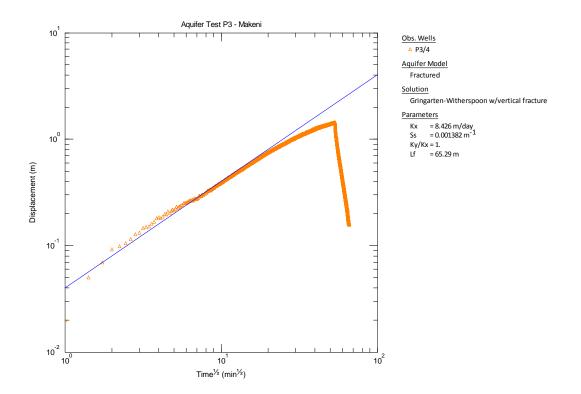
Early drawdown data observed at P3-4 suggests a linear flow pattern along a major vertical fault zone (Figure 12) in correspondence to the geological description in the drilling report. Late time-data shows a pseudo-radial pattern towards the well. The transmissivity obtained for this section is 280 m<sup>2</sup>/d with a storativity of 0.018. A similar transmissivity was obtained for the pumped well from step and aquifer test analysis.

Figure 12: Linear flow pattern observed at well P3-4 indicated by a straight-line section in the plot of drawdown vs.  $\sqrt{t}$

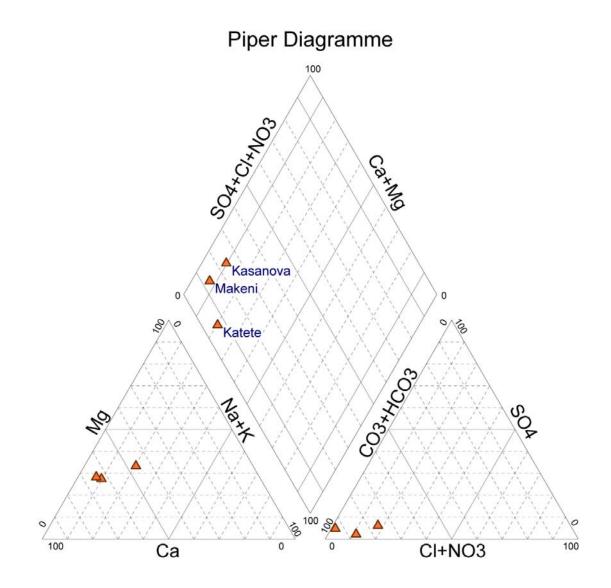
The piper diagram in Figure 2 classifies all three samples as calcium-magnesiumbicarbonate waters.

Figure 2: Piper diagramme of samples from test pumping

In general water quality is good and potable. Nitrate levels are well below the limit of the Zambian Drinking Water Standard (as are all other values). EC values below 800  $\mu$ S/cm at all sites reconfirm the assumption that influence from urban pollution does not exist yet. The sample from Katete – although situated in the Cheta Formation and thus expected to have lower dolomite content – shows the highest Mg/Ca ratio among the three (Katete: 0.4, Kasanova: 0.3, Makeni: 0.3).

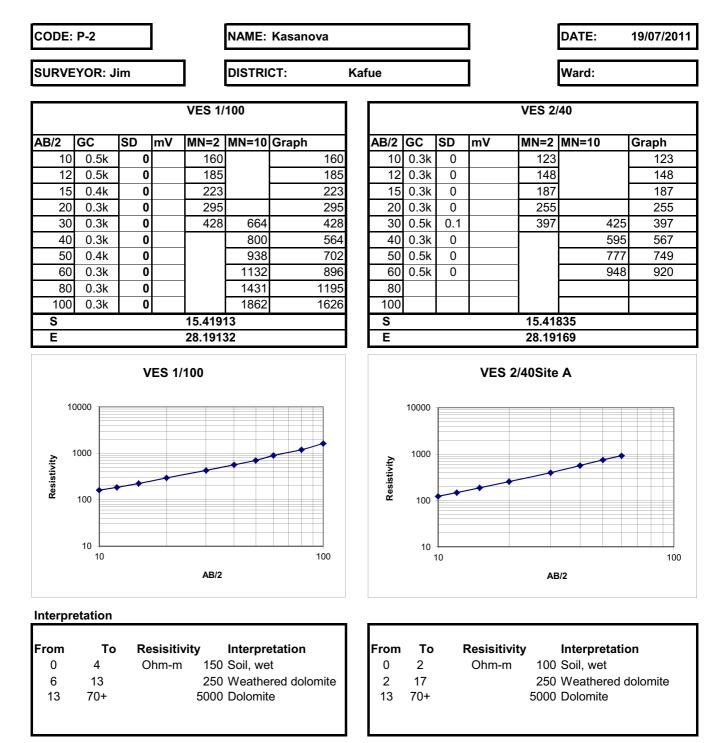
Ground contact very good. Data integrity good. All observations point to a 100% dolomite intersection Weathering layers in dolomite supressed - making interpretation subjective Air percussion drilling method suitable

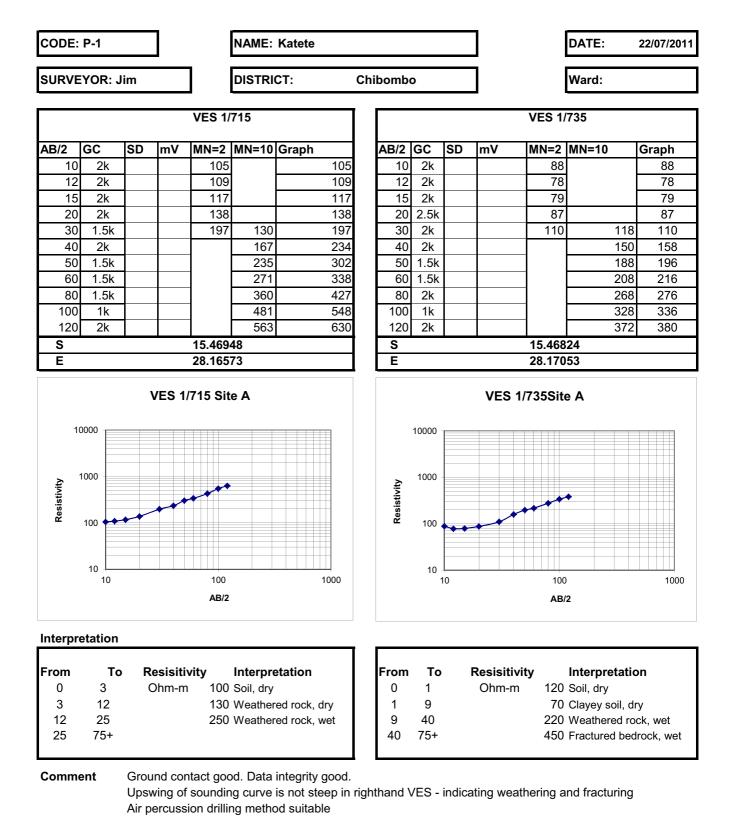
Figure 1.3: VES Data and Interpretation, P-1 (Katete) target.

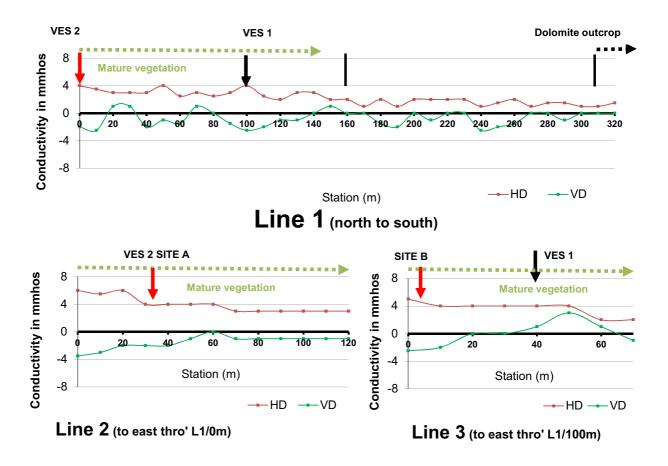
Figure 2.1 EM34 Conductivity profiles

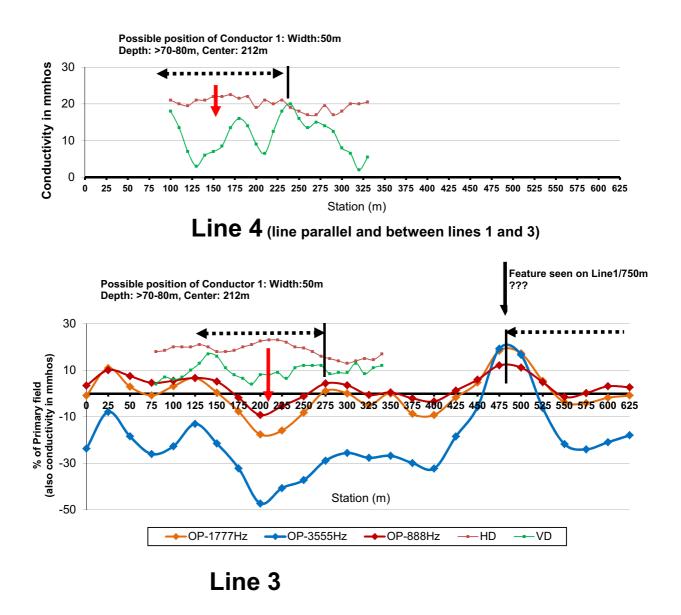
Figure 3.1 Max Min and EM34 EM profile lines

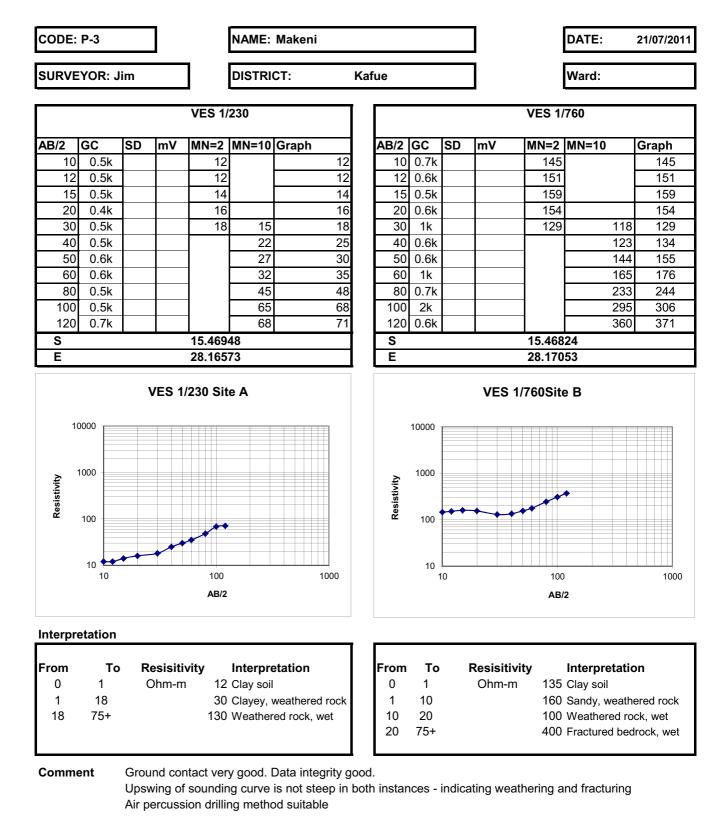
Figure 3.3: VES Data and Interpretation, P-3 (Makeni) target.
